# HISTORIC STRUCTURE and CULTURAL LANDSCAPE REPORT

South Manitou Island Light Station  
(Historic Structures 51-120 A-I)

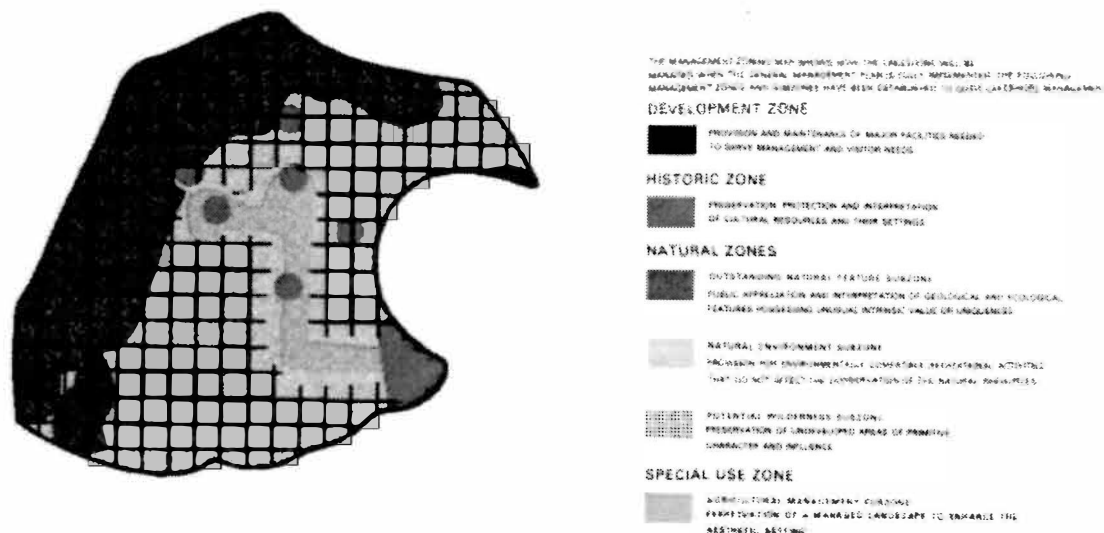
**Figure 4** Drawing from the General Management Plan for South Manitou Island, 1979.

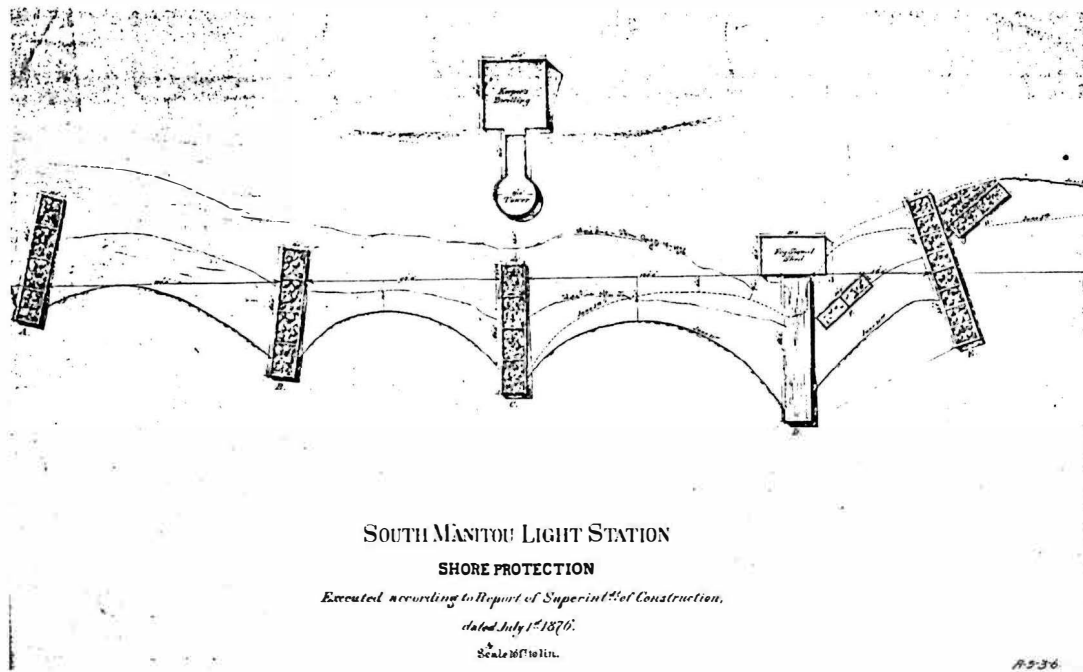
Figure 5 Shore Protection for the South Manitou Island Light Station, 1874.

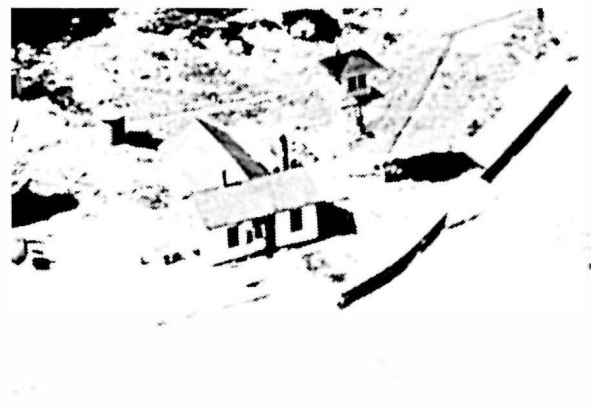
*Figure 8* View of the Fog Signal Building and watchtower; circa 1939-40 (SM #3292, Detail).

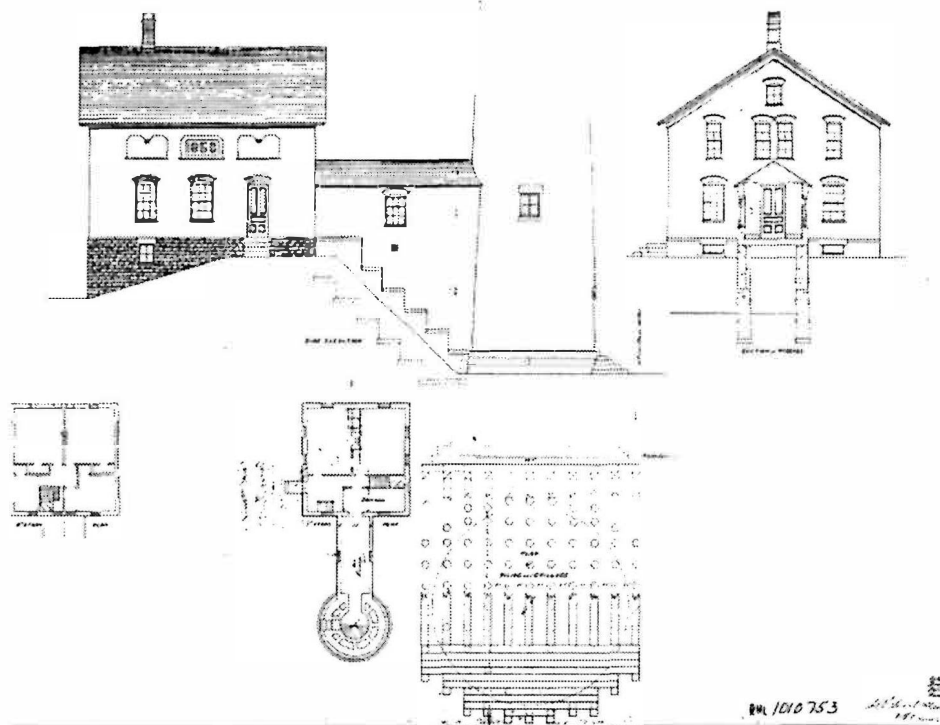
Figure 9 Non-executed construction drawing for the attached Passageway and Tower at the South Manitou Island Light Station, 1870.

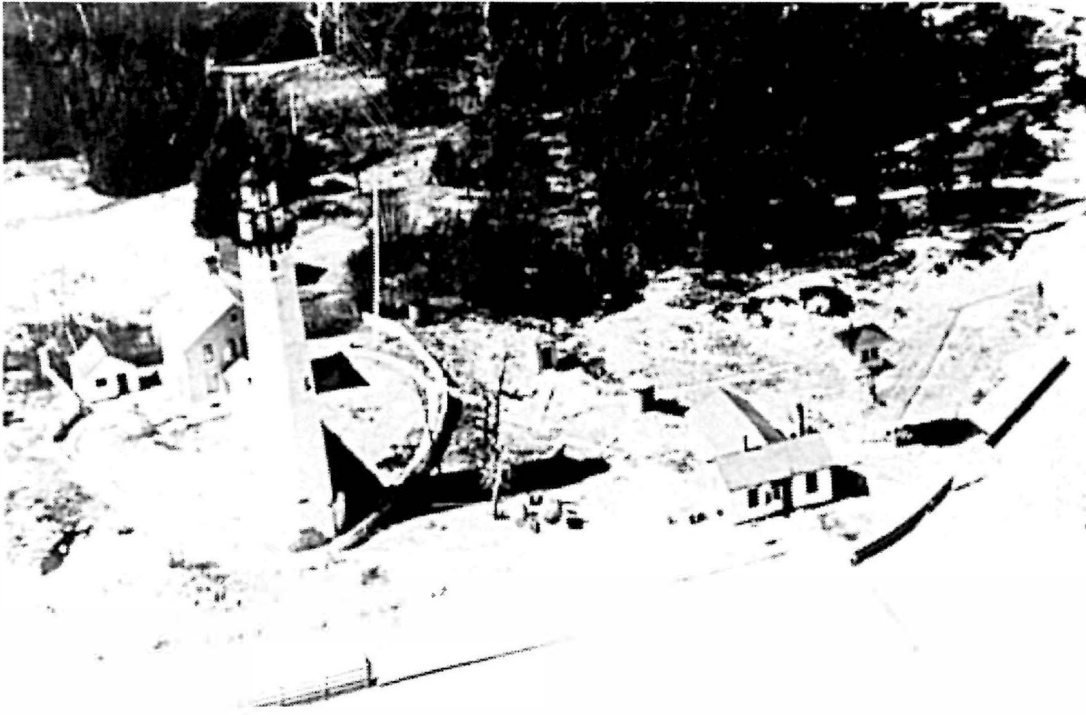
*Figure 16 Aerial view of the South Manitou Island Light Station, circa 1939 - 1940.*

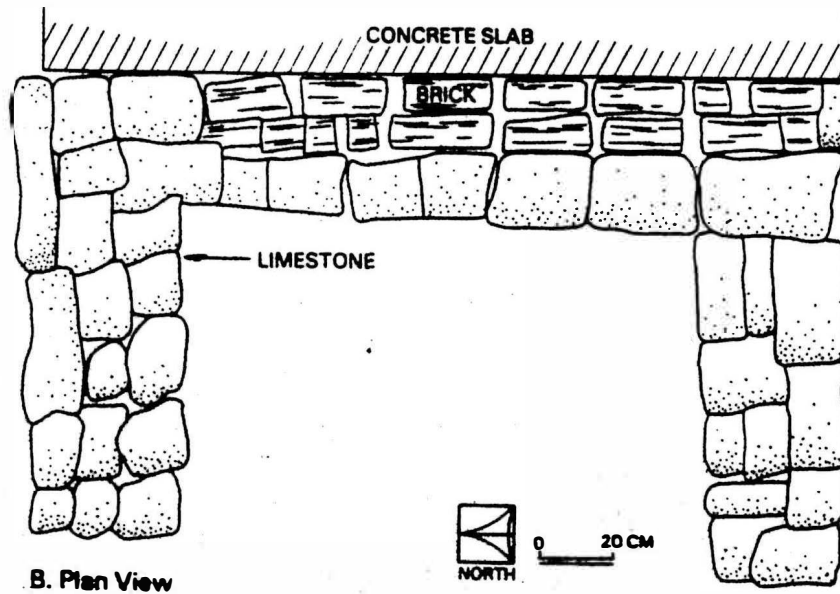
Figure 17 Plan view of the brick and cut limestone foundation unearthed southwest of the Keeper's Dwelling at the South Manitou Island Light Station, 1985.

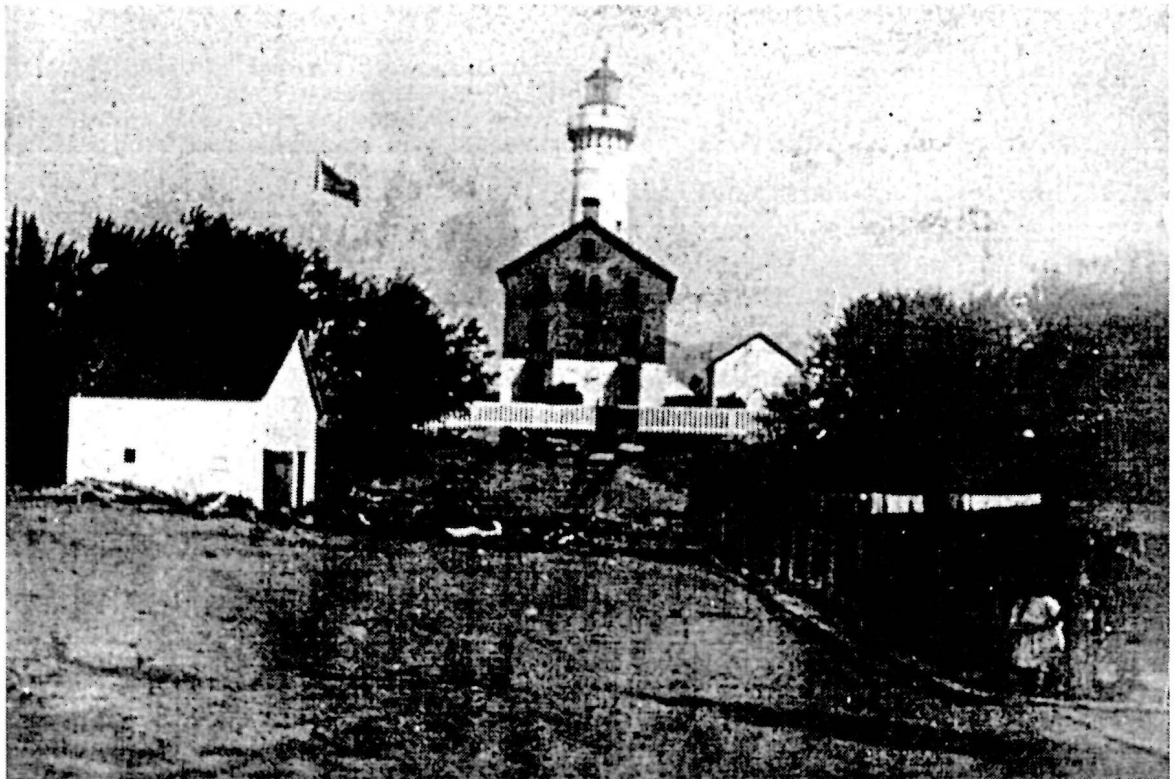
Figure 18 View looking east toward the South Manitou Island Light Station, circa 1928. Note the wood frame structure southwest of the Keeper's Dwelling and the wood picket fence.

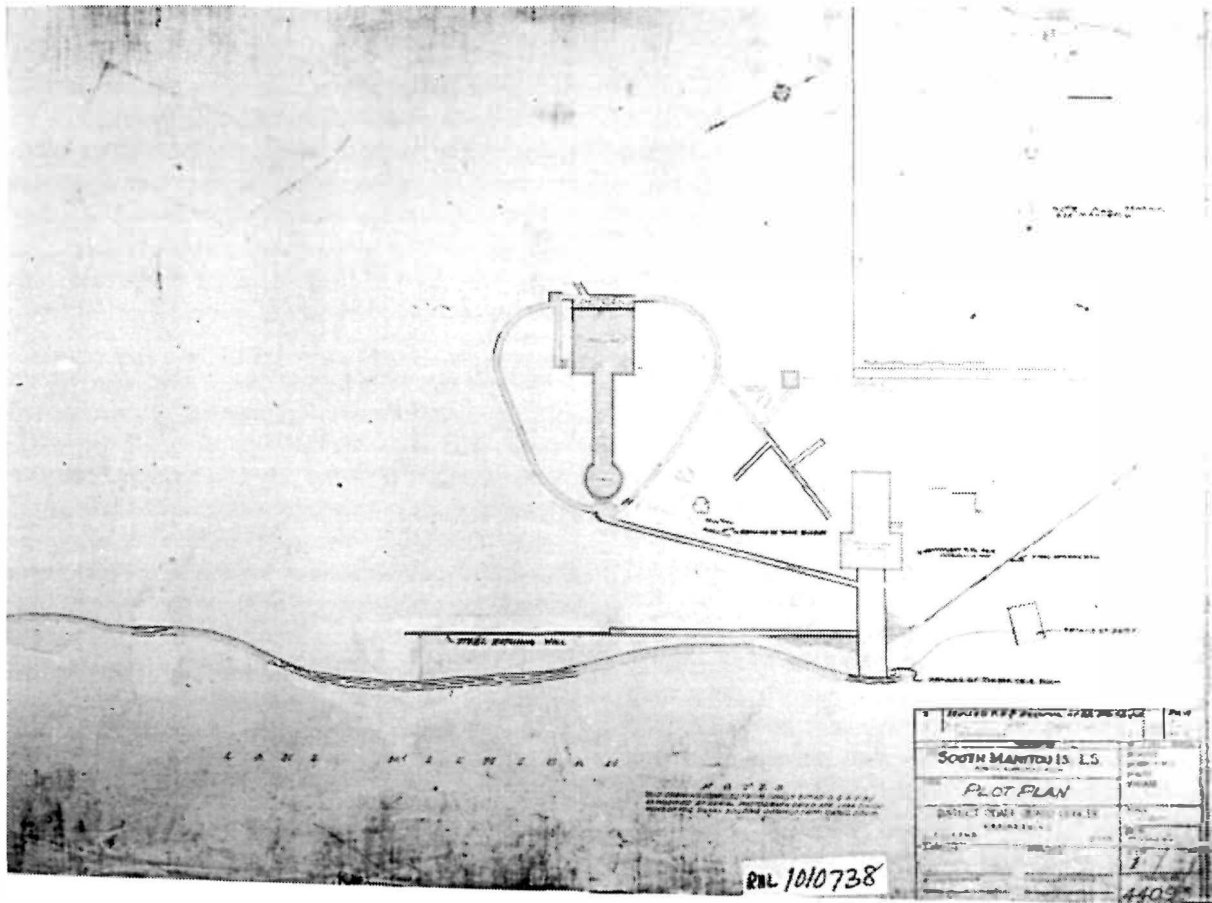
Figure 22 The 1944 South Manitou Is. L.S. Plot Plan , prepared by the U.S. Coast Guard in 1944,

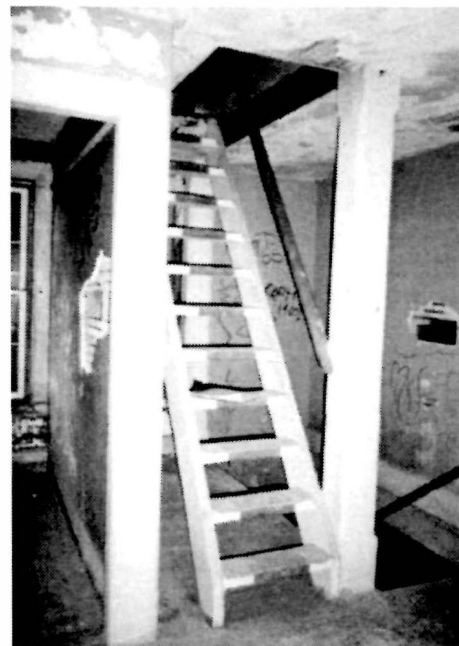
*Figure 1* View of the wood ship's ladder at the second floor central hall of the Dwelling, which leads up to the attic, 1994. Note the "scoop" at the corners of the wood treads and the painted runner.

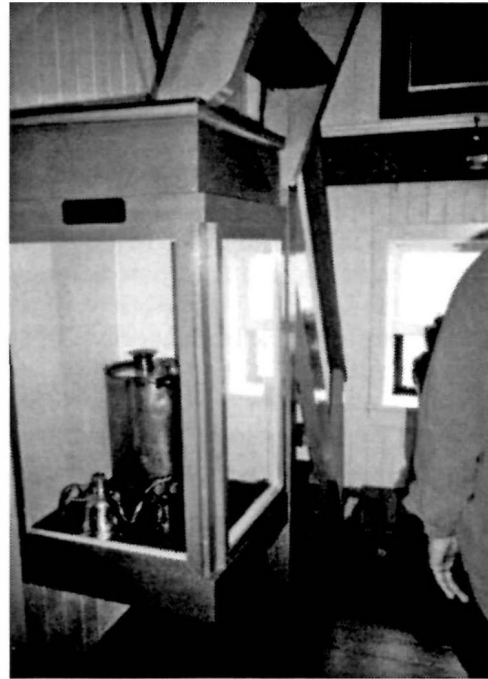
*Figure 3 View of the restored attic space at the Grand Traverse Lighthouse, 1994.*

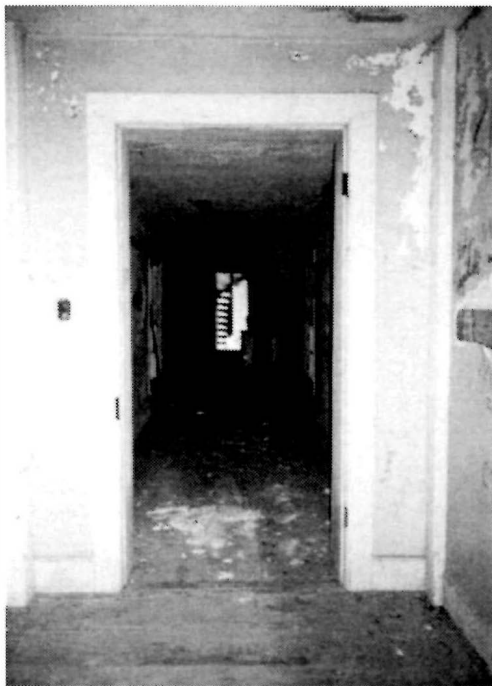
**Figure 6** View of the Passageway looking east through Door I-2 from Room 102, 1994. Prior to the construction of the Passageway, this was an exterior entrance door into the Dwelling.

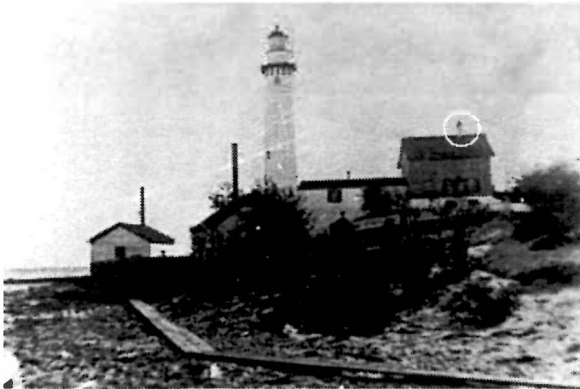
Figure 7 View of the South Manitou Island Light Station, circa the early 1890s.

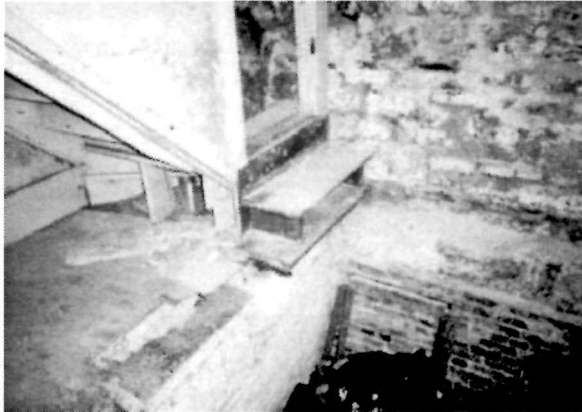
*Figure 11* View looking northwest in the storage room (Room B-03) in the Dwelling, 1994. Note the door opening at the left leading from the stair, which has one step leading into this room that is precariously hanging over the subcellar.

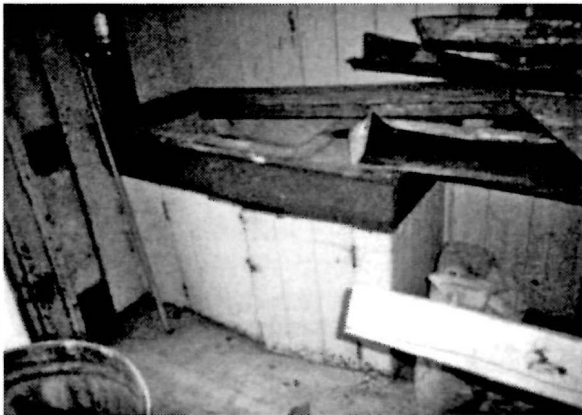
*Figure 12* View looking at the northwest corner of the kitchen (Room B-05) in the Dwelling, 1994. Note the area of missing wood wainscot at the left edge of the photo, revealing an earlier wall treatment.

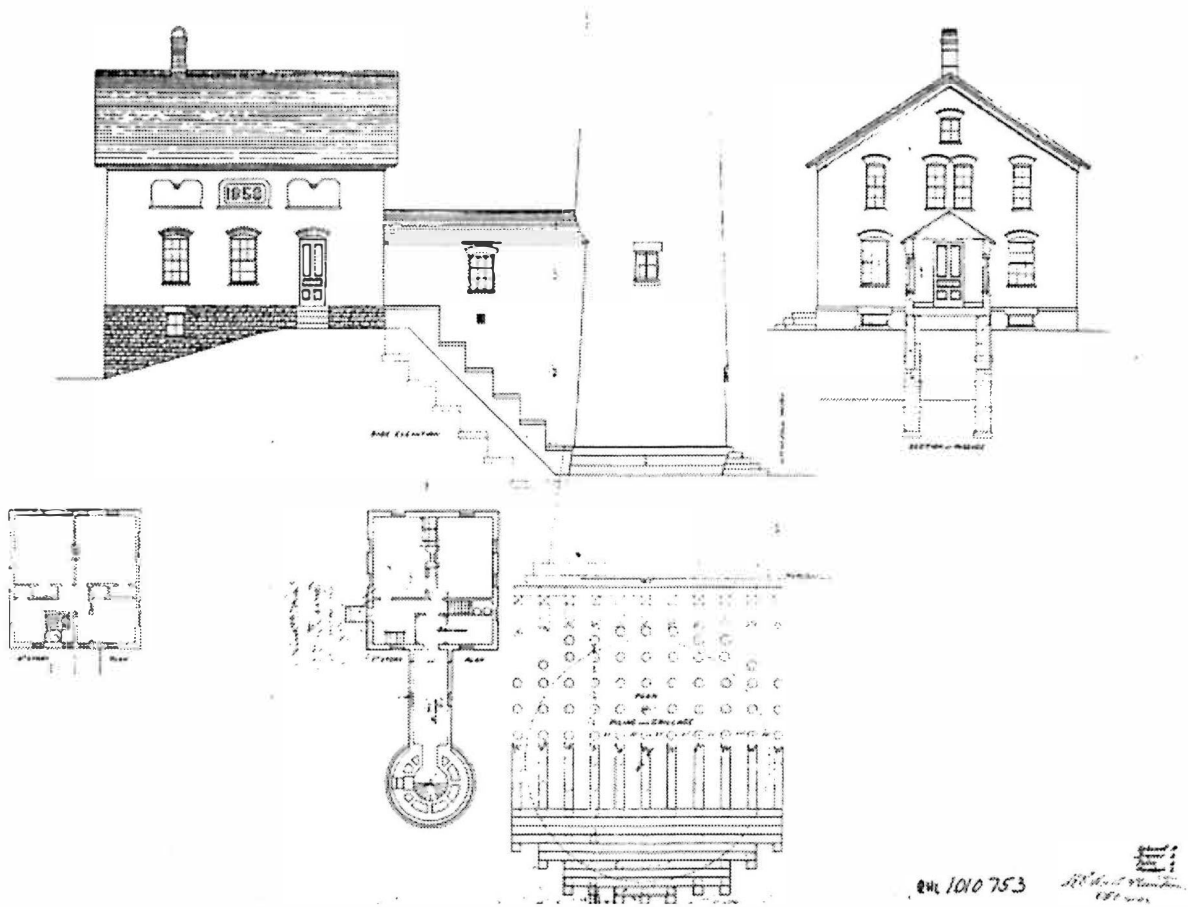
Figure 13 1870 drawing of the South Manitou Island Light Station, including the original Keeper's Dwelling, and the proposed Passageway and freestanding Light Tower.

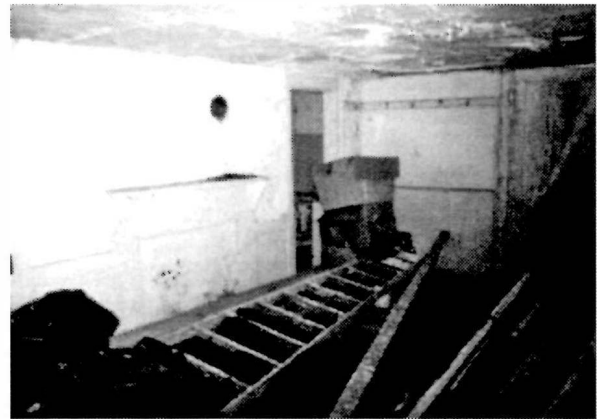
Figure 15 View looking toward the southwest corner of the kitchen (Room B-05) in the Dwelling. Note the overall deteriorated condition of the surfaces and finishes, and that the fireplace remains infilled with brick and plaster.

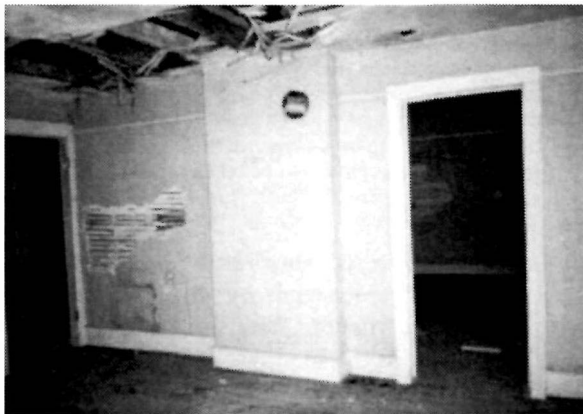
Figure 17 View of the south wall in the northwest bedroom (Room 204) in the Keeper's Dwelling, 1994. Note the rust at the plaster surface from the metal duct within the wall framing (at the bottom left corner of the photograph).

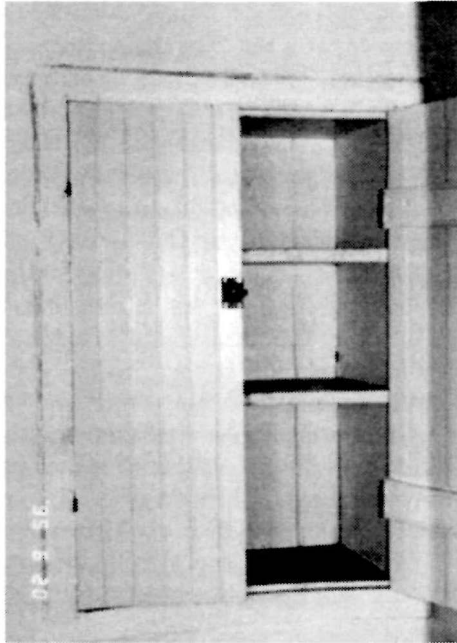
*Figure 18* Detail view of the wood lined storage closet in the work room of the Tower at the Au Sable Lighthouse on Lake Superior, 1995.

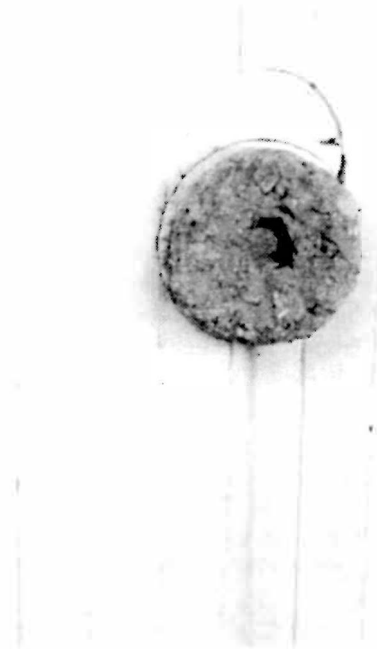
*Figure 19* Detail view of the concrete “plug” in the former stovepipe opening at the workroom of the Tower, 1994. There is also another circular marking in the wood wainscot, suggesting that the opening was relocated.

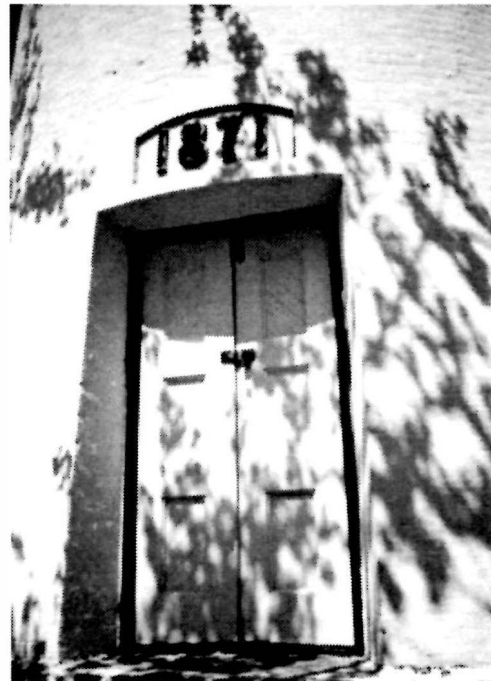
*Figure 21* Detail view of the wood panel doors leading into the base of the Tower, 1995.

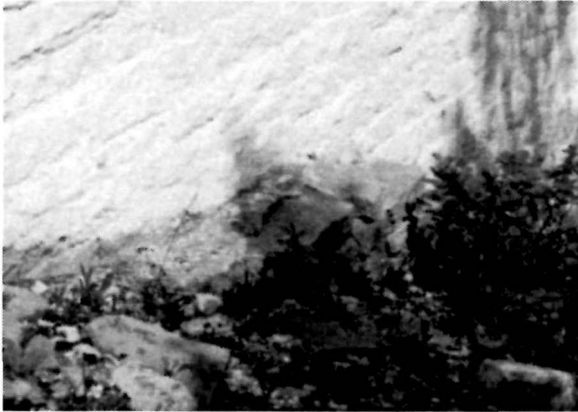
*Figure 22* Detail view of the exposed, unfinished stone along the south elevation of the Passageway, 1994.

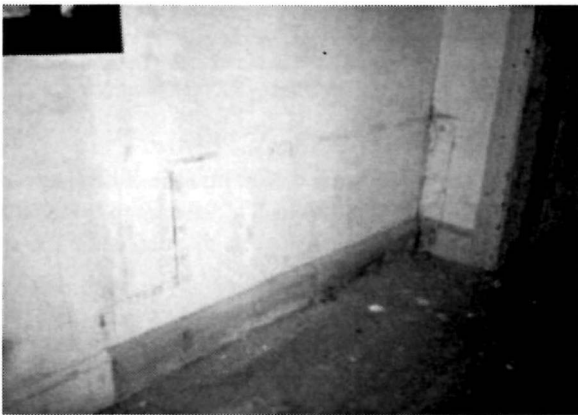
*Figure 23* View of the northeast corner of the Passageway, 1994. Note the ghosted outline on the plaster, and the coinciding joint where the wood baseboard has been replaced.

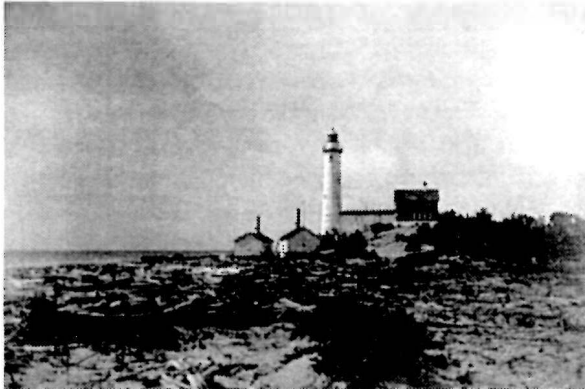
Figure 24 View looking south toward the South Manitou Island Light Station, circa 1884.

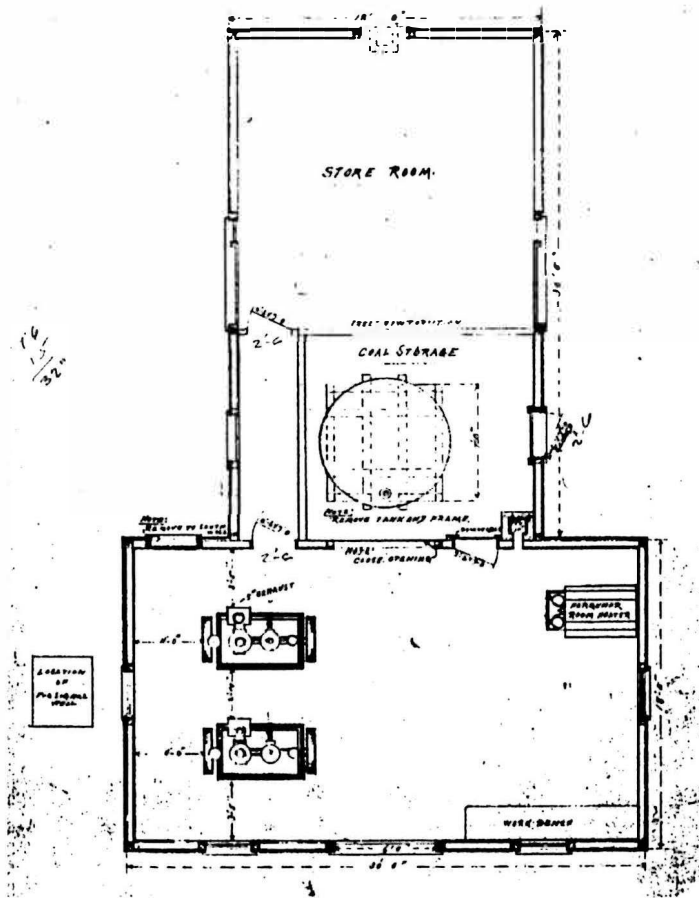
Figure 26 Drawing of the combined Fog Signal Building, 1941.

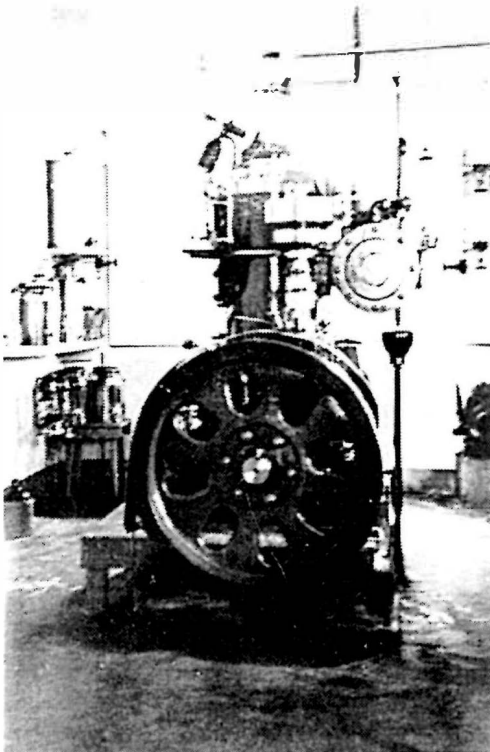
*Figure 29* One of the two replacement engines installed at South Manitou circa 1902. Photo, taken from a family album, circa 1911-1949.

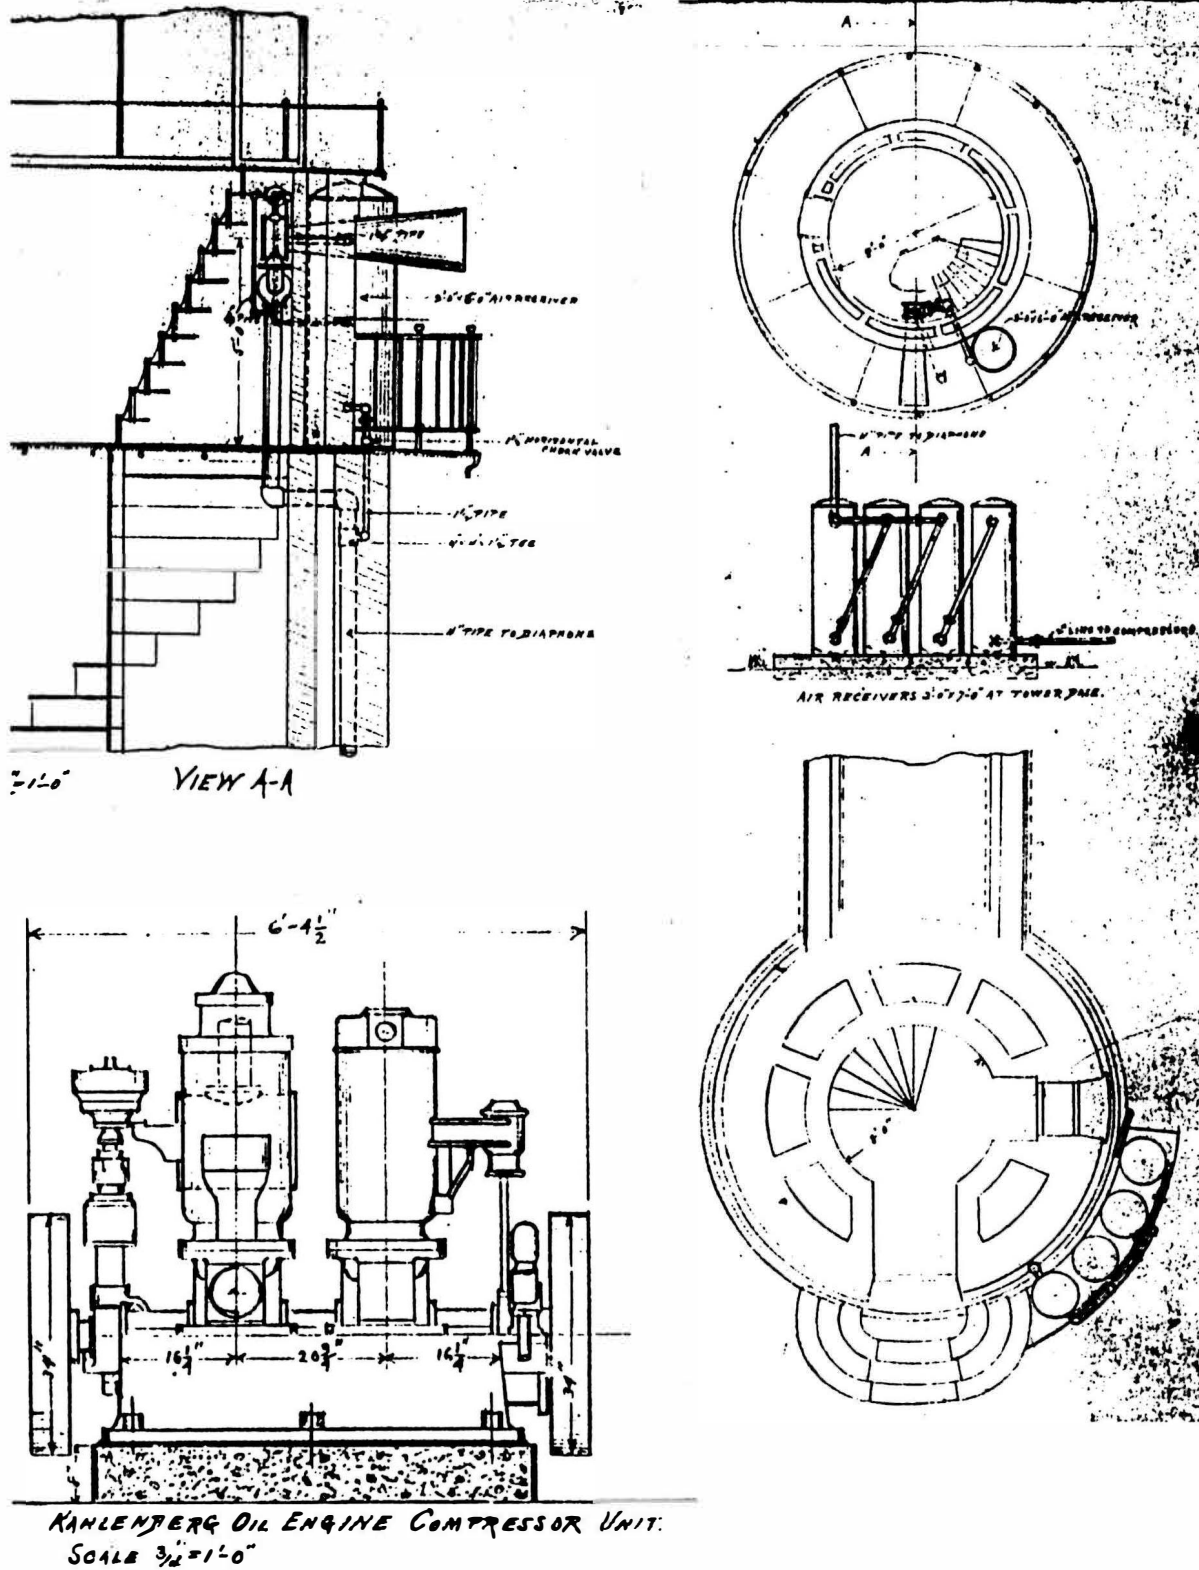
Figure 30 Details of drawing entitled "South Manitou Island Installation of Air Diaphone to Replace Steam Boilers," 1934.

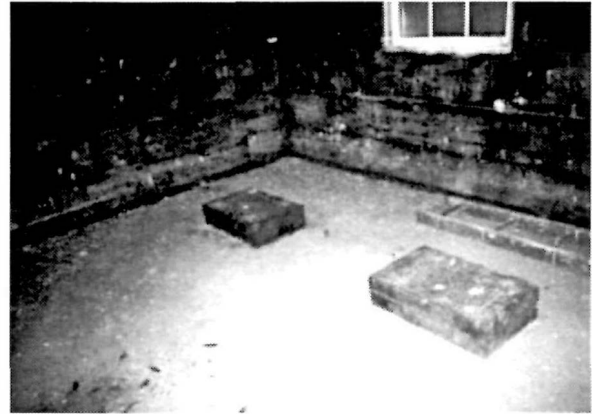
Figure 31 Interior view looking northeast inside of the Fog Signal Building, 1994.

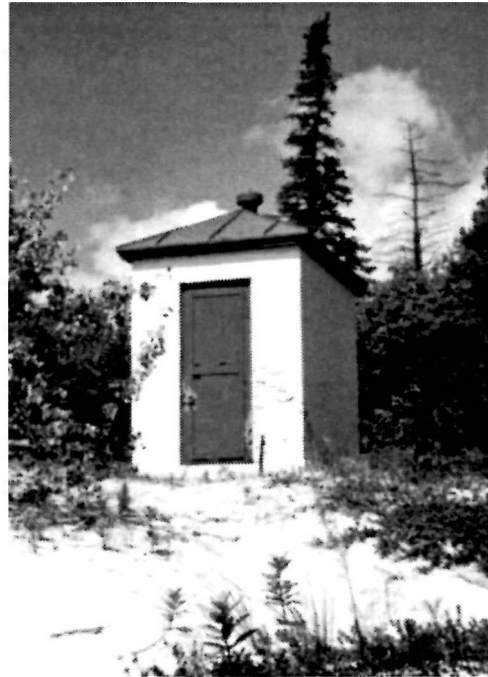
*Figure 32* View of the Brick Oil House at the South Manitou Island Light Station, 1994.

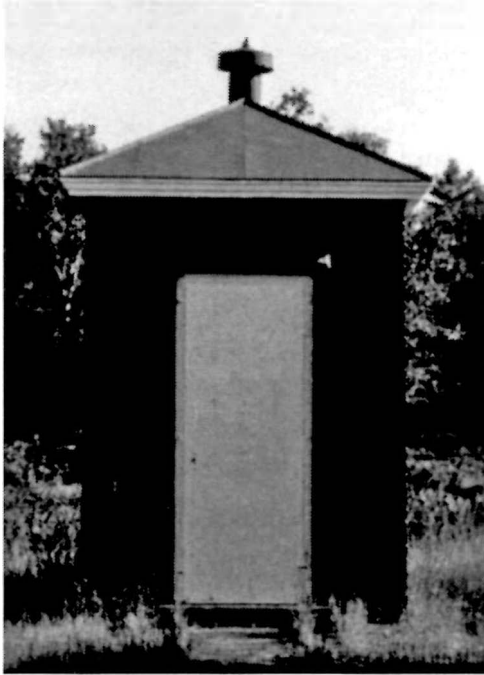
Figure 34 View of the Brick Oil House at the Au Sable Lighthouse Complex, Lake Superior, 1995.

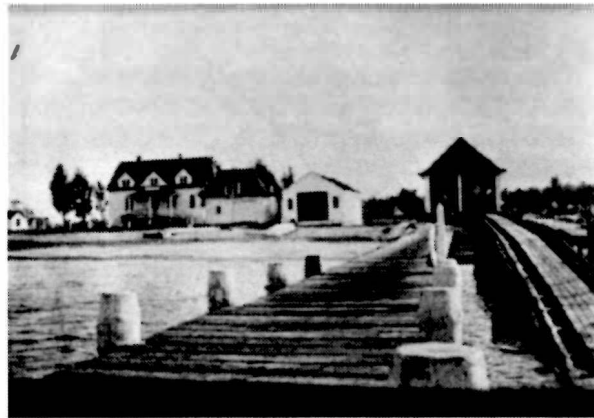
Figure 37 View looking west toward the U.S. Coast Guard Station and the Light Station's Boathouse, circa early 1900s.

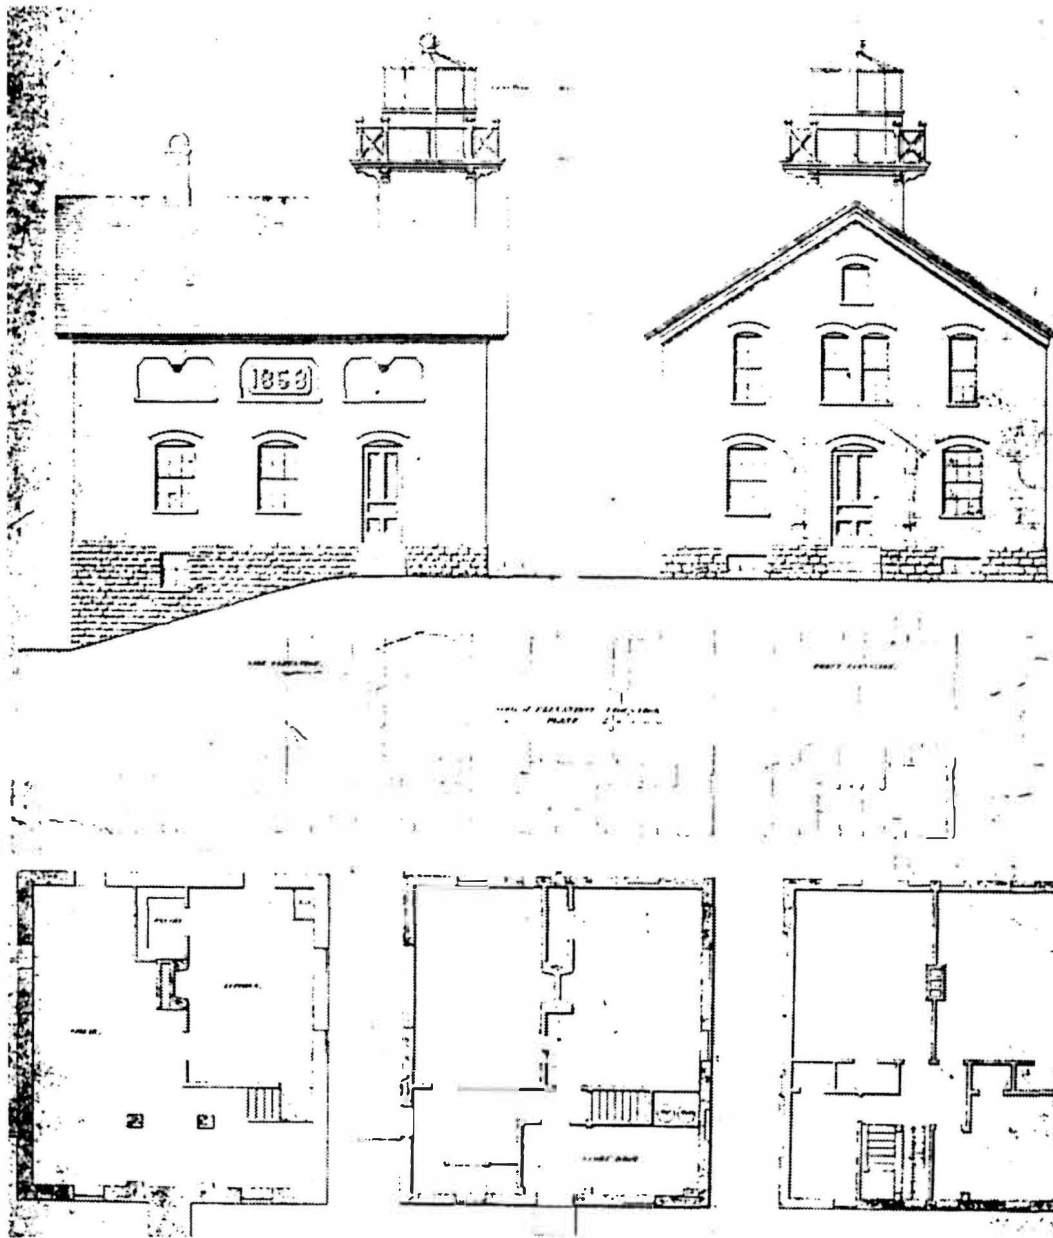
Figure 2 1858 drawing of the South Manitou Island Keeper's Dwelling; the original has "As built in 1858" marked on it.

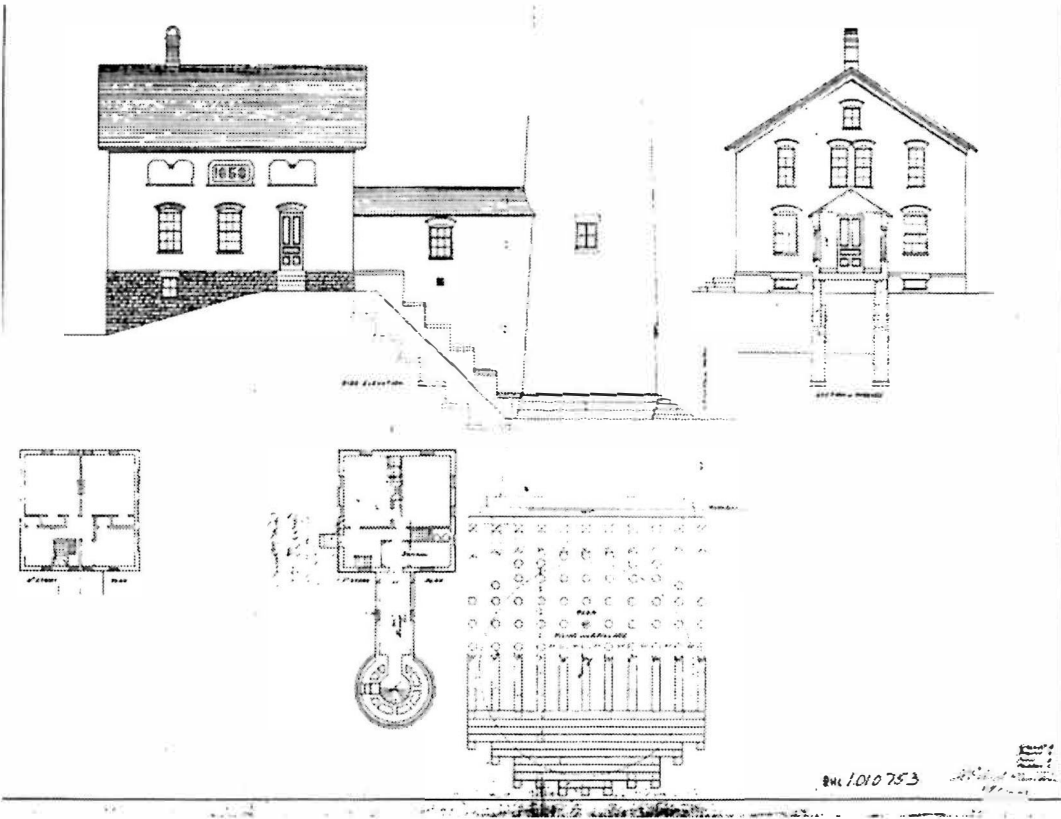
Figure 3 1870 construction drawing for the new Passageway and independent Tower at the South Manitou Island Light Station.

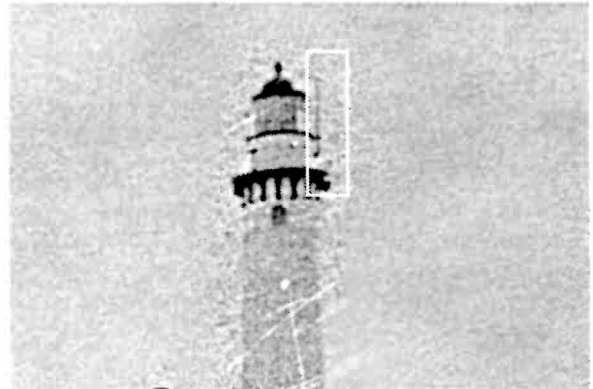
Figure 4 View looking south of the South Manitou Island Light Station, circa early 1890s (Detail). Note the smokestack above the parapet at the west side of the Tower.

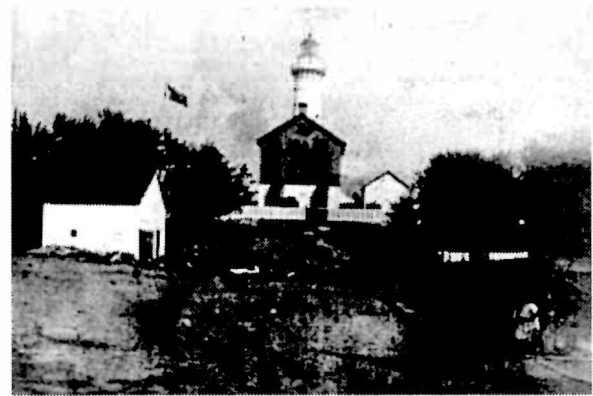
Figure 5 View of the west elevation of the Keeper's Dwelling, circa 1928. Note the wood vestibules around each of the entrances.

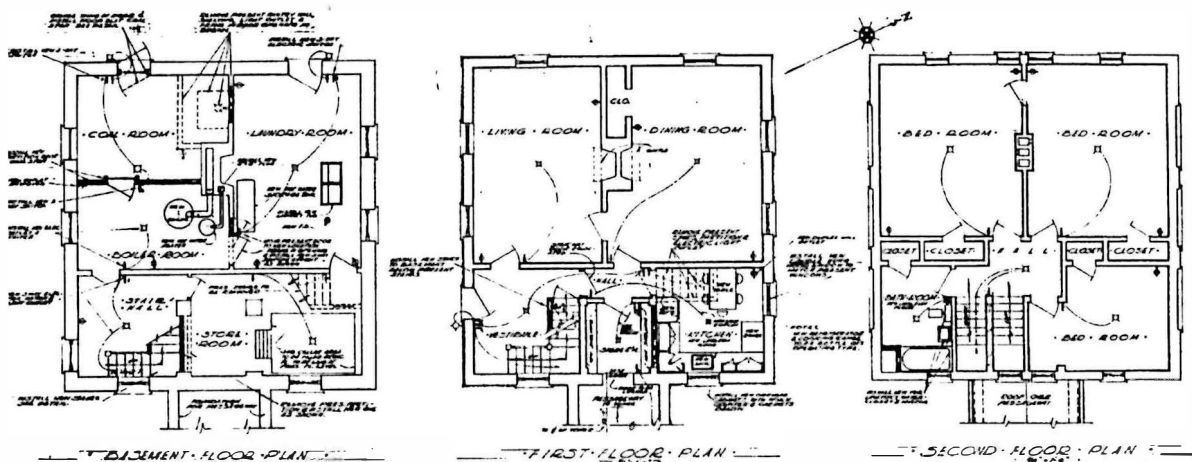
Figure 7 Detail, construction drawings for the proposed repairs and improvements to the South Manitou Island Light Station Keeper's Dwelling, 1945.

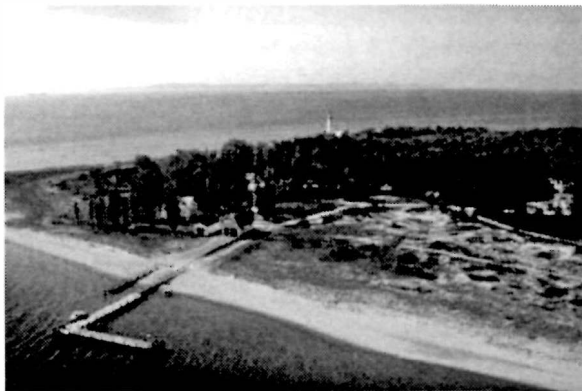
*Figure 2* Aerial view looking south of the South Manitou Island Light Station and Life-Saving Station Historical District, 1995.

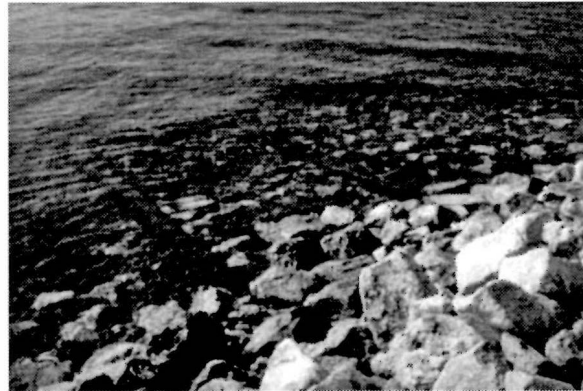
Figure 10 View of the timber cribbing in front of the Fog Signal Building, 1995.

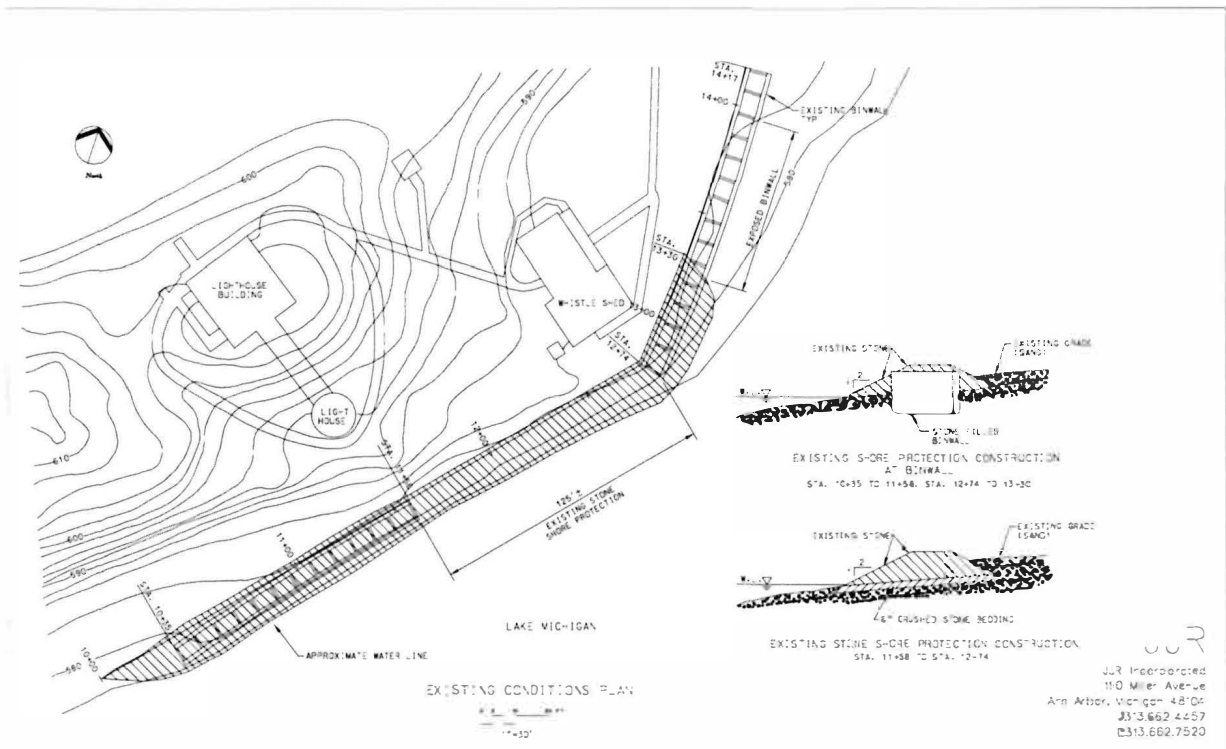
Figure 15 Existing shoreline conditions.

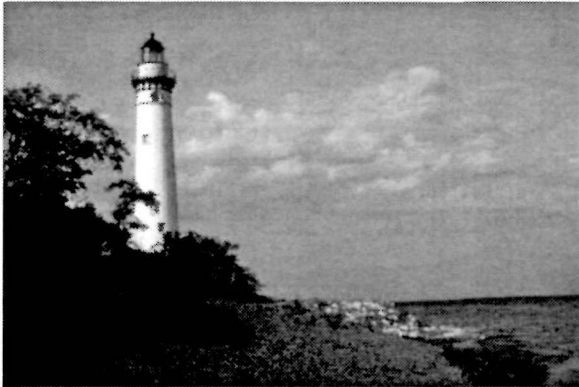
Figure 16 View of the Tower at the South Manitou Island Light Station from the southwest, 1995.

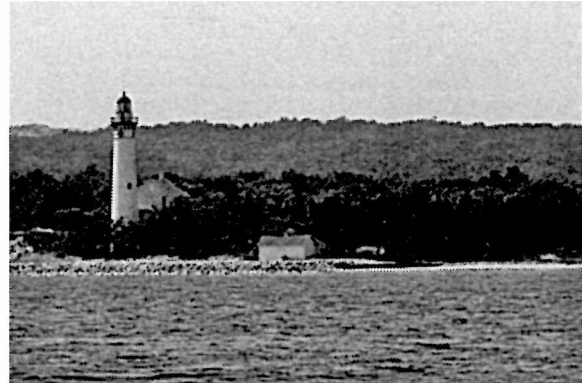
Figure 29 View of the South Manitou Island Light Station from the Manitou Passage, 1995.

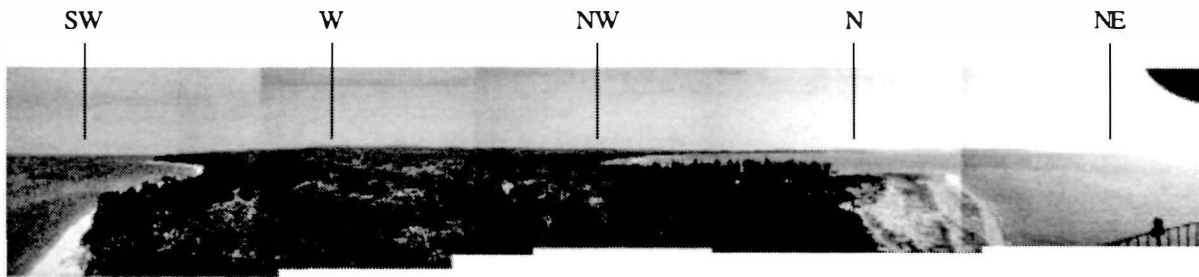
Figure 32 Panoramic View of South Manitou Island from the Light Tower, 1995.

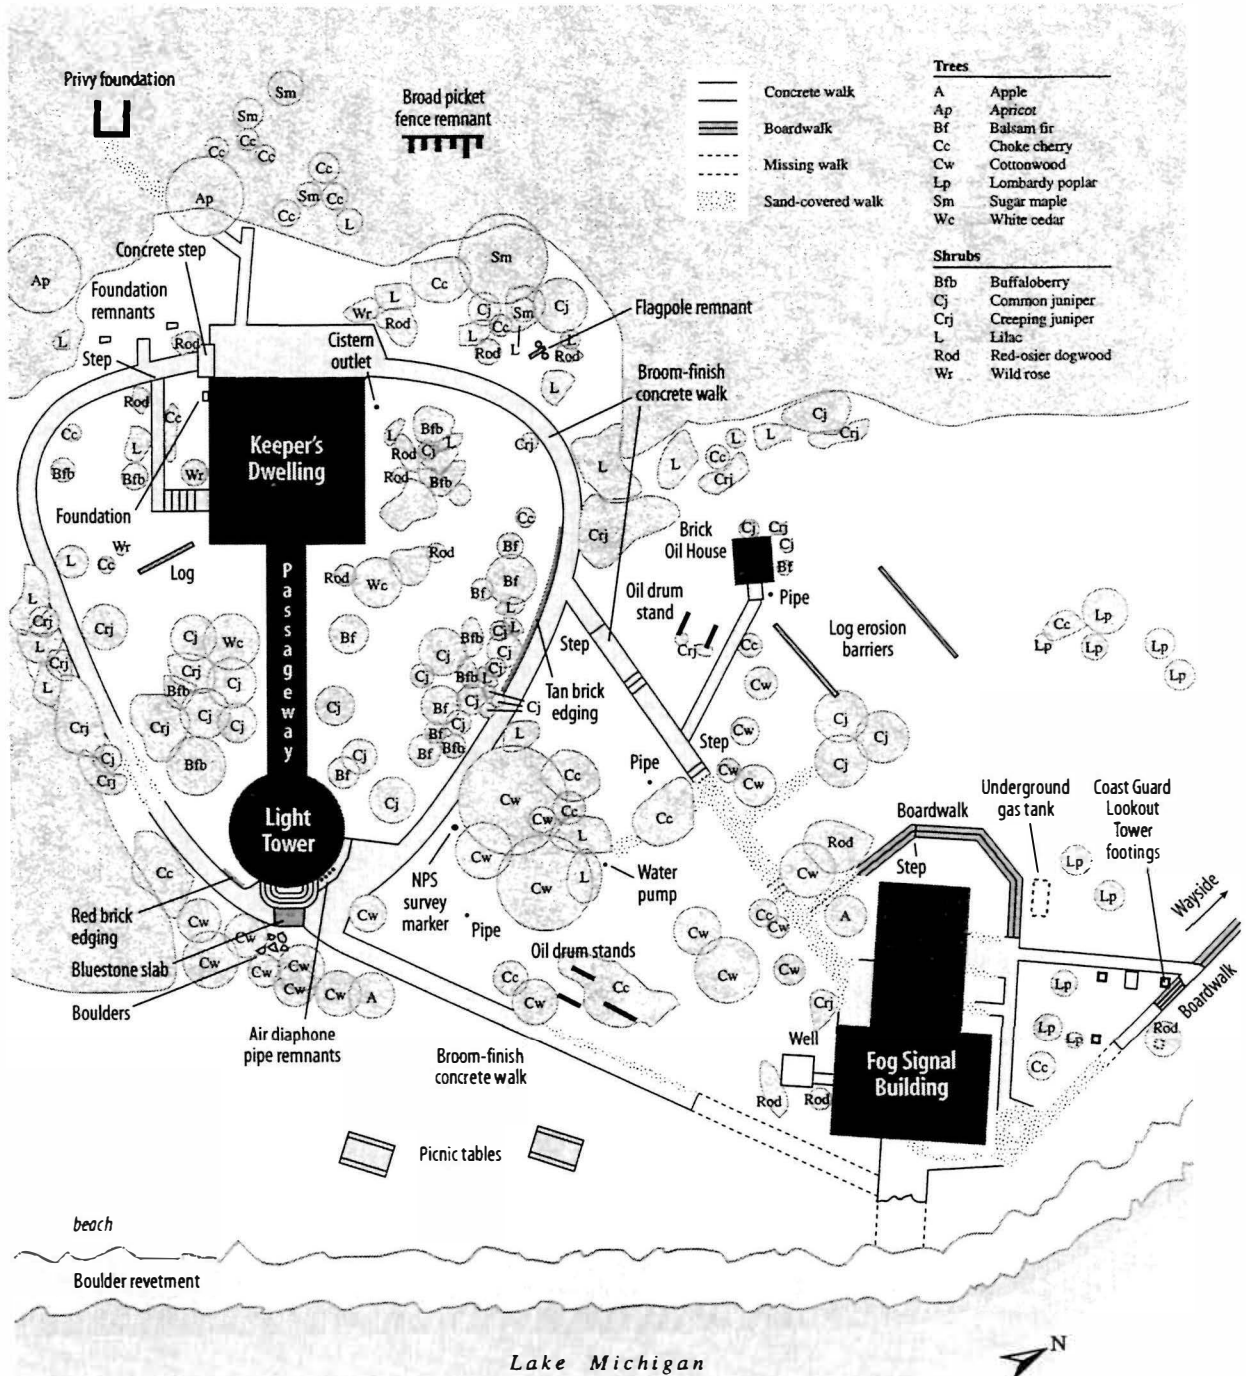
**Map Sources:**  
 South Manitou Light Station, Mich., March 16, 1887 (based on September 1884 survey of George Y. Wisner).  
 South Manitou Is. L. S., South Manitou, Mich., Plot Plan, June 27, 1944.  
 South Manitou Is. L. S., South Manitou, Mich., Revised Plot Plan, May 10, 1965.  
 U. S. Lighthouse Reservation, Historic American Buildings Survey, 1988.  
 Fieldwork conducted by Land and Community Associates, June 1995, June 1997.  
 Drawing prepared by Land and Community Associates, 1996. Revised March 1998.
