# HISTORIC STRUCTURE and CULTURAL LANDSCAPE REPORT

South Manitou Island Light Station  
(Historic Structures 51-120 A-I)

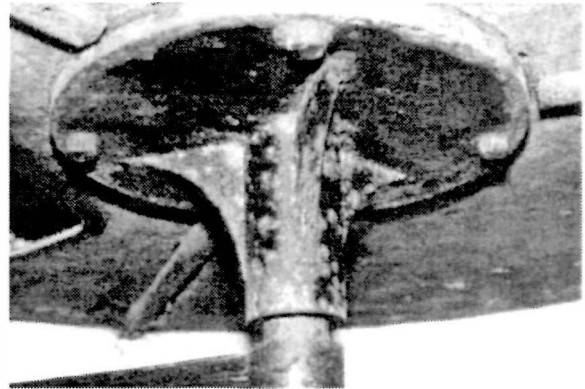
Figure 1 View of the top connection of the Spiral Stair, 1995.

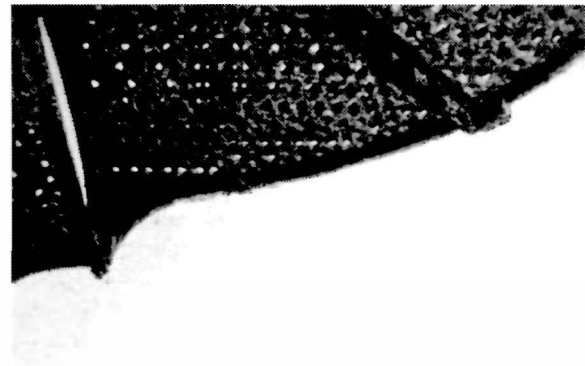
Figure 3 Detailed view of the Landing Support, 1995.

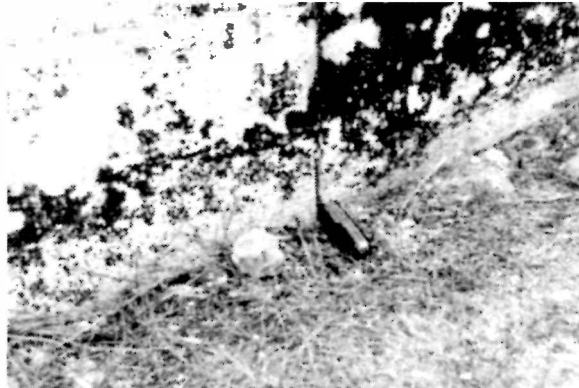
Figure 4 View of the soft joints at the base of the light tower, 1995.

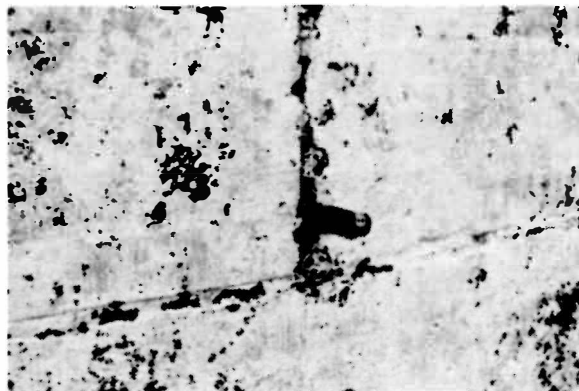
Figure 5 View of the soft joints at the base of the Light Tower, 1995.

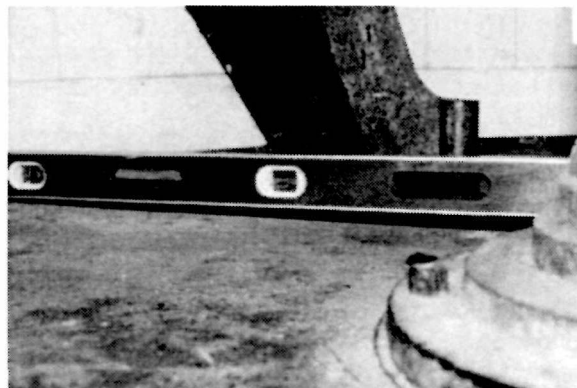
Figure 6 View of the promenade landing (Lantern Room) which slopes to the middle of the Tower, 1995.

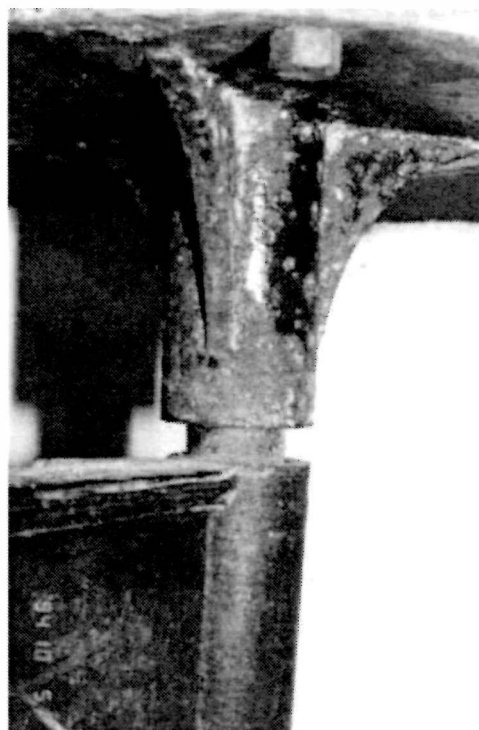
Figure 7 View of the 1" gap at the top of the spiral stair, 1995.

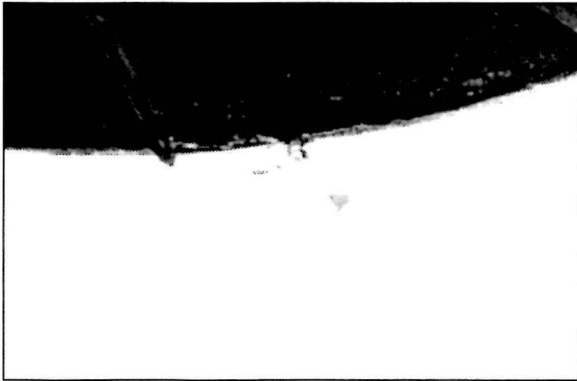
**Figure 8** View of the missing or broken support bracket at a landing in the Tower, 1995.

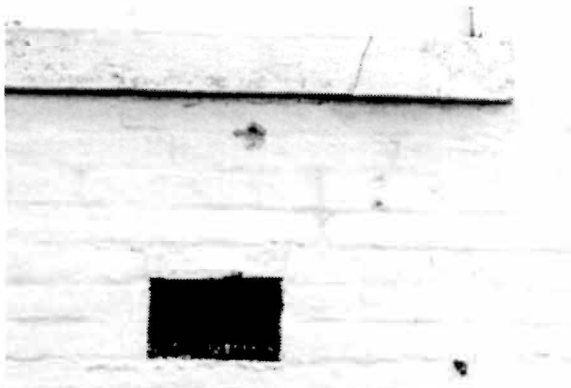
Figure 9 View of the north wall of the Passageway, showing the window sill crack, 1995.

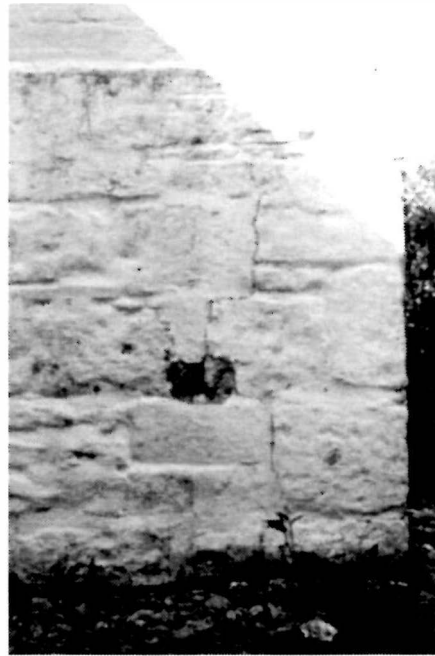
*Figure 10* View of the foundation wall distress of the east wall of the Keeper's Dwelling, 1995.

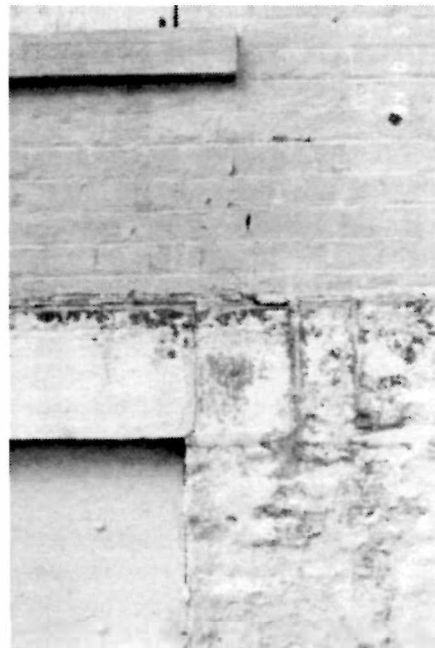
*Figure 11* View of the east wall of the Keeper's Dwelling, south side, showing the window head stone cracking, 1995.

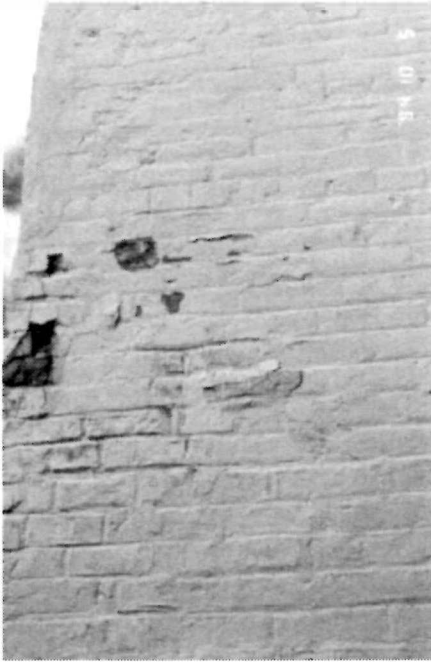
*Figure 12* View of the east wall of the Keeper's Dwelling, south side, showing surface spalls near corner, 1995.

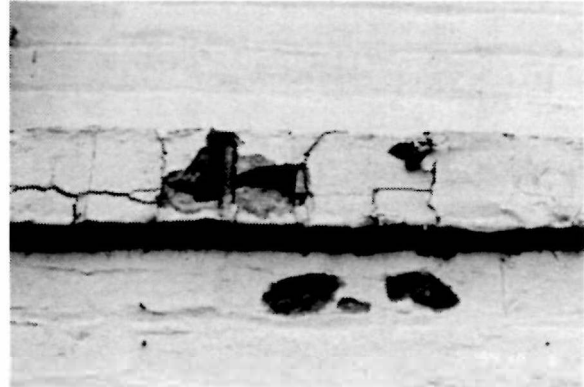
*Figure 13* View of the deterioration at the north wall window sill, 1995.

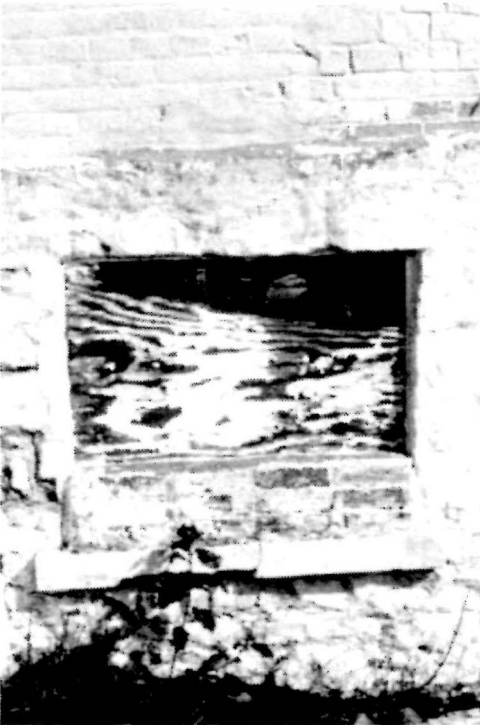
Figure 14 View of the south wall of the Keepers Dwelling, showing the east basement window, 1995.

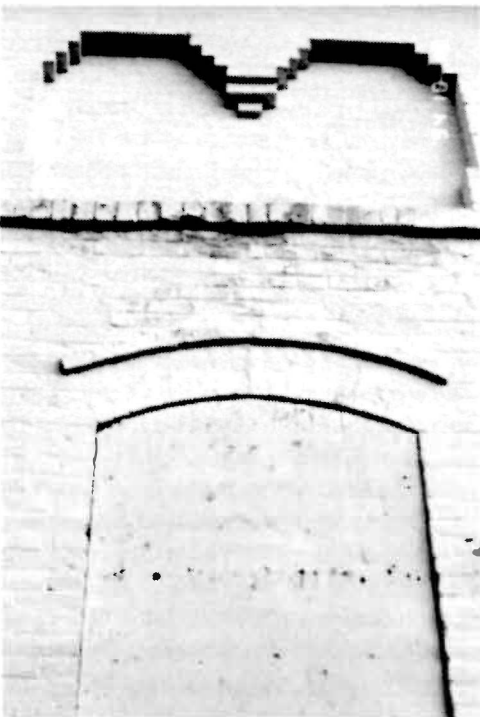
Figure 15 View of the south wall of the Keeper's Dwelling, showing the cracked keystone, 1995.

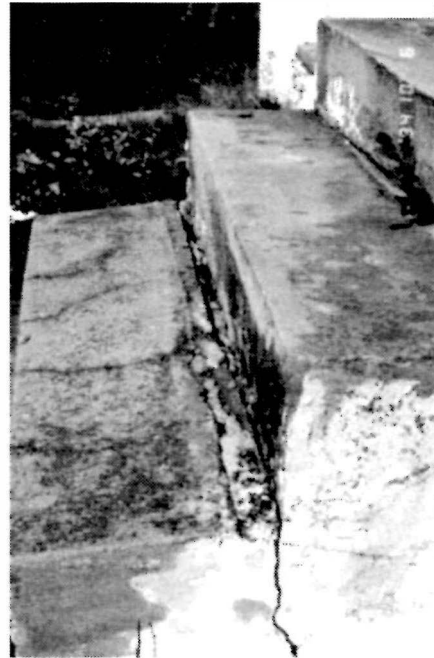
Figure 16 View of the stair distress at the south exterior stair of the Keeper's Dwelling, 1995.

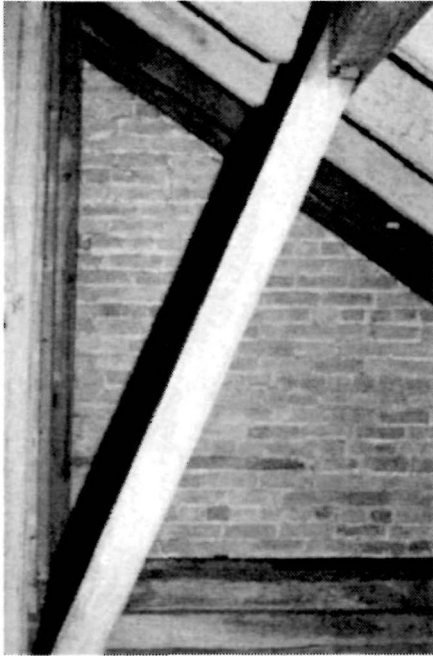
Figure 17 View of the diagonal strut and birds mouth jointing in the attic of the Keeper's Dwelling, 1995.

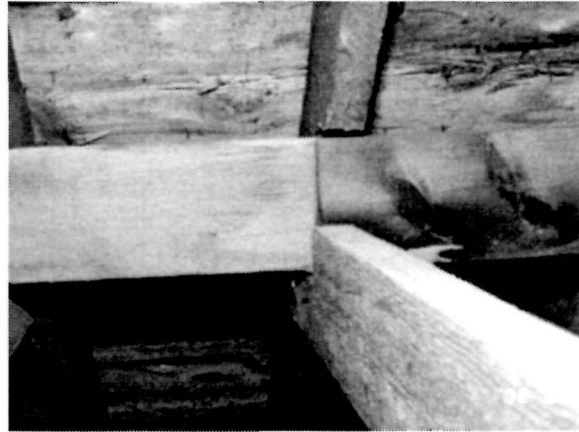
Figure 18 View of the beam butt joint at the north side of the roof, 1995.

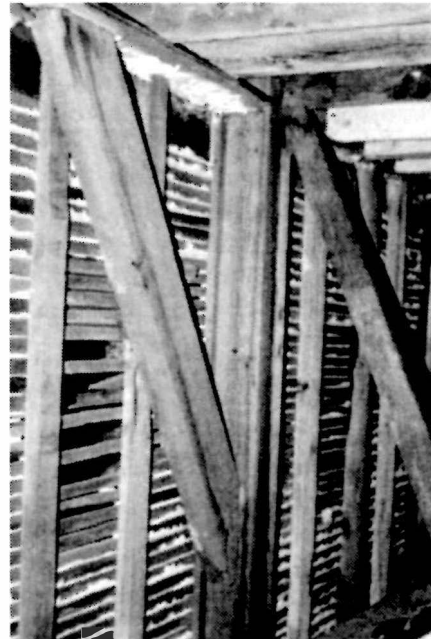
*Figure 21* View of the columns and diagonal bracing in the attic at the original Tower (roof lantern) location, 1995.

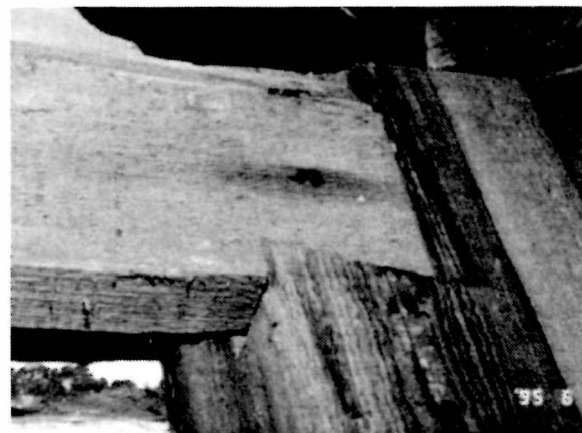
*Figure 22* View of the heavy timber joinery at the original Tower, 1995.

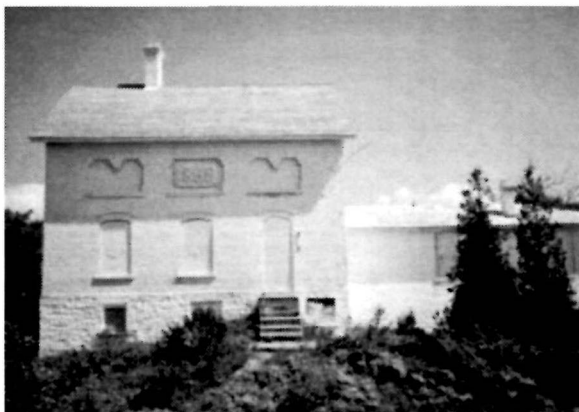
Figure 23 View of the south elevation of the Keeper's Dwelling, 1994. Note the decorative brick recesses at the second floor, and the raised brick "eyebrows" above the door and window openings.

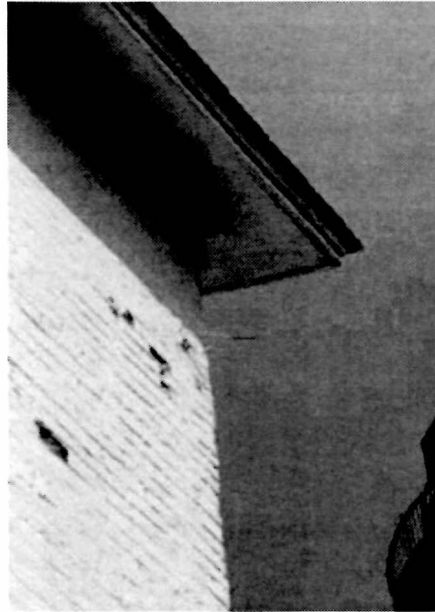
*Figure 27* View of the southeast corner of the Keeper's Dwelling, 1994. Note the deteriorated and spalling brick and the metal bracket which previously supported a downspout.

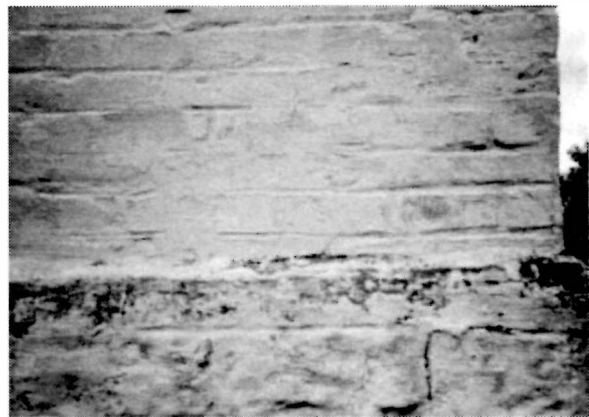
*Figure 28* View of the west end of the north elevation of the Keeper's Dwelling, 1994. Note that the parging is crudely tooled to resemble mortar joints, a typical condition of the exterior brick wall surfaces.

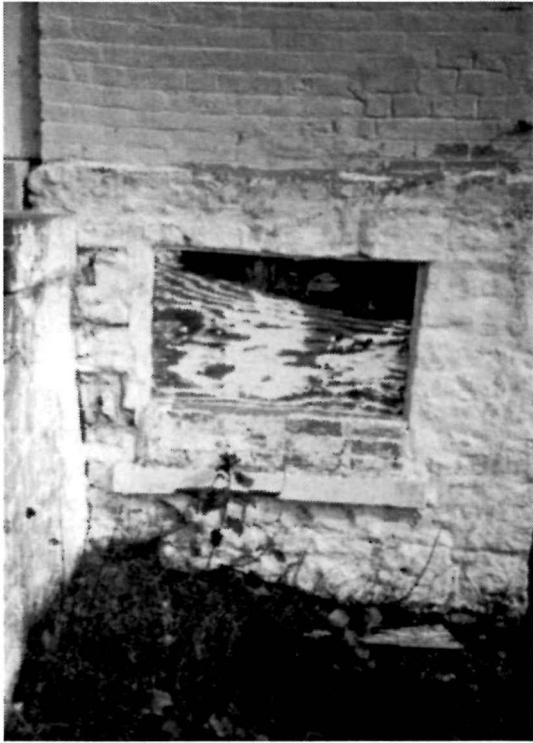
*Figure 29* View of the basement window (D-1) at the east end of the south elevation of the Keeper's Dwelling, 1994. Note the deteriorated foundation wall between the window and the concrete steps.

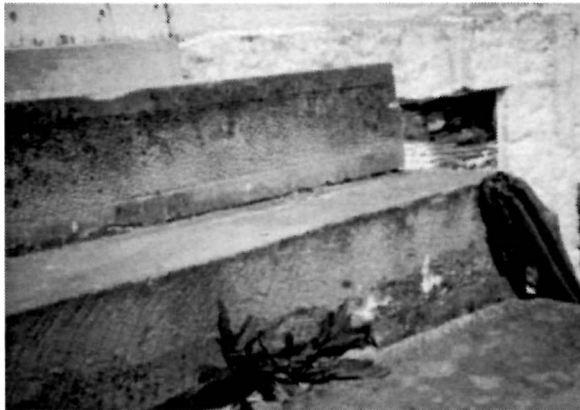
*Figure 30* Detail view of the exterior concrete steps leading to the main entrance into the Keeper's Dwelling along the south elevation, 1994. The face of both the top riser and the door sill have an elaborate tooled pattern, while the face of the risers below are less ornate.

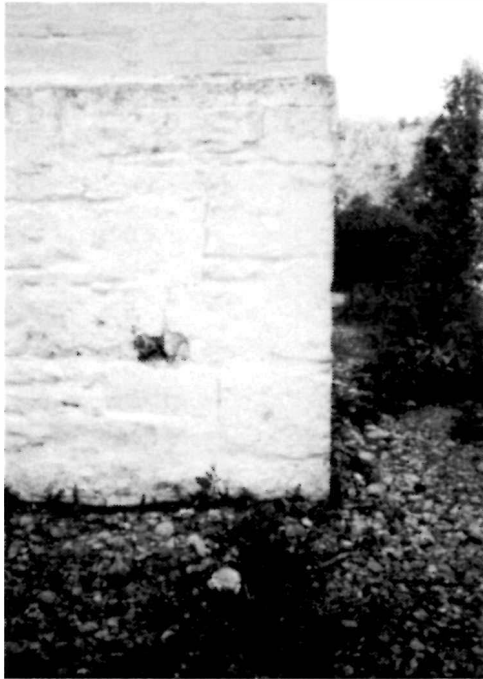
*Figure 31* View of the northeast corner of the stone foundation wall at the Keeper's Dwelling, 1994. Note the cracking of the cementitious parge coat along the profile of the cut stone quoining.

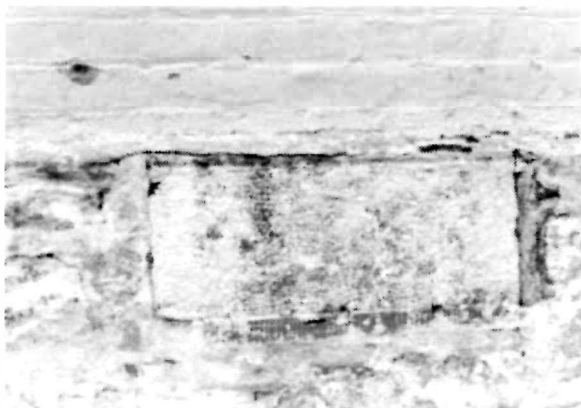
*Figure 32* Detail view of the flush stone lintel (its purpose unknown) located near the east end of the north elevation of the Keeper's Dwelling, 1994.

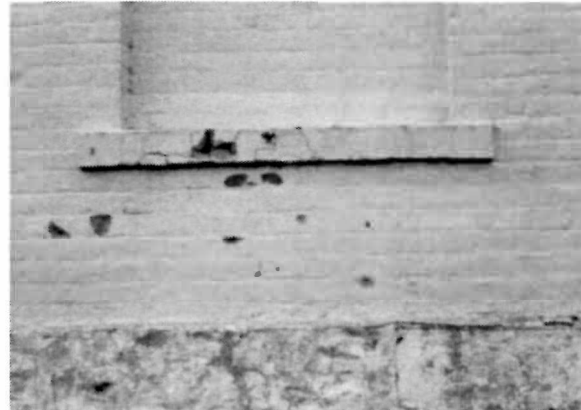
*Figure 33* Detail view of the deteriorated brick sill, and the wall surface below, at the false window opening at the east end of the north elevation, 1994.

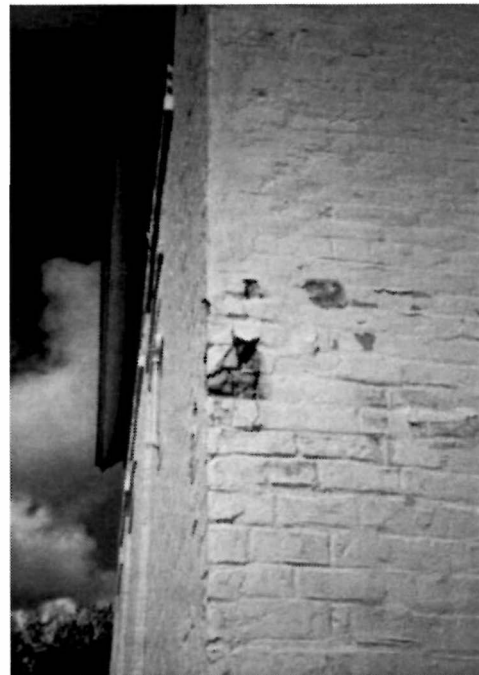
Figure 34 View looking west at the southeast corner of the Keeper's Dwelling, 1994. Note the deteriorated condition of both the cementitious parging and the underlying brick.

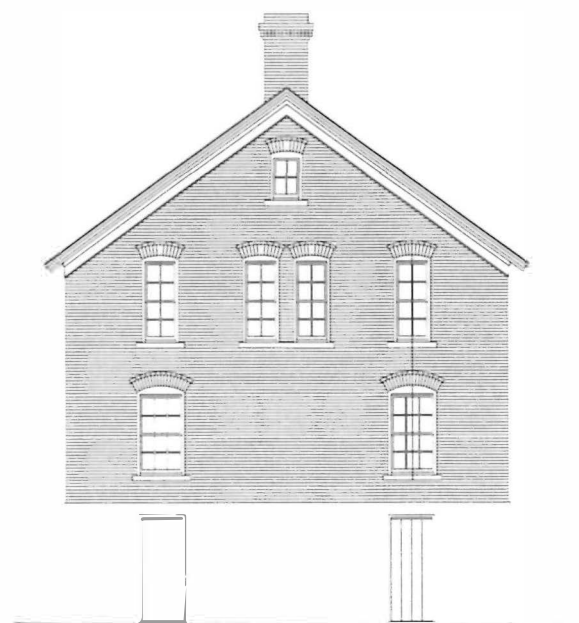
Figure 35 Drawing of the west elevation of the Keeper's Dwelling showing the exposure of the foundation, 1994.

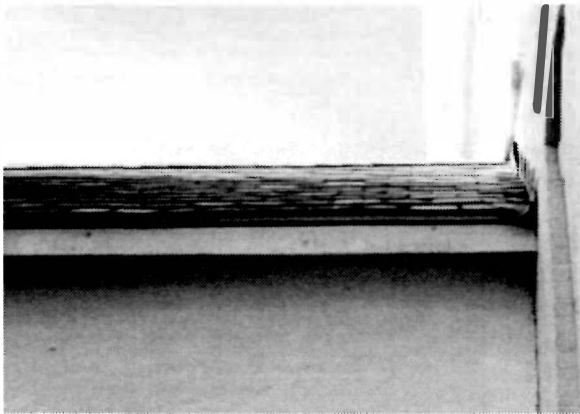
Figure 36 Detail view looking south at the intersection of the Passageway's roof and the east wall of the Keeper's Dwelling, 1994.

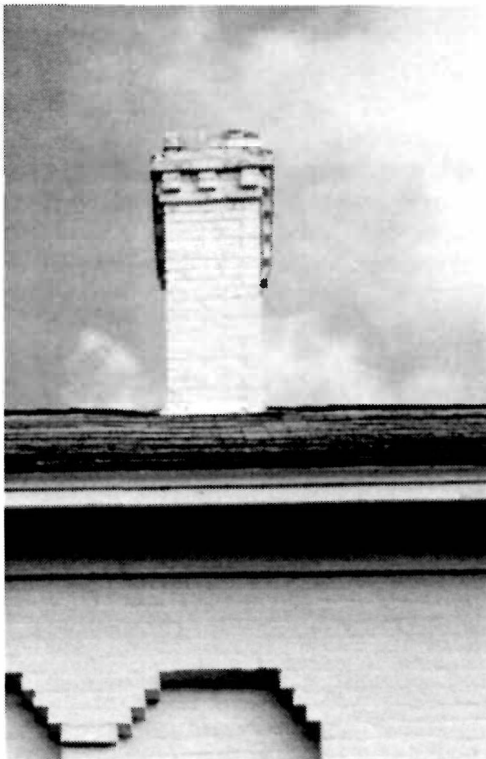
Figure 37 View of the deteriorated top portion of the chimney, 1994.

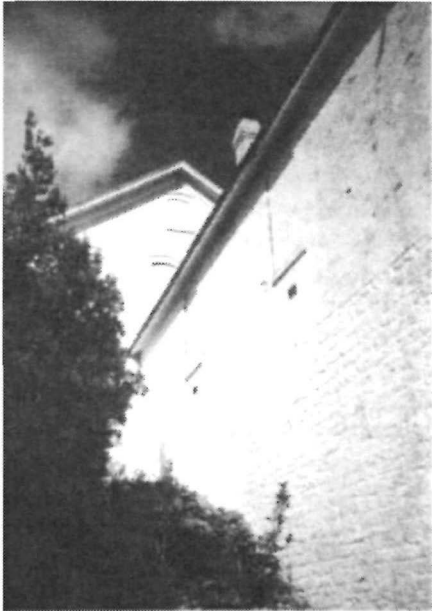
Figure 38 View of the south elevation of the Passageway, 1994.

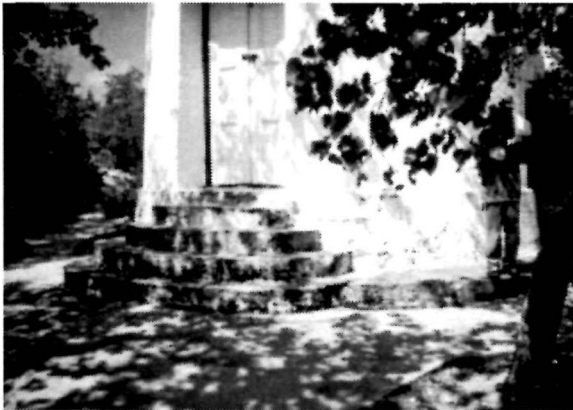
Figure 40 Detail view of the stone steps at the base of the Tower, 1994.

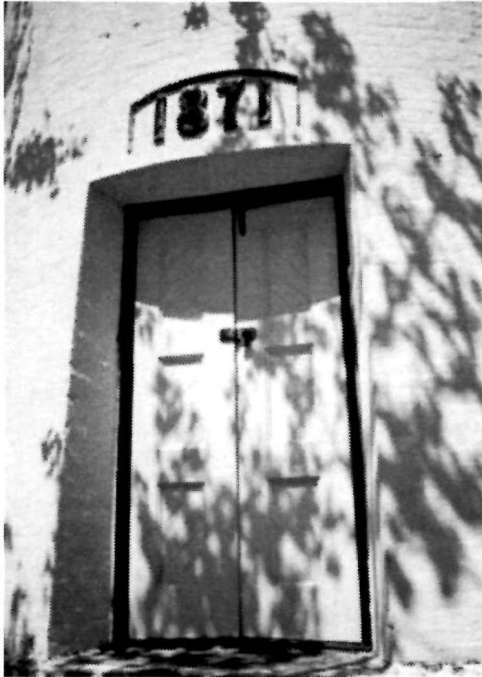
Figure 41 Detail view of the pair of doors at the base entrance into the Tower, 1994.

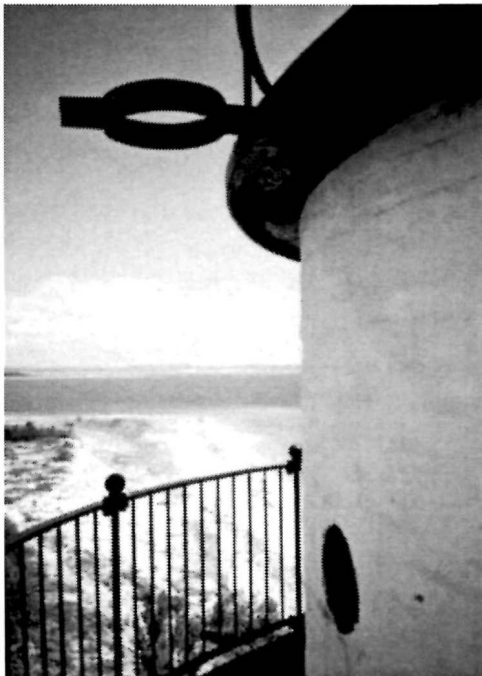
Figure 42 Detail view of the exterior of the Tower, including a remaining metal bracket, which formerly supported the chimney stack from the stove in the work room, 1994.

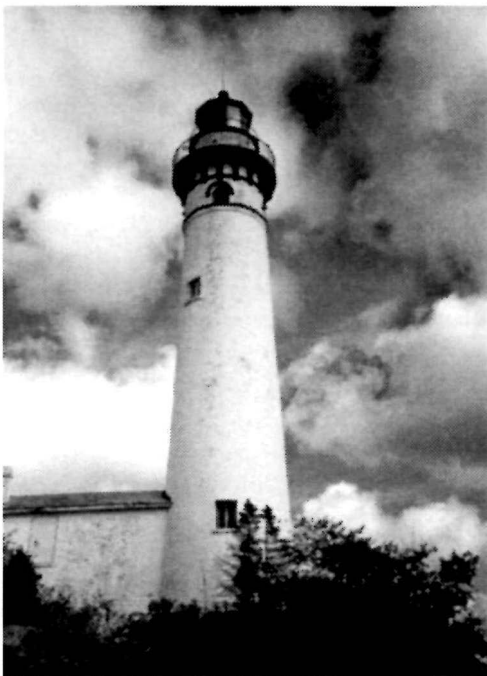
*Figure 44* View looking north at the Light Tower, 1994.

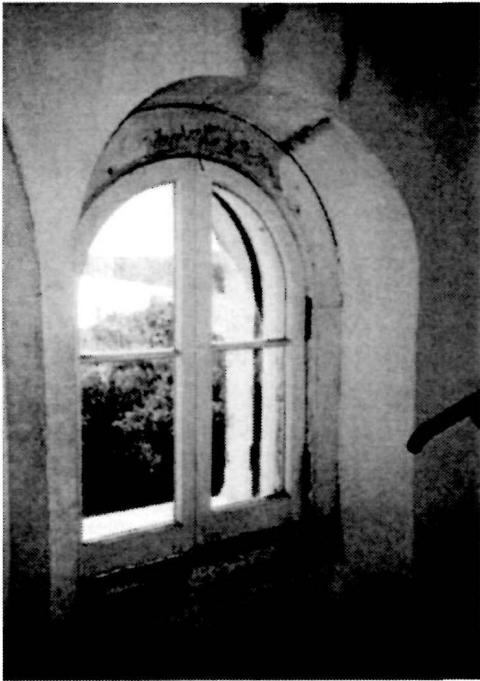
*Figure 45 Interior view of one of the round top windows at the Watchroom level of the Tower, 1994.*

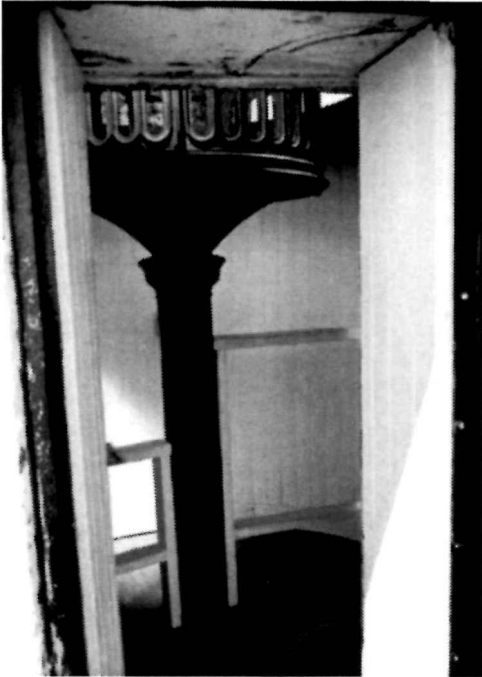
*Figure 46* View looking into the Lantern Room of the Tower toward the cast iron pedestal, which formerly supported the third order Fresnel lens, 1994.

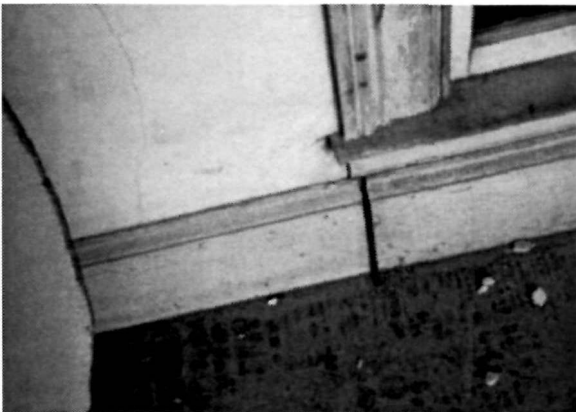
*Figure 47* Detail view of the separating joint in the wood baseboard beneath a window in the Passageway, a typical condition beneath all four of the Passageway windows, 1994.

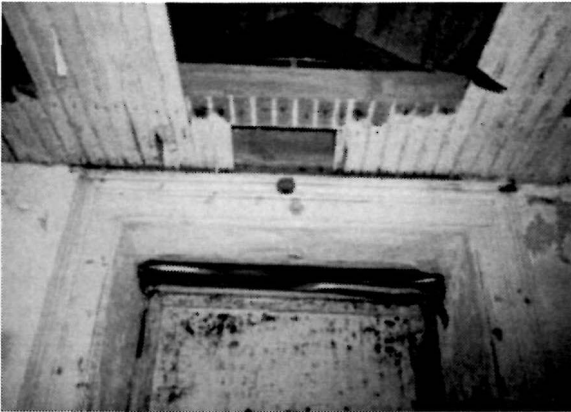
**Figure 49** Detail view of the head of the door opening between the Passageway and the Tower, 1994. Note the small circular opening through which the electrical conduit to the Tower was formerly fed.

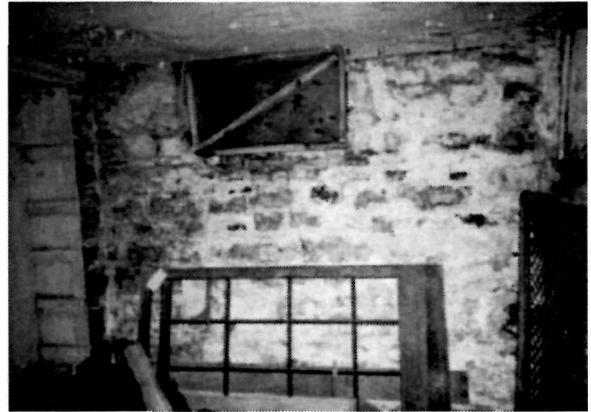
**Figure 50** View of the east wall in the southeast basement storage room (Room B-01) of the Keeper's Dwelling, 1994. Note the remnants of the parging that was tooled to resemble masonry.

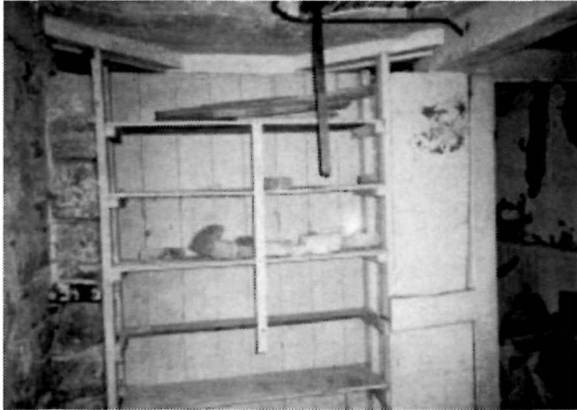
*Figure 51* View of the south wall of the northeast basement storage room (Room B-02) in the Keeper's Dwelling, 1995.

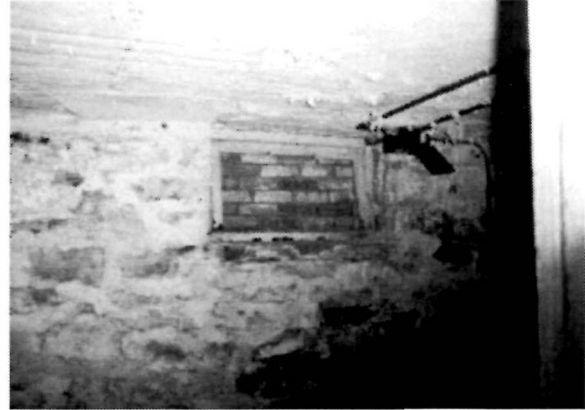
*Figure 53* View of the east wall in the northeast basement storage room (Room B-03) of the Keeper's Dwelling, 1994. Note that most of the parging has worn or broken off of the stone wall surface.

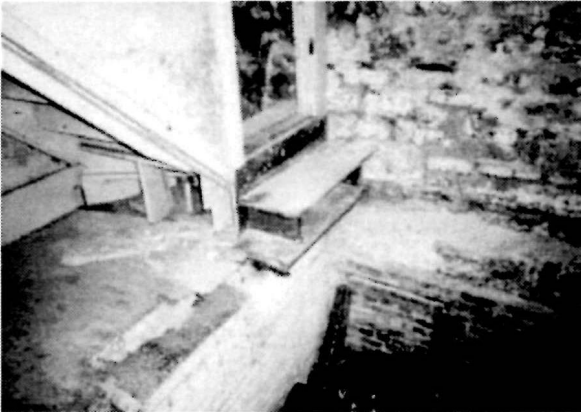
**Figure 54** View of the stair that hangs precariously over the subcellar (Room B-03) in the Keeper's Dwelling, 1994

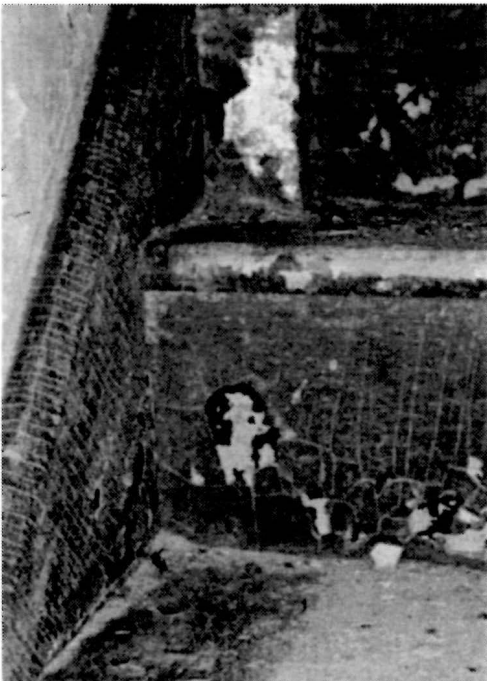
**Figure 55** Detail view of the basement stair (Room B-04) of the Keeper's Dwelling, 1994. Note the paint failure and buildup, and the change in color indicating the previous location of the stair runner.

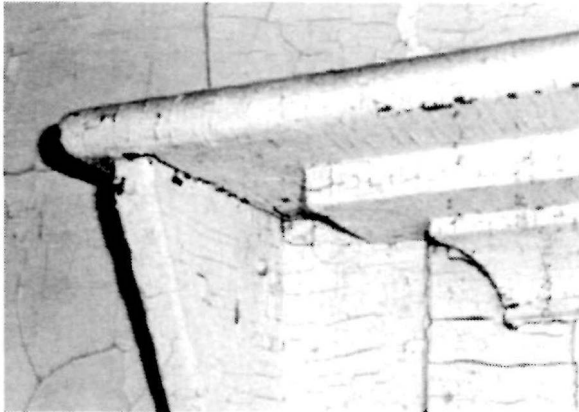
*Figure 56* Detail view of the wood fireplace mantle in the Keeper's Kitchen (Room B-05), 1994. Note the paint buildup and excessive cracking.

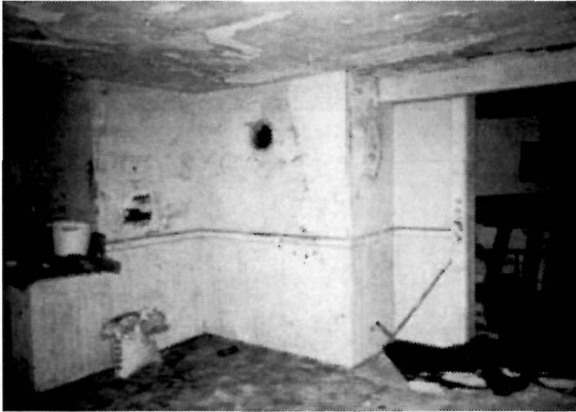
**Figure 57** View looking northwest in the Assistant Keeper's Kitchen (Room B-06). Note the deterioration of the plaster at both the ceiling and walls.

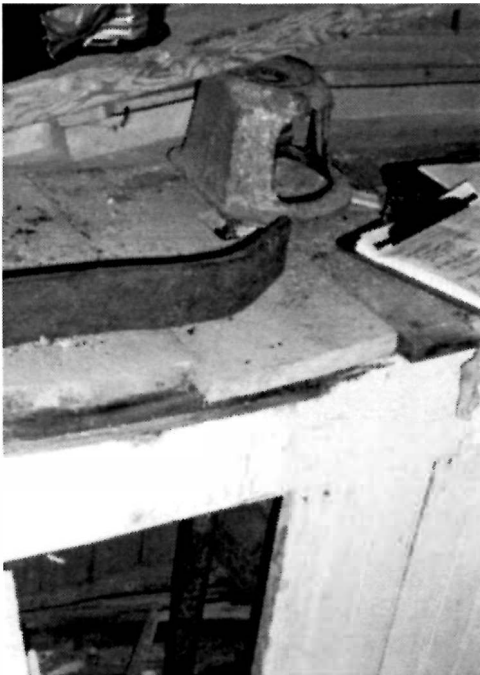
**Figure 58** Detail view of the wood beaded board cabinet and the remaining piece of the metal hand pump at the sink in the northwest corner of the Assistant Keeper's Kitchen (Room B-06), 1995.

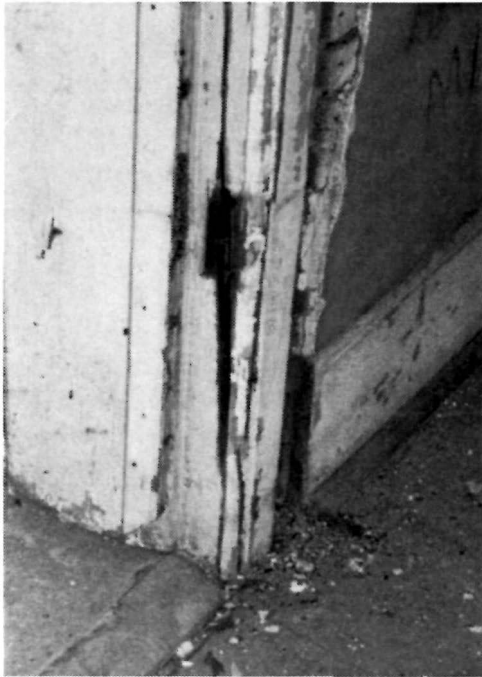
**Figure 59** Detail view of the deteriorated and damaged wood door jamb at Door E-4 in Room 101 of the Keeper's Dwelling, 1994.

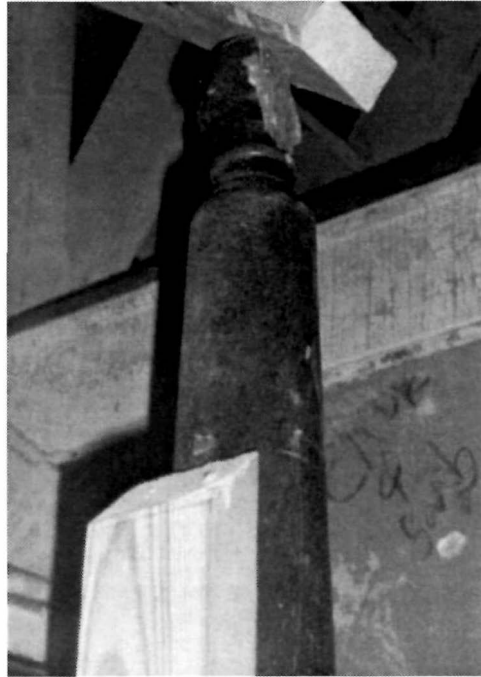
**Figure 61** Detail view of the intermediate newel post, the only remaining element of the balustrade at the stair in the northwest corner of Room 101 of the Keeper's Dwelling, 1994.

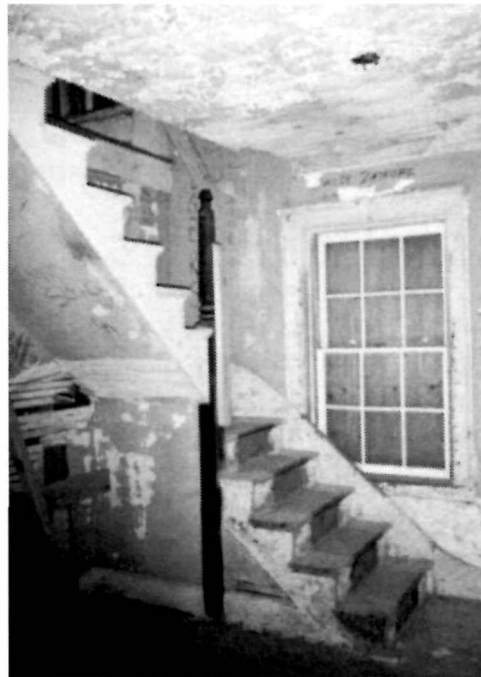
**Figure 62** View looking northeast in the Entrance Hall (Room 101) toward the stair, 1994. Note that the balustrade and some of the tread nosing are missing at the stair, and the deteriorated condition of the adjacent plaster surfaces

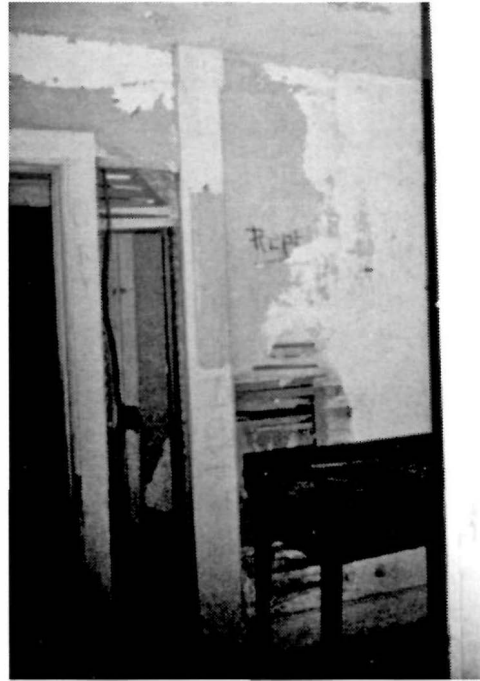
Figure 63 View of the west wall in the Keeper's Office (Room 102), 1994. Note the ghosted outline in the paint at the chamfered wood post, indicating that something was previously hung (and painted around) in this location.

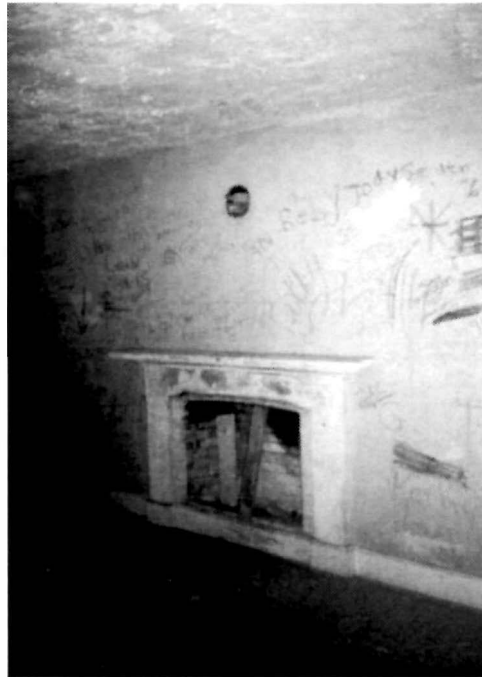
**Figure 64** View of the fireplace along the north wall of the South Parlor (Room 104), 1994. Note that although the brick and plaster infill has been removed at this fireplace, the baseboard remains across the opening.

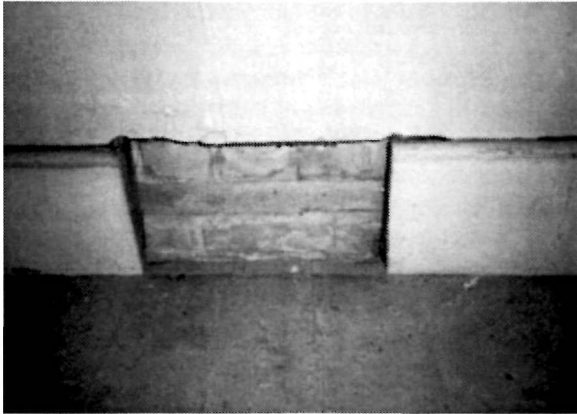
**Figure 65** Detail view of the south wall of the southeast bedroom (Room 201), 1995. The wood baseboard has been cut and removed, exposing the wood nailer within the brick coursing to which the baseboard is attached.

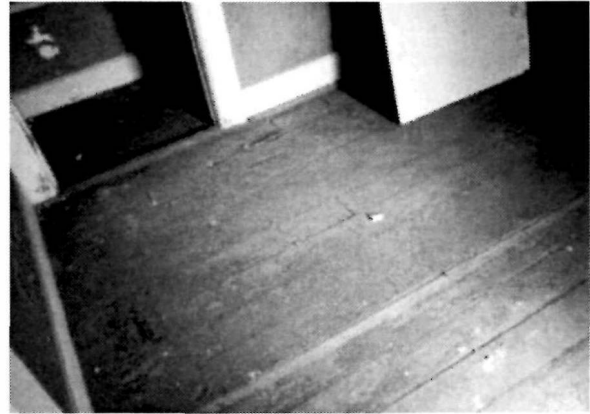
**Figure 66** View looking southwest at the floor of the Stair Hall (Room 202), 1995. The heavy paint buildup has caused the paint to fail and loosen in large chunks.

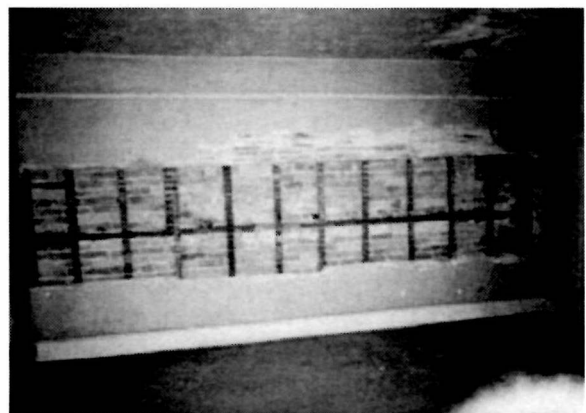
*Figure 67* View of the north wall in the northwest bedroom (Room 204), 1994. The large area of missing plaster has revealed a wood plate within the brick coursing, presumably incorporated as a nailing surface for the wood lath.

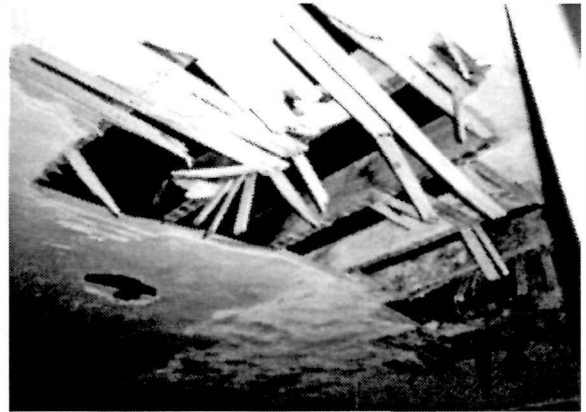
**Figure 68** View of the ceiling in the southwest bedroom (Room 205), 1994. Note the large amount of missing plaster and broken lath, both the result of vandalism.

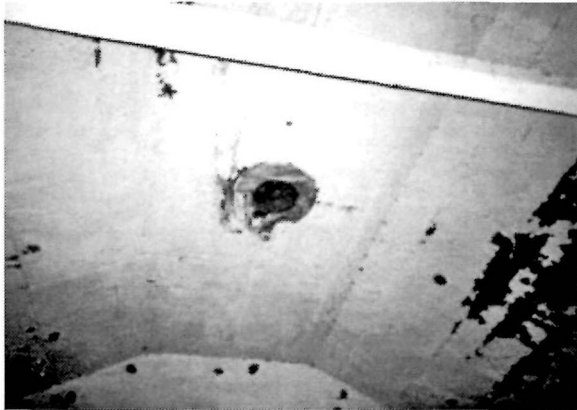
**Figure 69** Detail view of an opening in the ceiling of the Fog Signal Building, 1995. A metal chimney stack once extended through this opening.

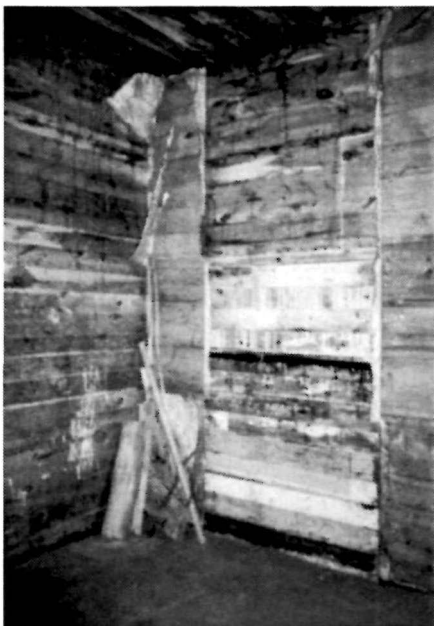
Figure 74 View looking at the southwest corner of the Coal Bin in the Fog Signal Building, 1995.

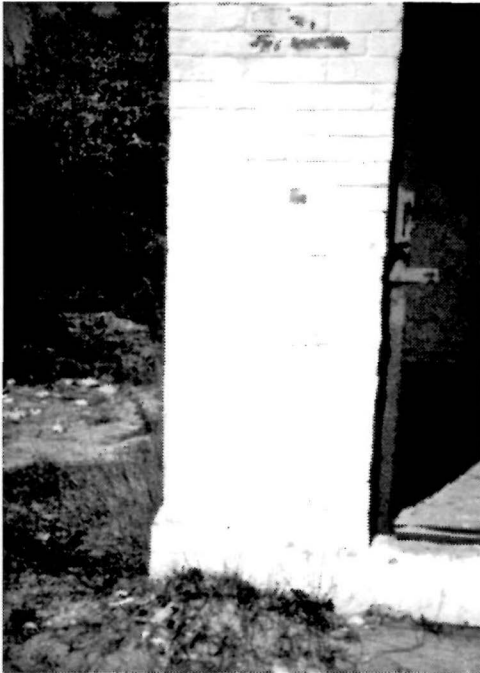
Figure 76 Detail view of the south corner of the east elevation of the Brick Oil House, 1994. Note the parging, which was tooled to resemble brickwork and is falling off.

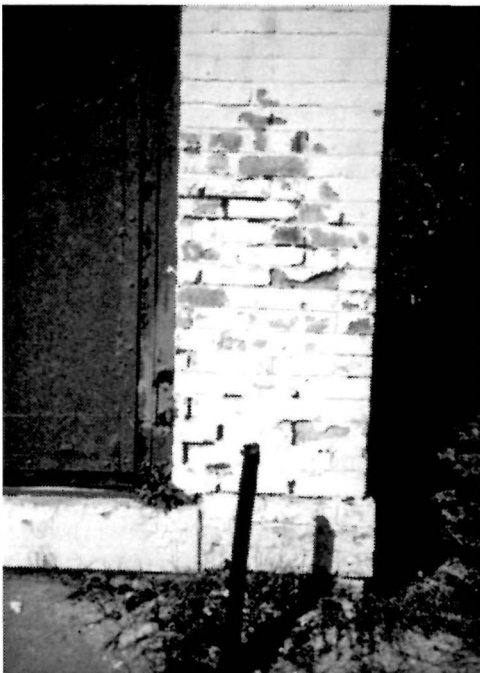
Figure 77 Detail view of the north end of the east elevation of the Brick Oil House, 1994. Note the spalling brick and deteriorated mortar joints.

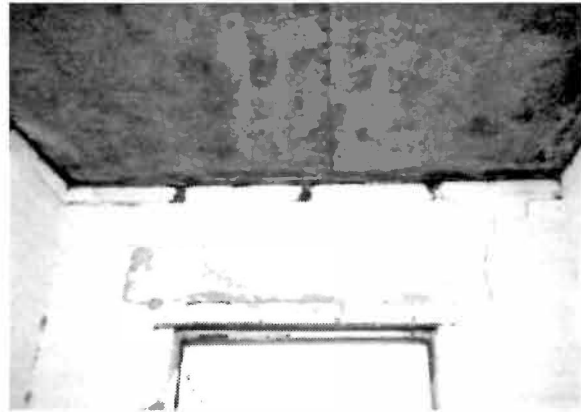
Figure 78 Detail interior view of the door head and ceiling of the Brick Oil House, 1994.

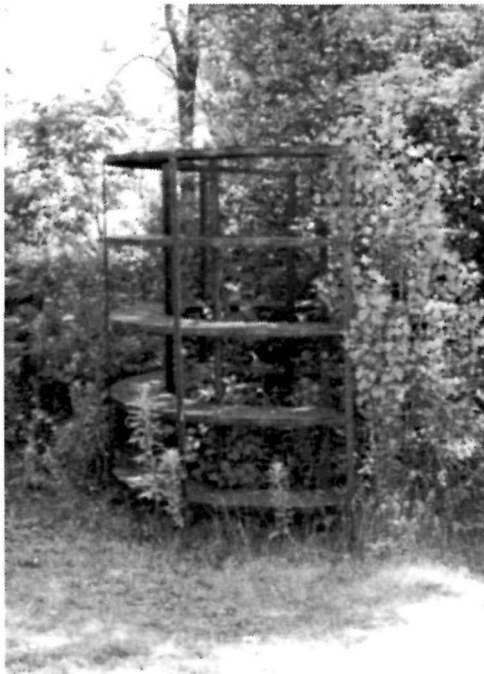
**Figure 80** View of the rusted metal shelving previously located inside the Metal Oil House, 1994.

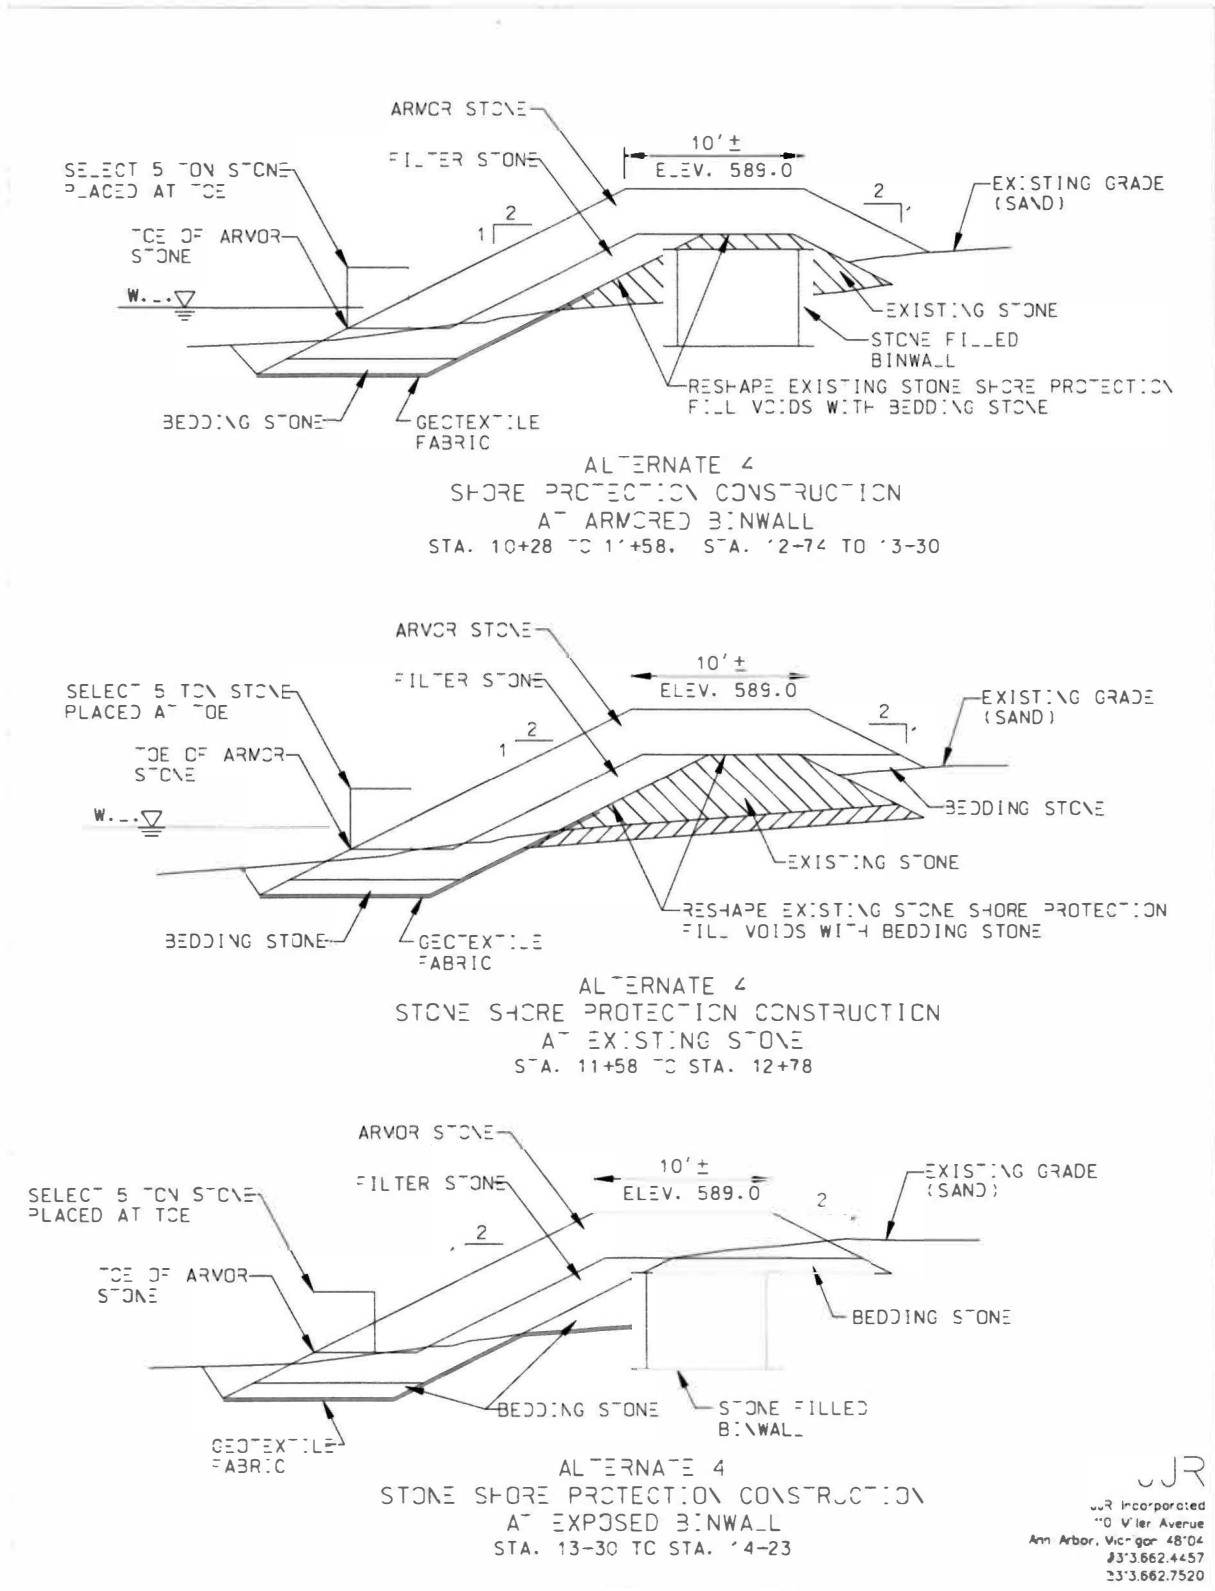
Figure 5: Preliminary cross-section recommendations for shoreline stabilization.

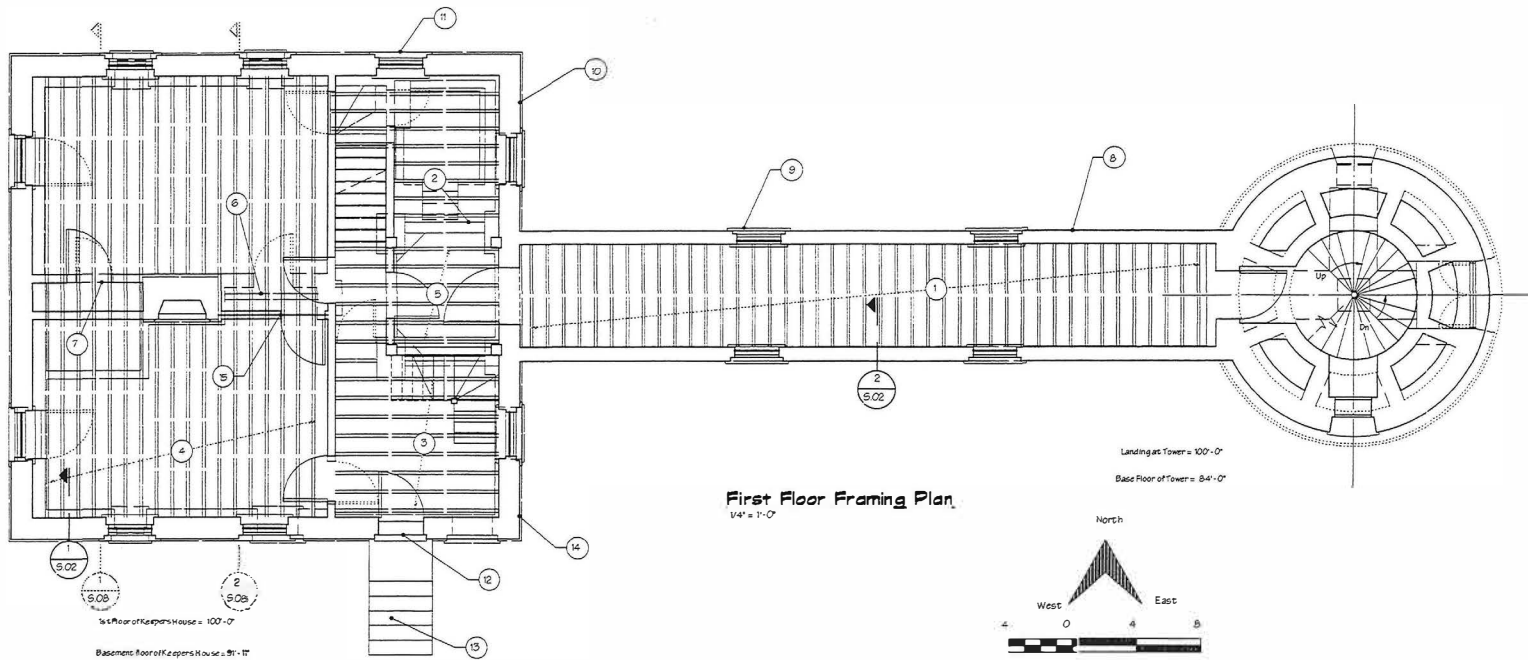
First Floor Framing Plan  
1/4" = 1'-0"
