# HISTORIC STRUCTURE and CULTURAL LANDSCAPE REPORT

South Manitou Island Light Station  
(Historic Structures 51-120 A-I)

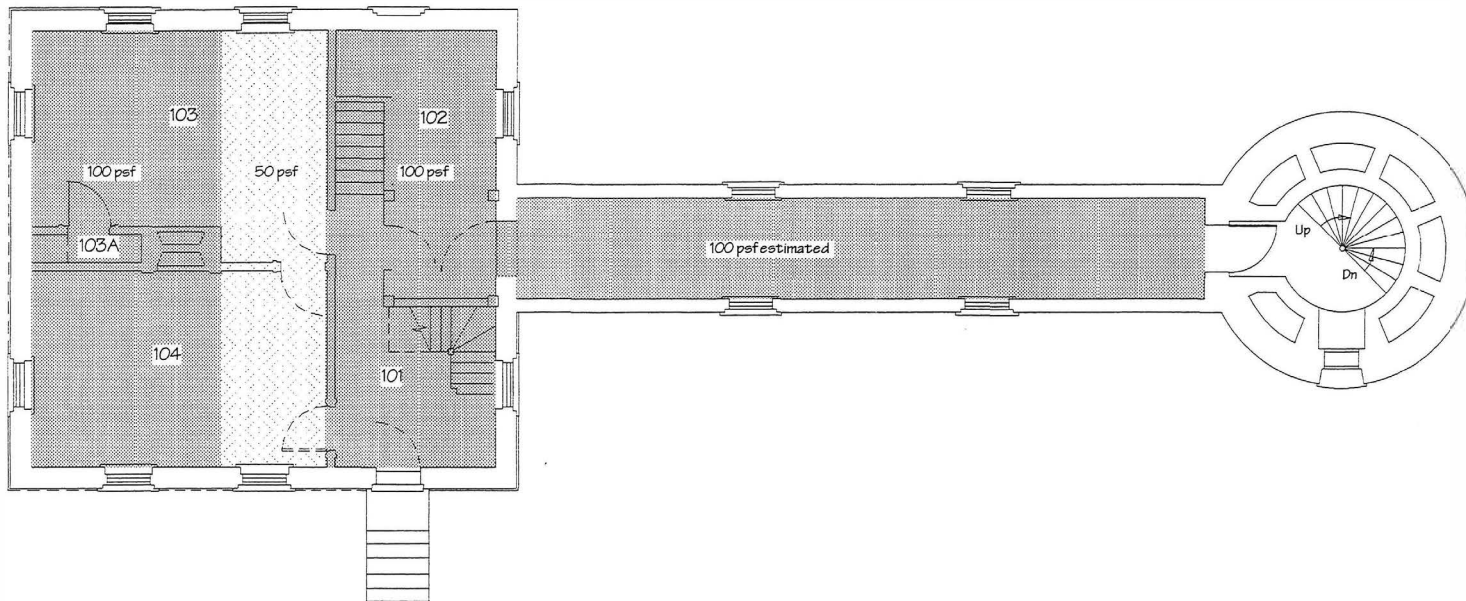
FIRST FLOOR PLAN - EXISTING CONDITIONS - LOAD AREAS

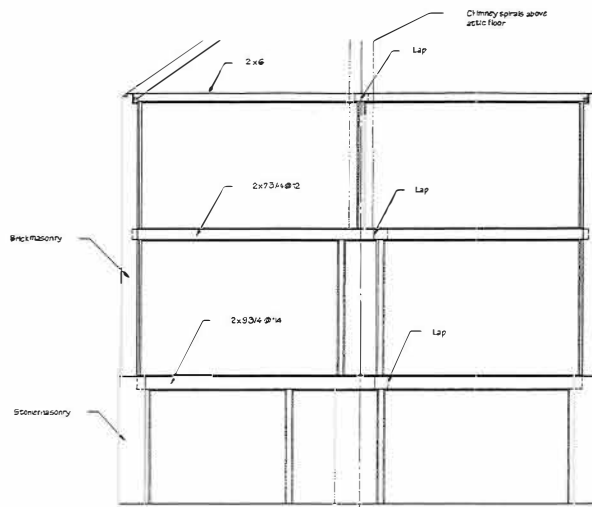
1  
S.08  
North-south framing at west side of fireplace/chimney  
1/4" = 1'-0"

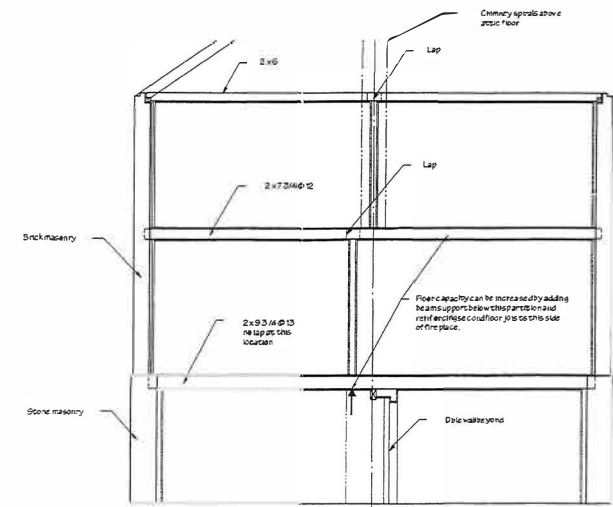
2  
S.08  
North-south framing at east side of fireplace/chimney  
1/4" = 1'-0"

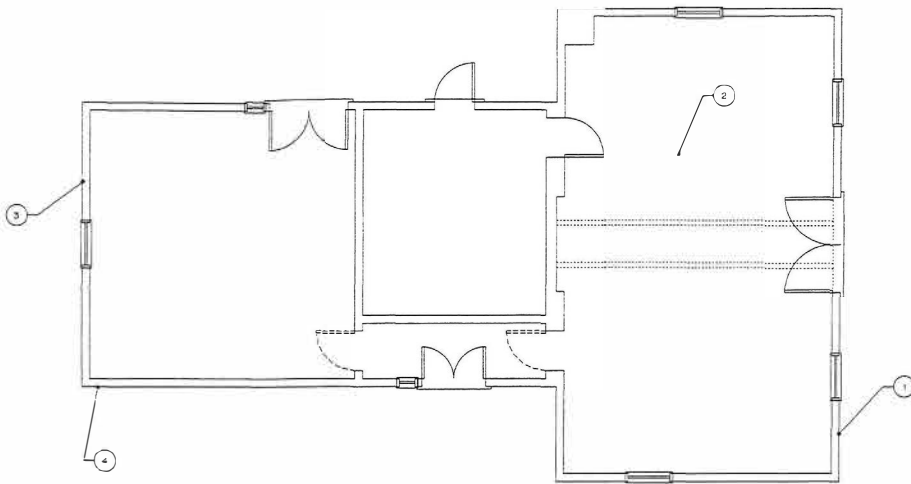
DESIGNED:	SUB SHEET NO.	TITLE OF SHEET	DRAWING NO.
DRAWN:	S.08	KEEPER'S DWELLING AND TOWER EXISTING CONDITIONS	XXX
TECH REVIEW:			XXXX
DATE:		SOUTH MANITOU ISLAND LIGHT STATION SLEEPING BEAR DUNES NATIONAL LAKESHORE	PKGS. NO. X
			SHEET OF XX

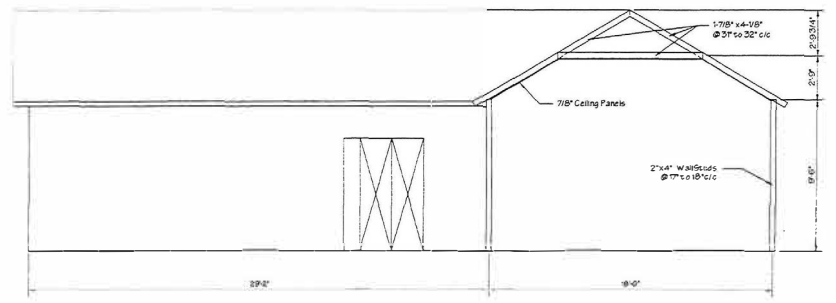
**FOG SIGNAL CROSS SECTION**

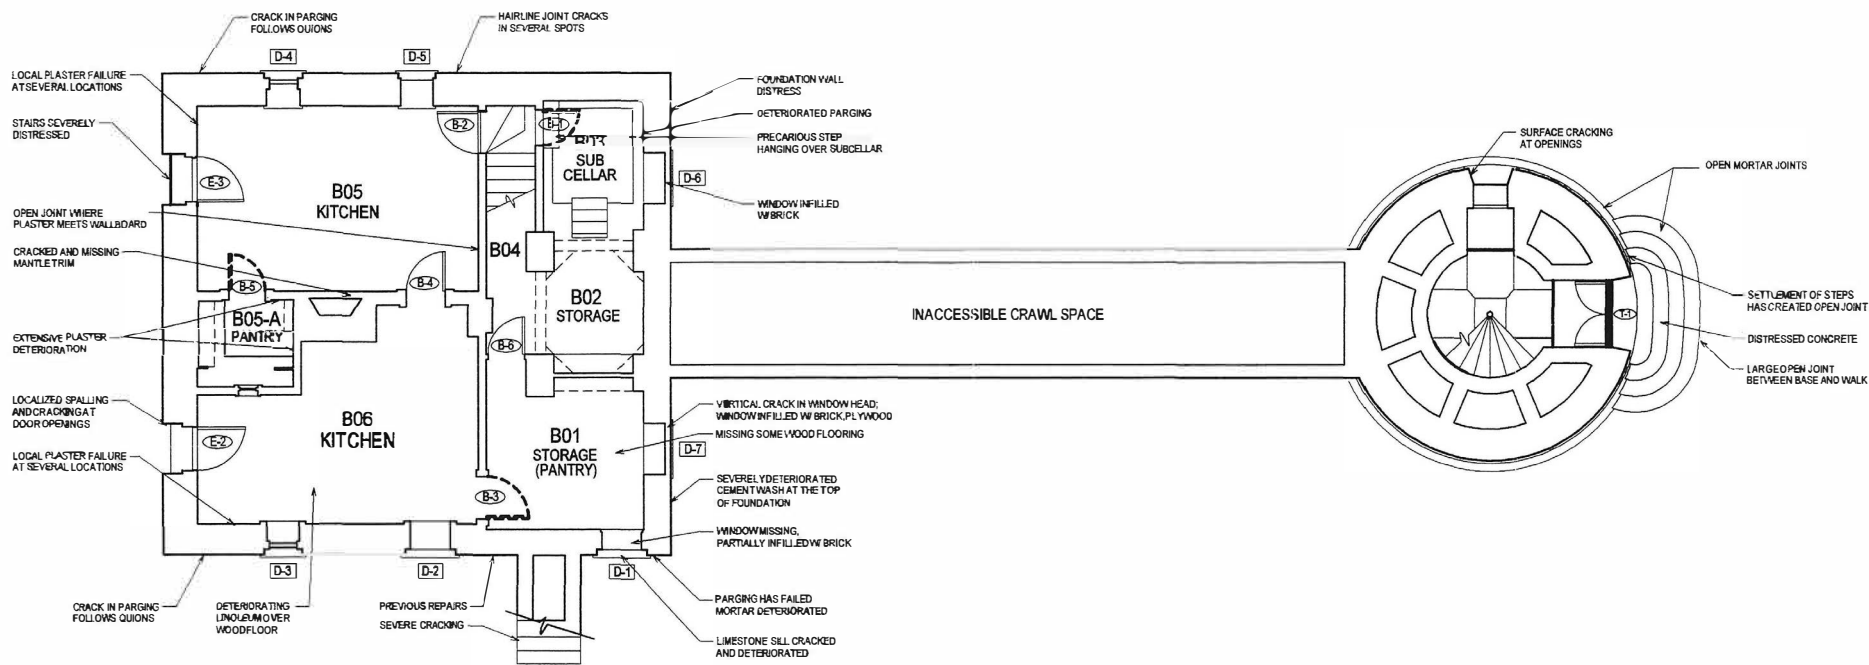
**BASEMENT PLAN - EXISTING CONDITIONS**

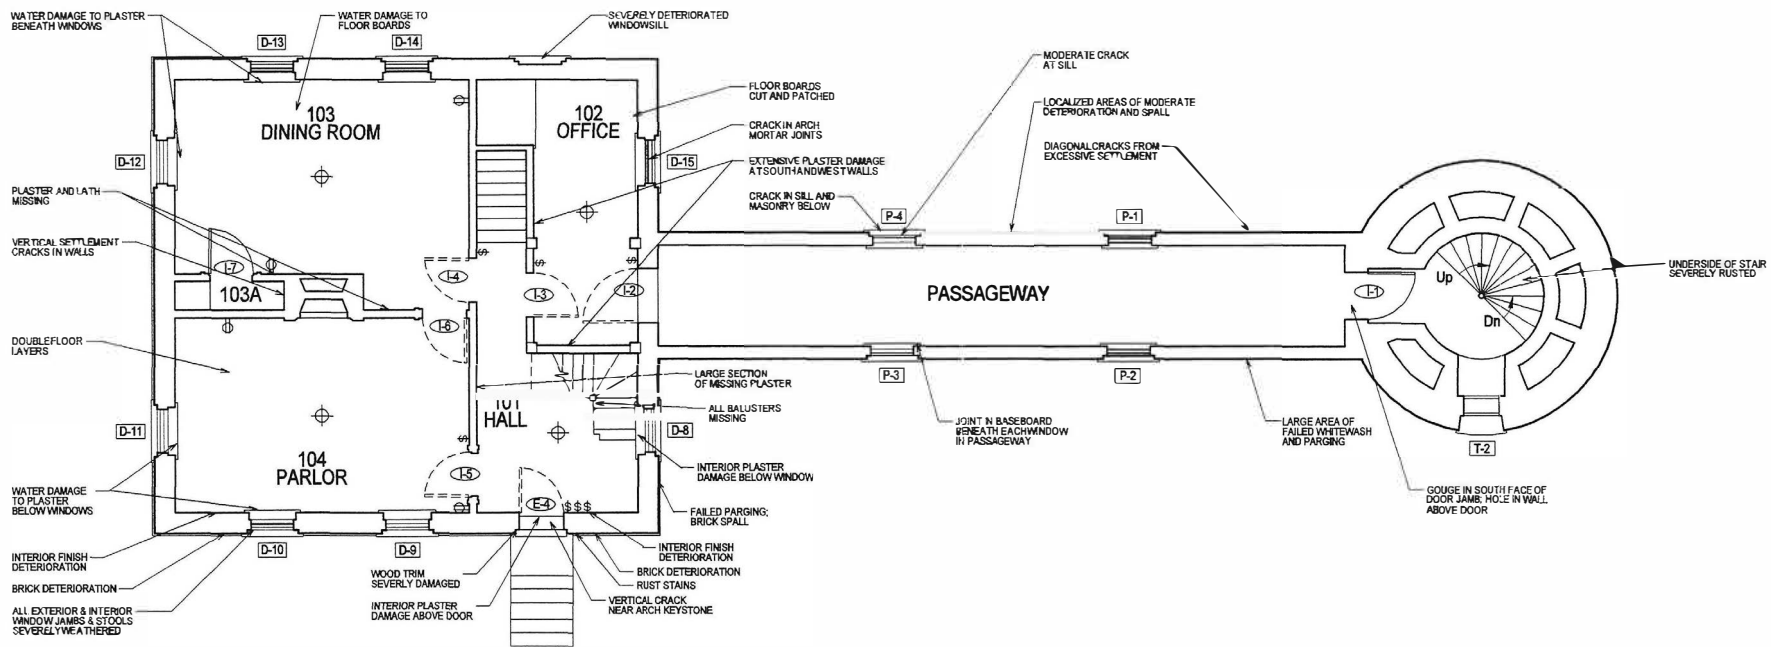
**FIRST FLOOR PLAN - EXISTING CONDITIONS**

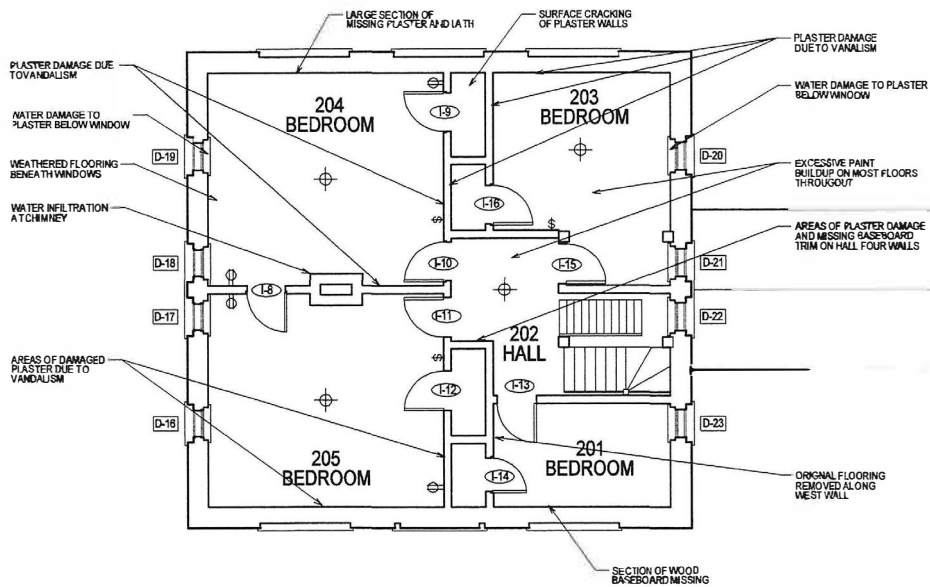
## SECOND FLOOR PLAN - EXISTING CONDITIONS

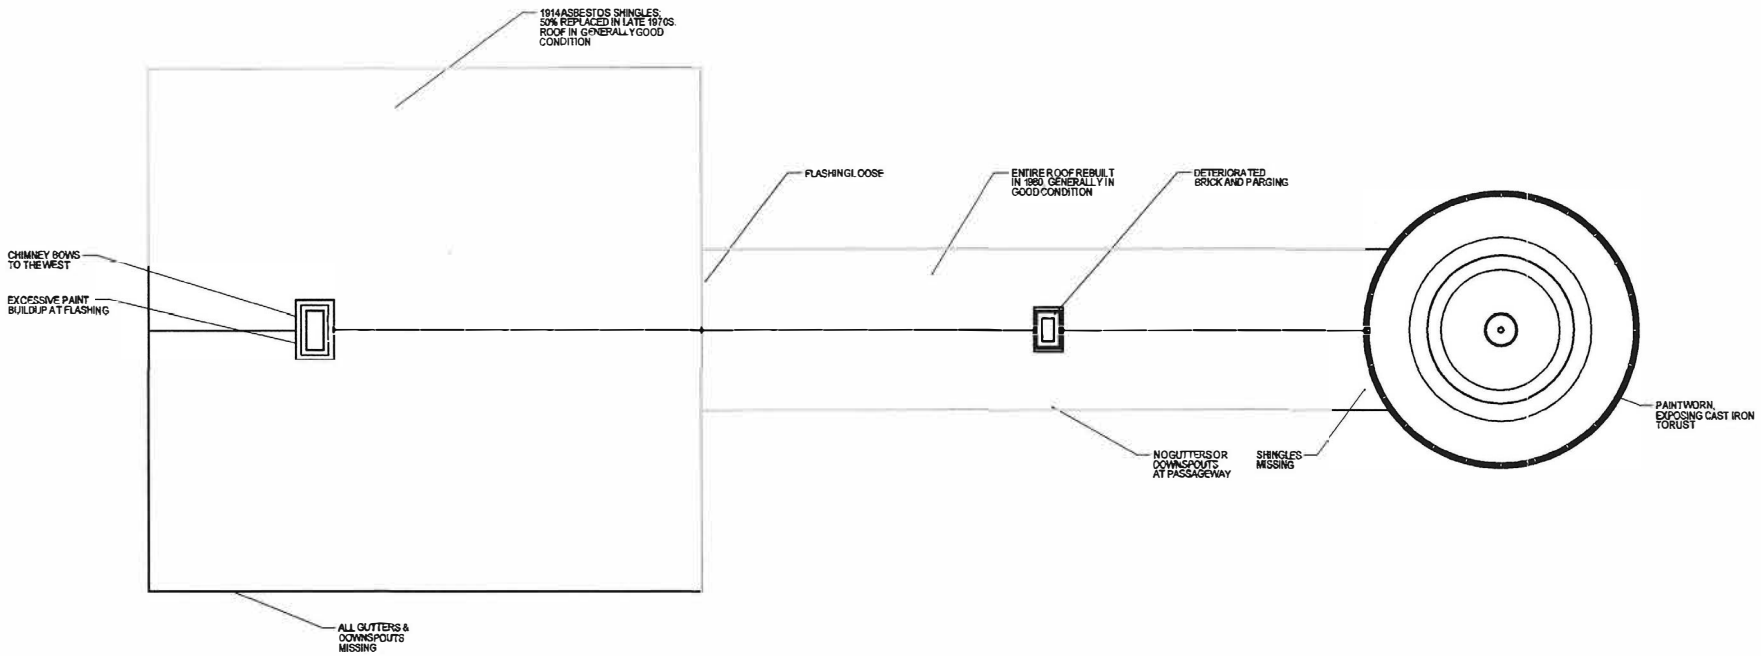
**ROOF PLAN - EXISTING CONDITIONS**

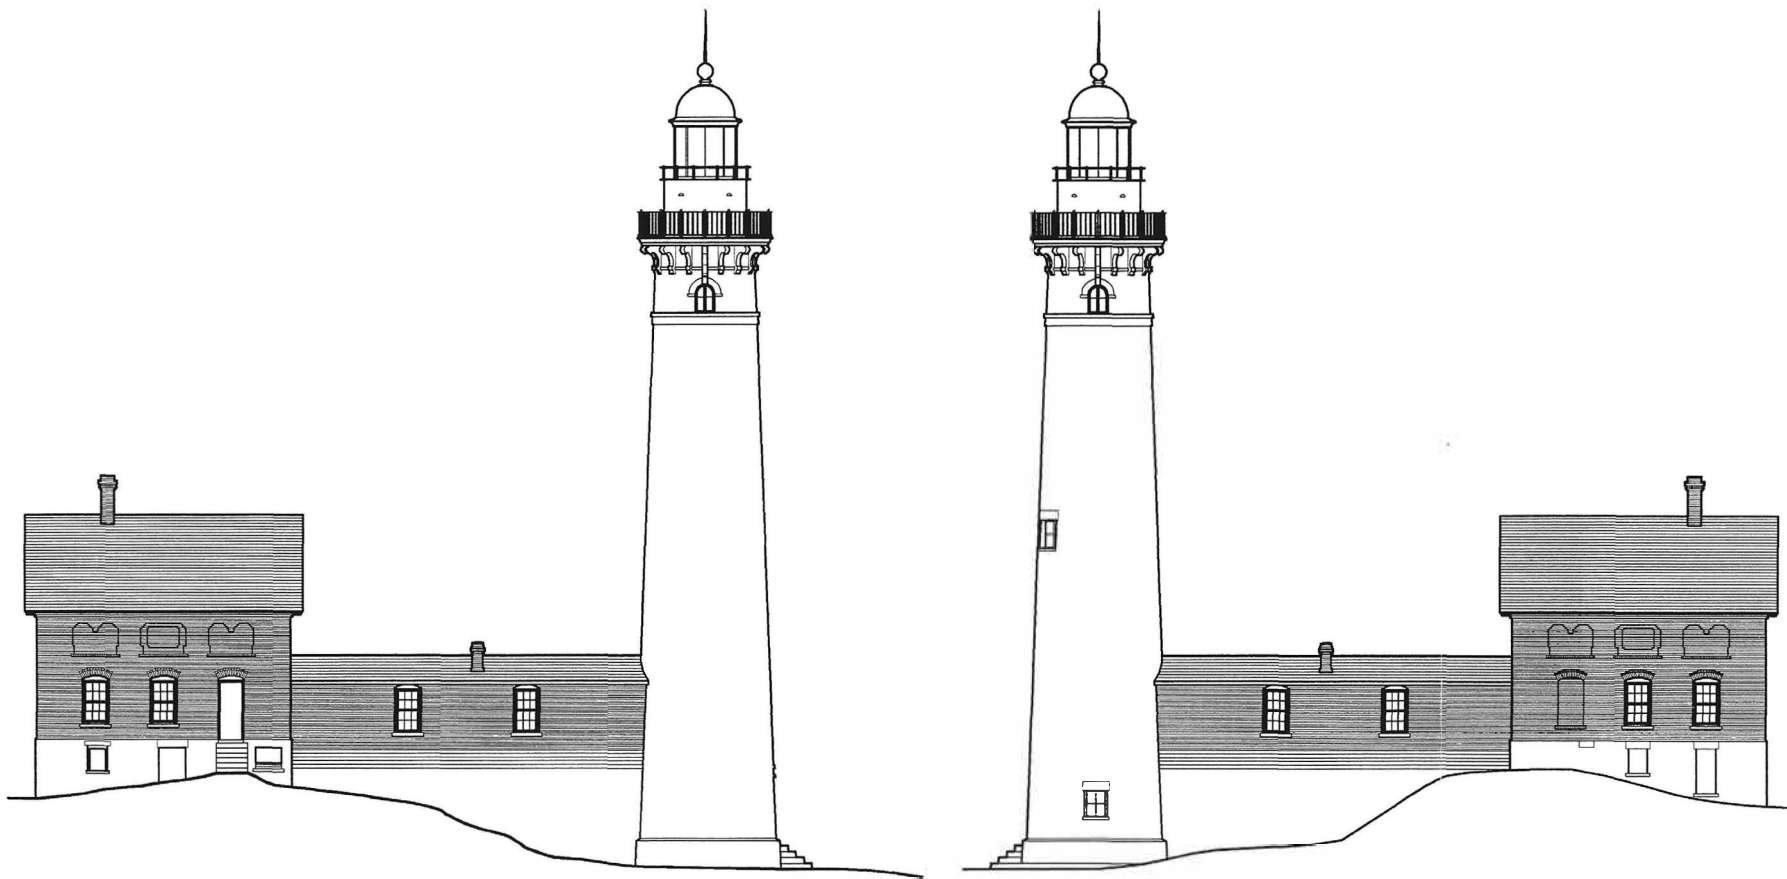
**SOUTH ELEVATION - EXISTING CONDITIONS**

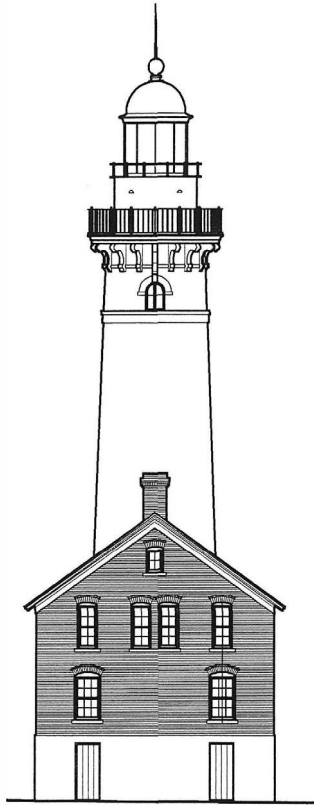
**WEST ELEVATION - EXISTING CONDITIONS**  
 SCALE: 1/16" = 1' - 0"

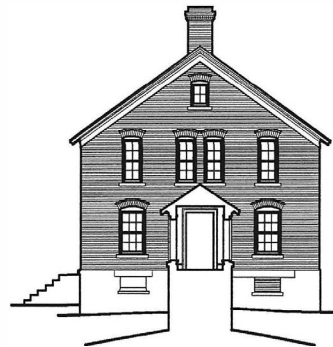
**EAST ELEVATION - EXISTING CONDITIONS**  
 SCALE: 1/16" = 1' - 0"

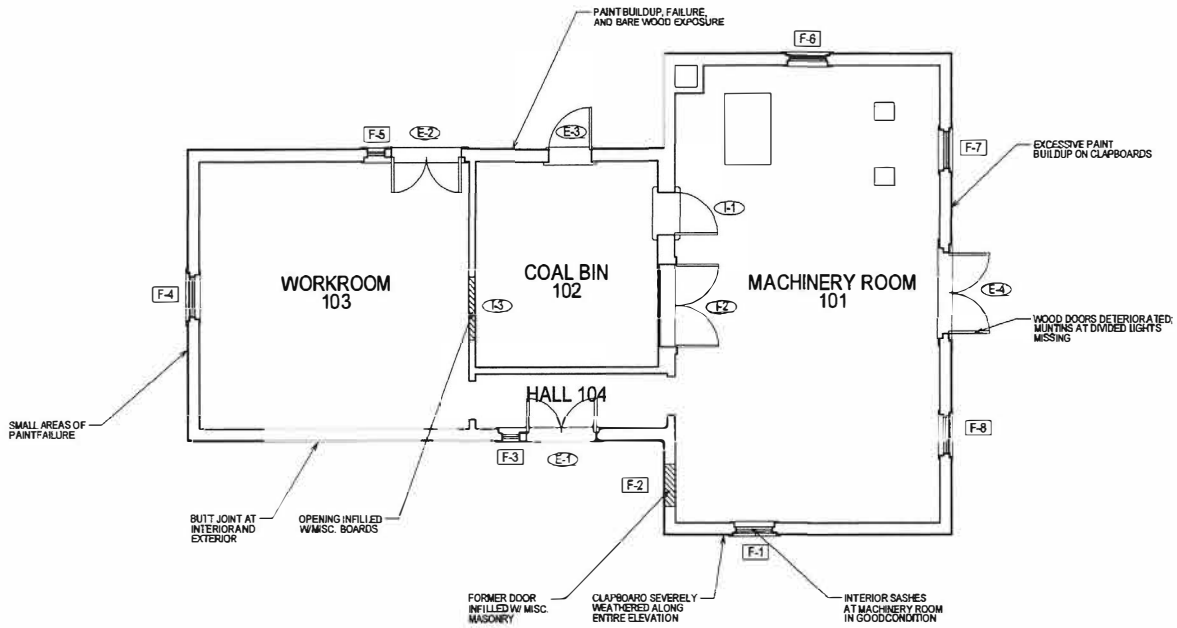
**FIRST FLOOR PLAN - EXISTING CONDITIONS**

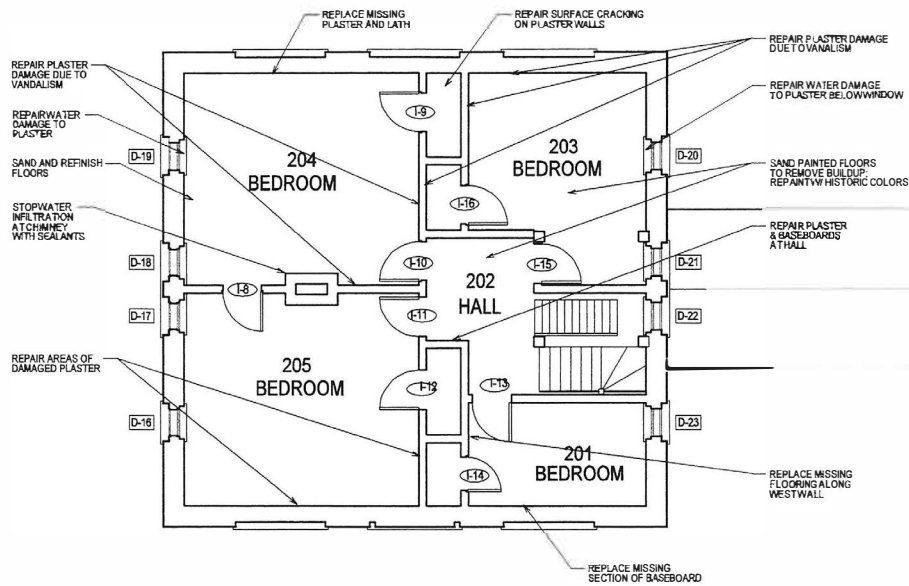
## SECOND FLOOR PLAN - RECOMMENDED TREATMENTS

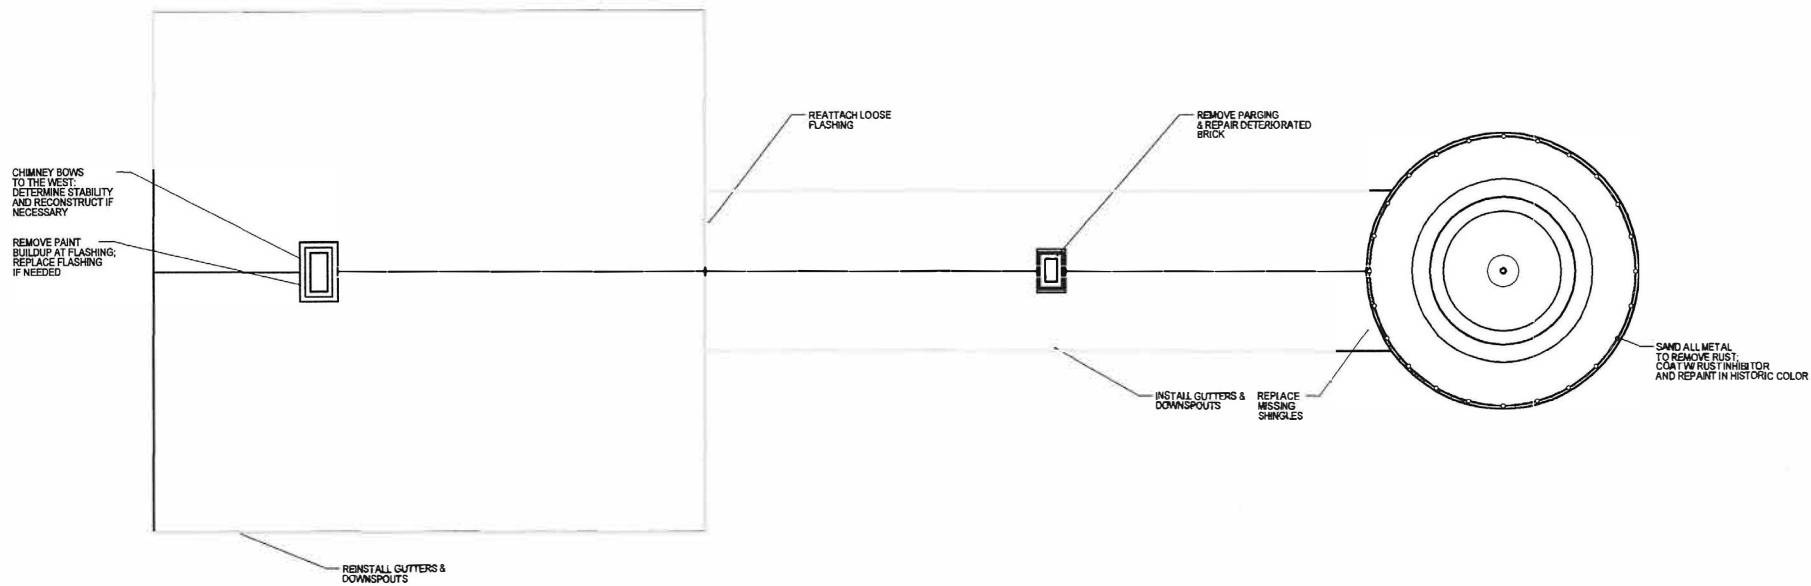
### ROOF PLAN - RECOMMENDED TREATMENTS

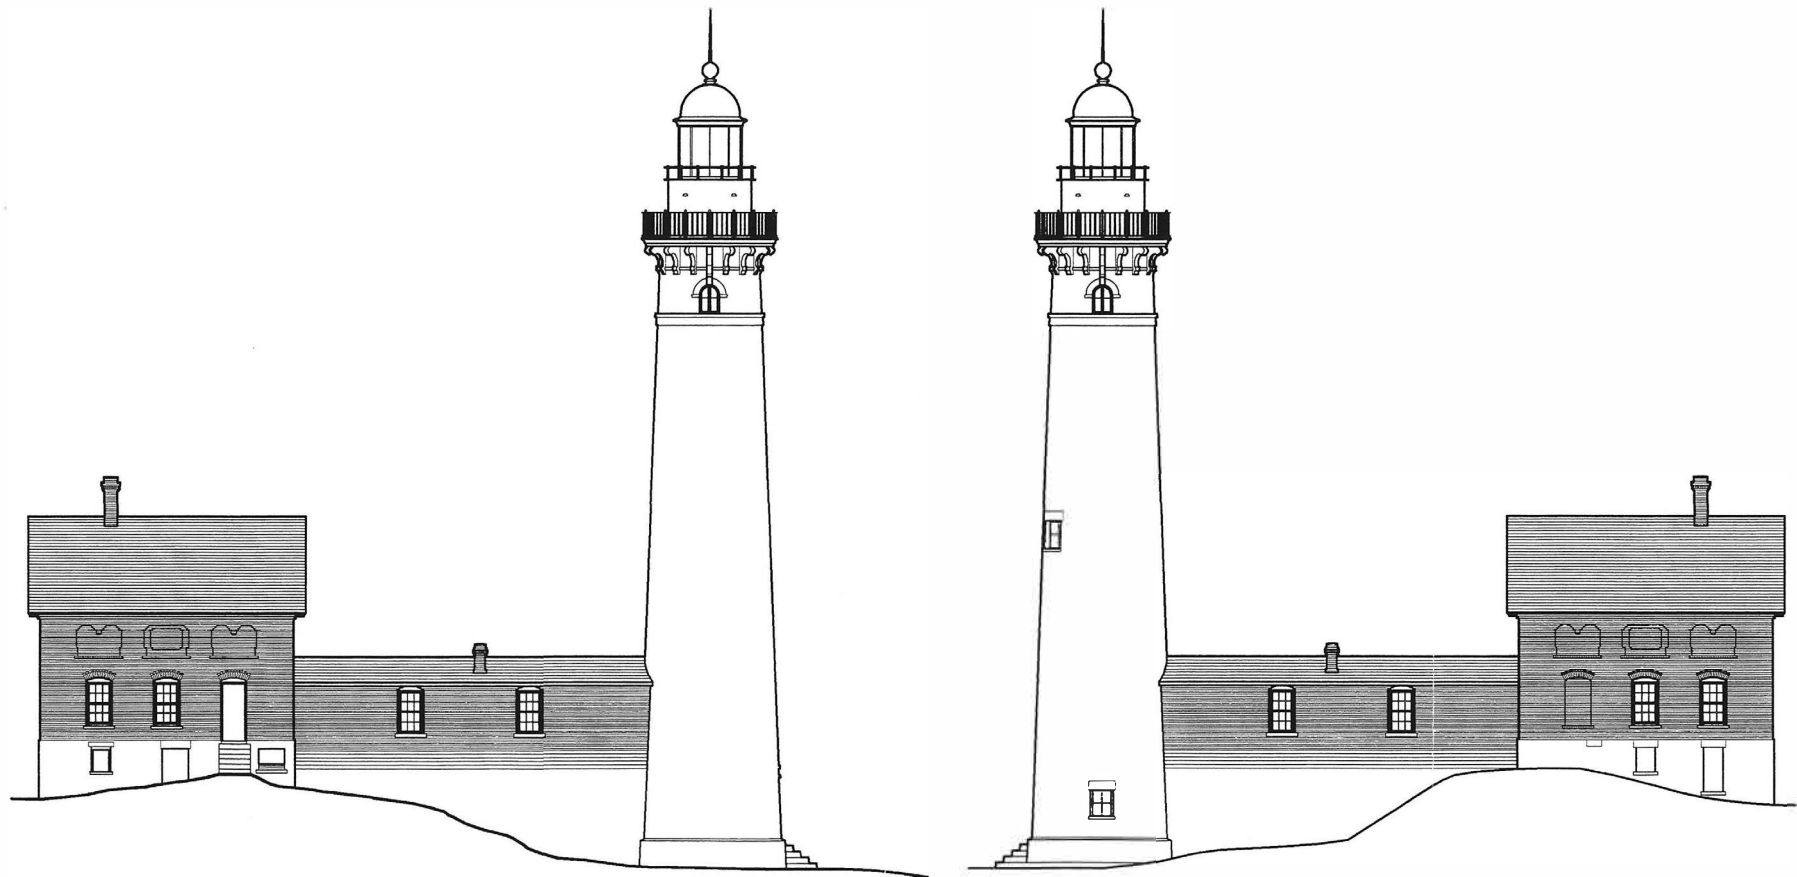
**SOUTH ELEVATION - RECOMMENDED TREATMENTS**  
 SCALE: 1/16" = 1' - 0"

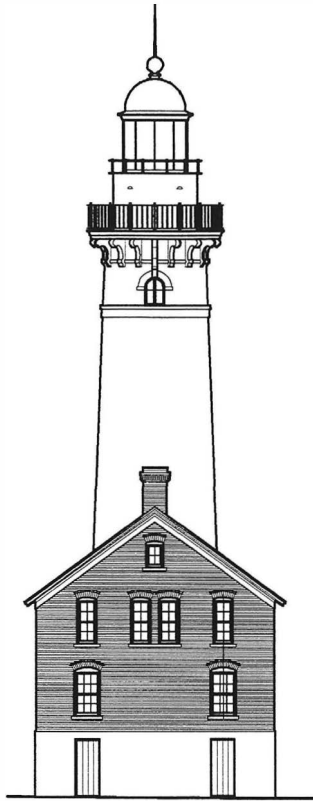
**WEST ELEVATION - RECOMMENDED TREATMENTS**

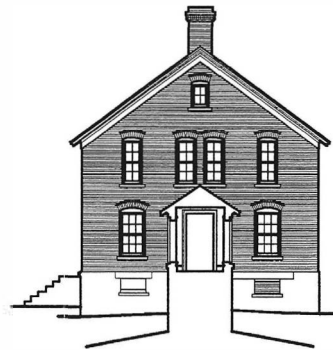
**EAST ELEVATION - RECOMMENDED TREATMENTS**

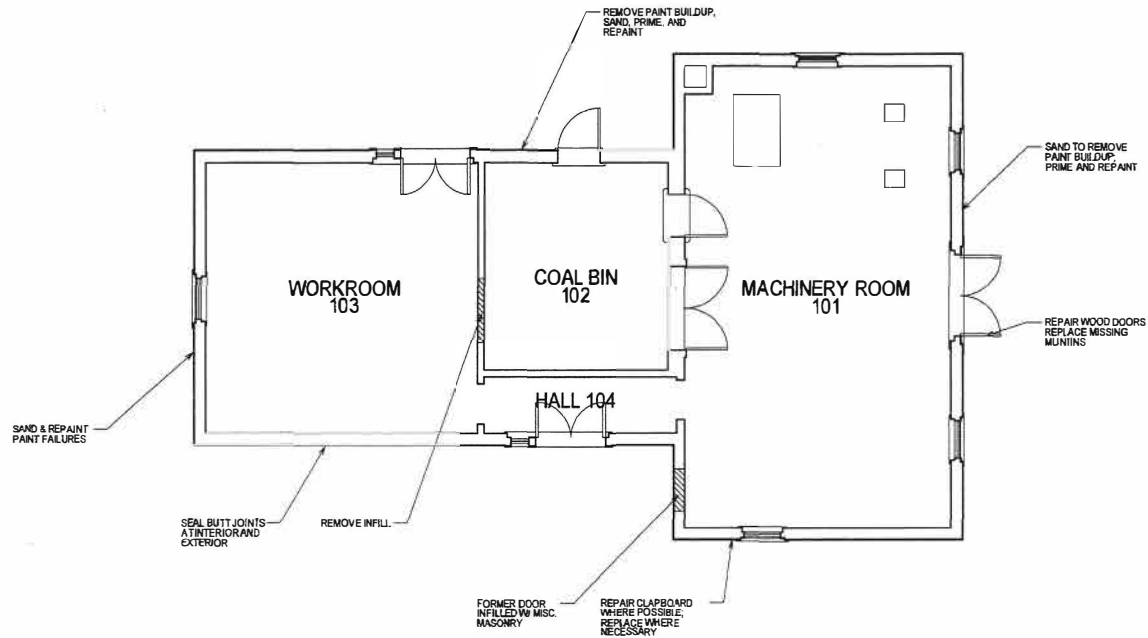
**FIRST FLOOR PLAN - RECOMMENDED TREATMENTS**

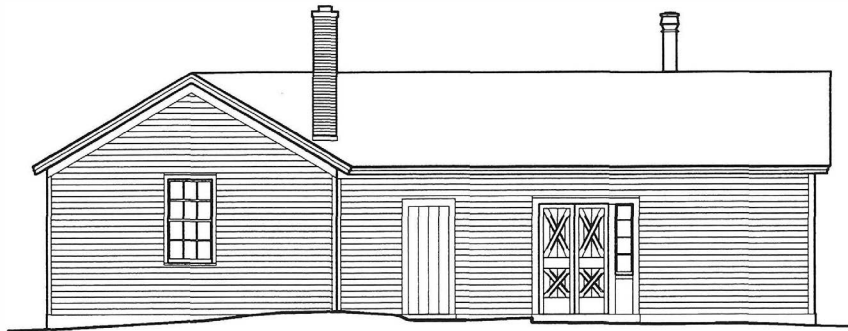
<b>Fitzpatrick Structural Engineering, P.C.</b> <small>719-172 N. MICHIGAN ST. ANN ARBOR MI 48104 734-769-0020 Fax 734-769-3065</small>	<b>ISSUED</b> DATE: 07/26/09 INITIAL: B.R.	<b>PREPARED</b> DESIGNED: S.J., B.R. DRAWN: B.R. CHECKED: S.J. FILED: QUINN EVANS ARCHITECTS	<b>SHEET TITLE</b>  <b>FLOOR PLAN</b>	<b>UNITED STATES DEPARTMENT OF THE INTERIOR</b> <b>NATIONAL PARK SERVICE</b> <b>PLANNING RESOURCE PRESERVATION</b> MIDWEST REGIONAL OFFICE  RECOMMENDED TREATMENTS FOG SIGNAL BUILDING SOUTH MANITOU ISLAND LIGHT STATION SLEEPING BEAR DUNES NATIONAL LAKESHORE	FILE NAME: FOGSIG.DGN SUB SHEET NO.: A.7	DRAWING NO.: SHEET <b>07</b> OF <b>08</b>

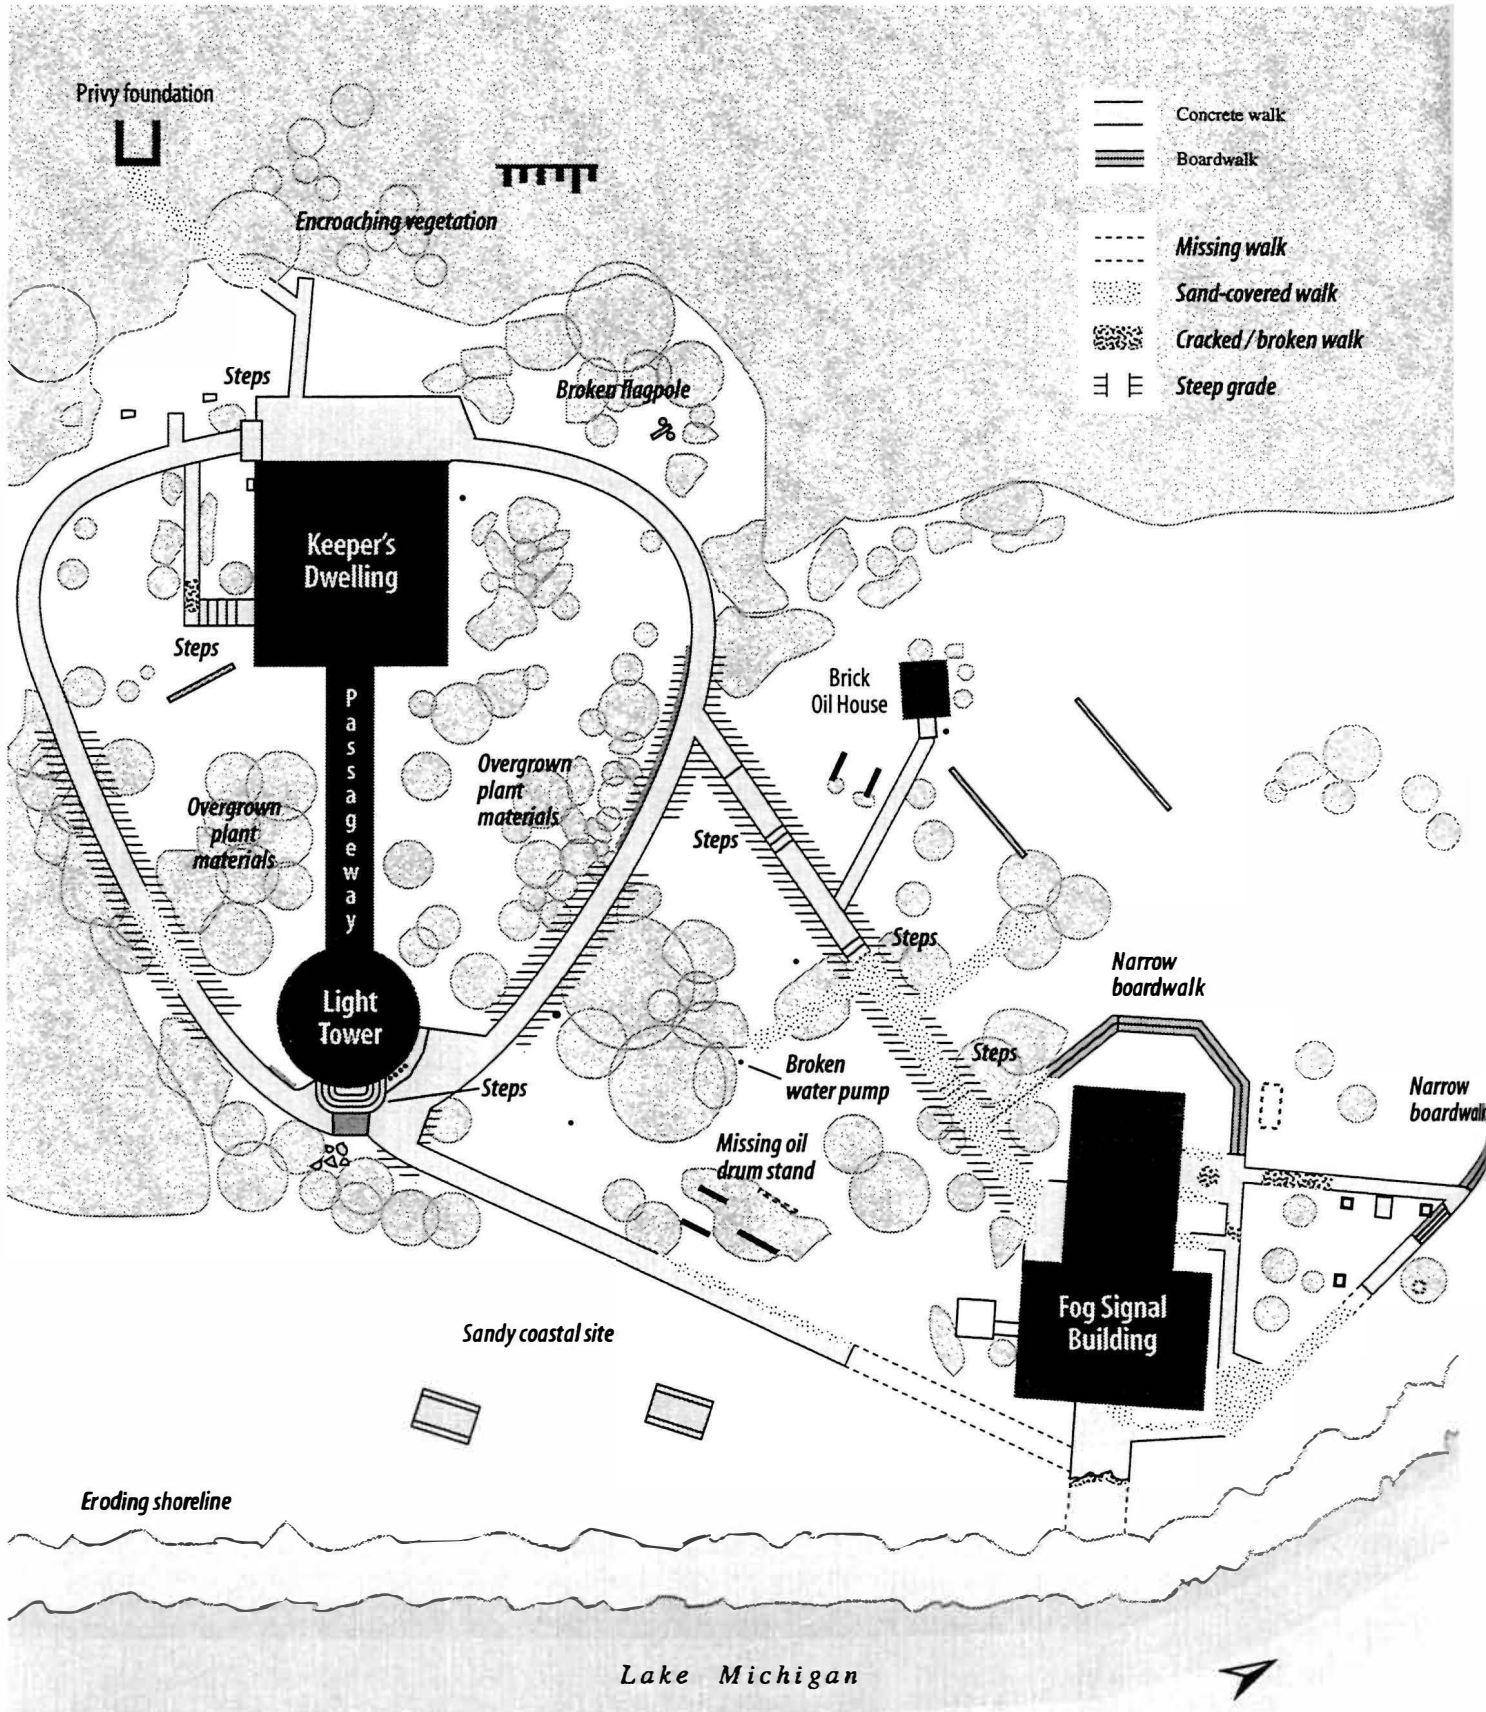
*Exhibit 9*  
**SOUTH MANITOU ISLAND LIGHT STATION**  
**Landscape Existing Conditions 1997**

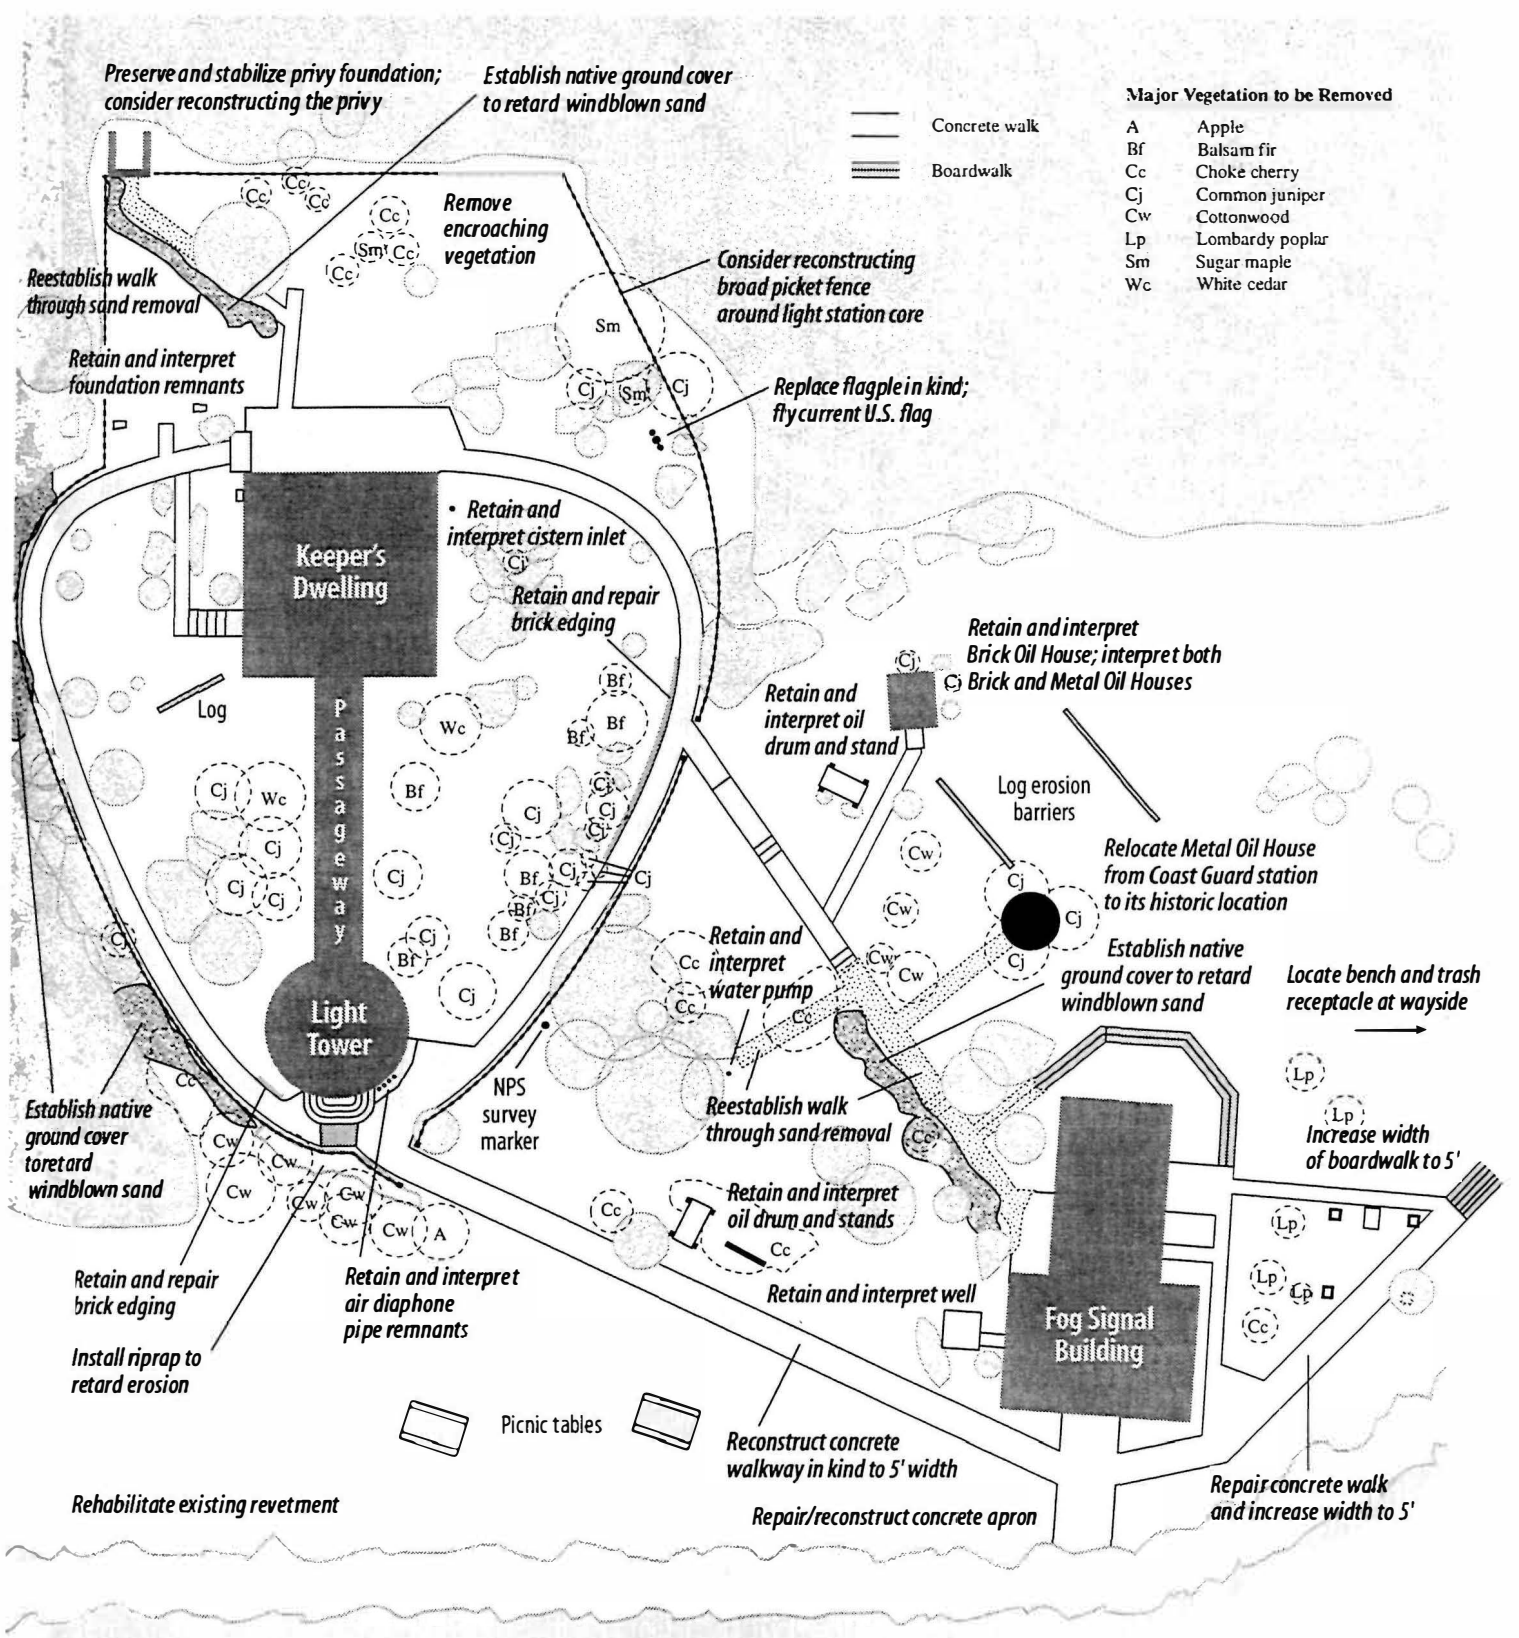
**Major Vegetation to be Removed**
