Sleeping Bear Dunes National Lakeshore
Michigan

North Manitou Island Life-Saving Station Cultural Landscape Report

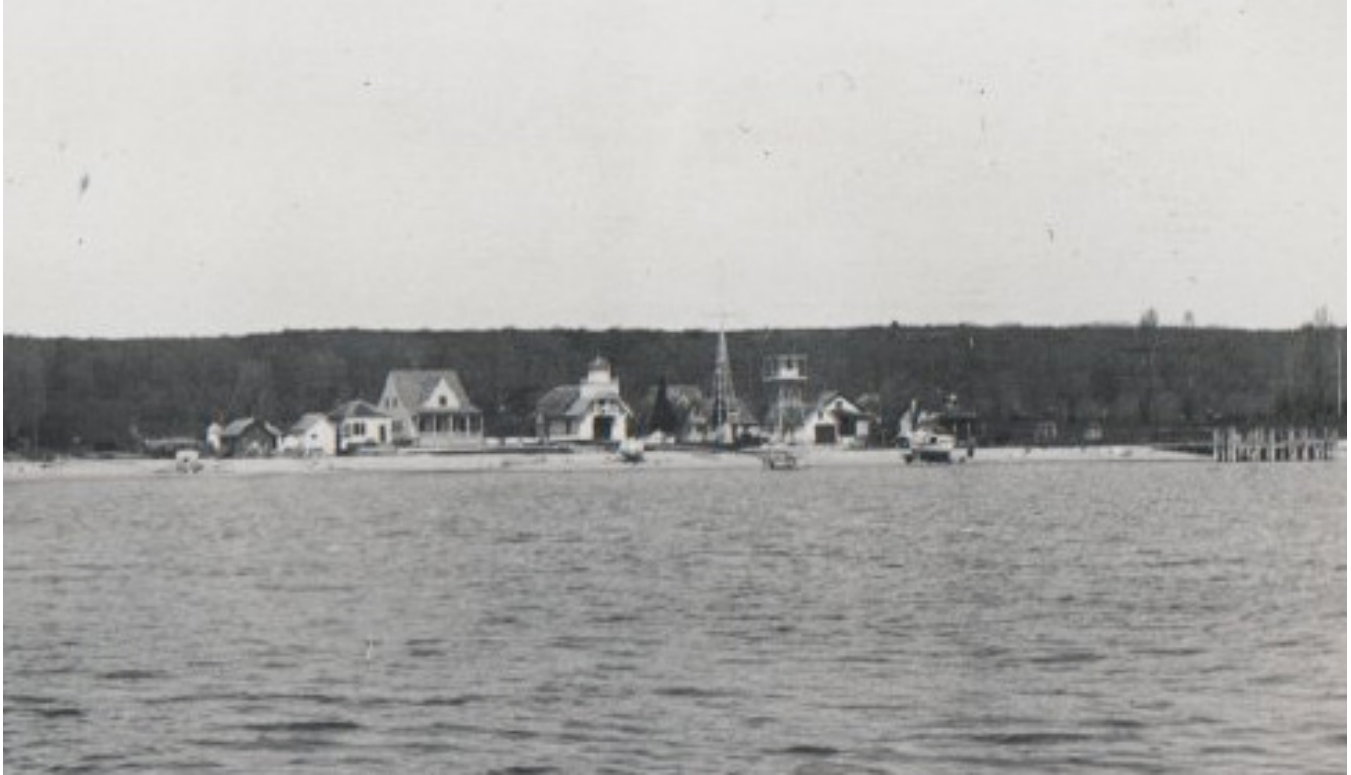
Figure 1-4. North Manitou Island Life-Saving Station (source: Sleeping Bear Dunes National Lakeshore, undated).

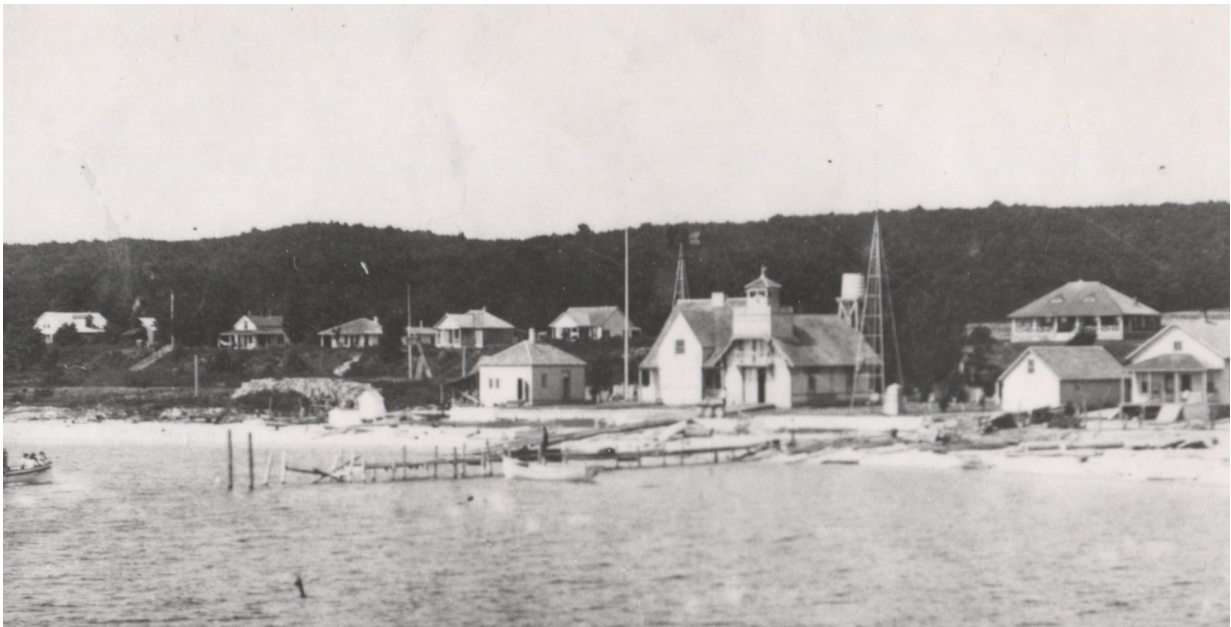
Figure 2-15. Cottage Row set on a slight rise behind North Manitou Island Life-Saving Station, before 1915 (source: Leelanau Historical Society).

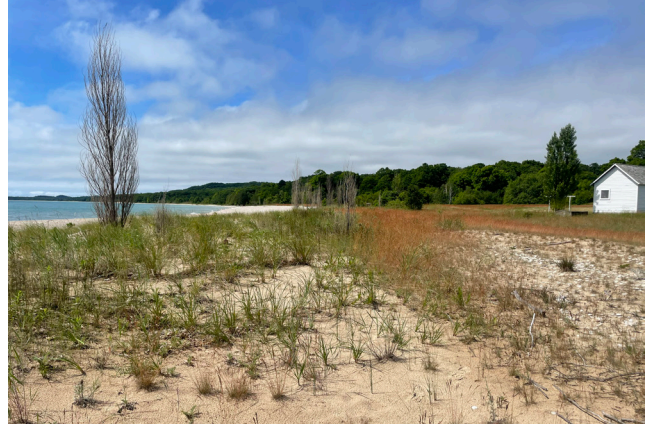
Figure 3-4. Beach and dune complex (source: Mundus Bishop, 2024).

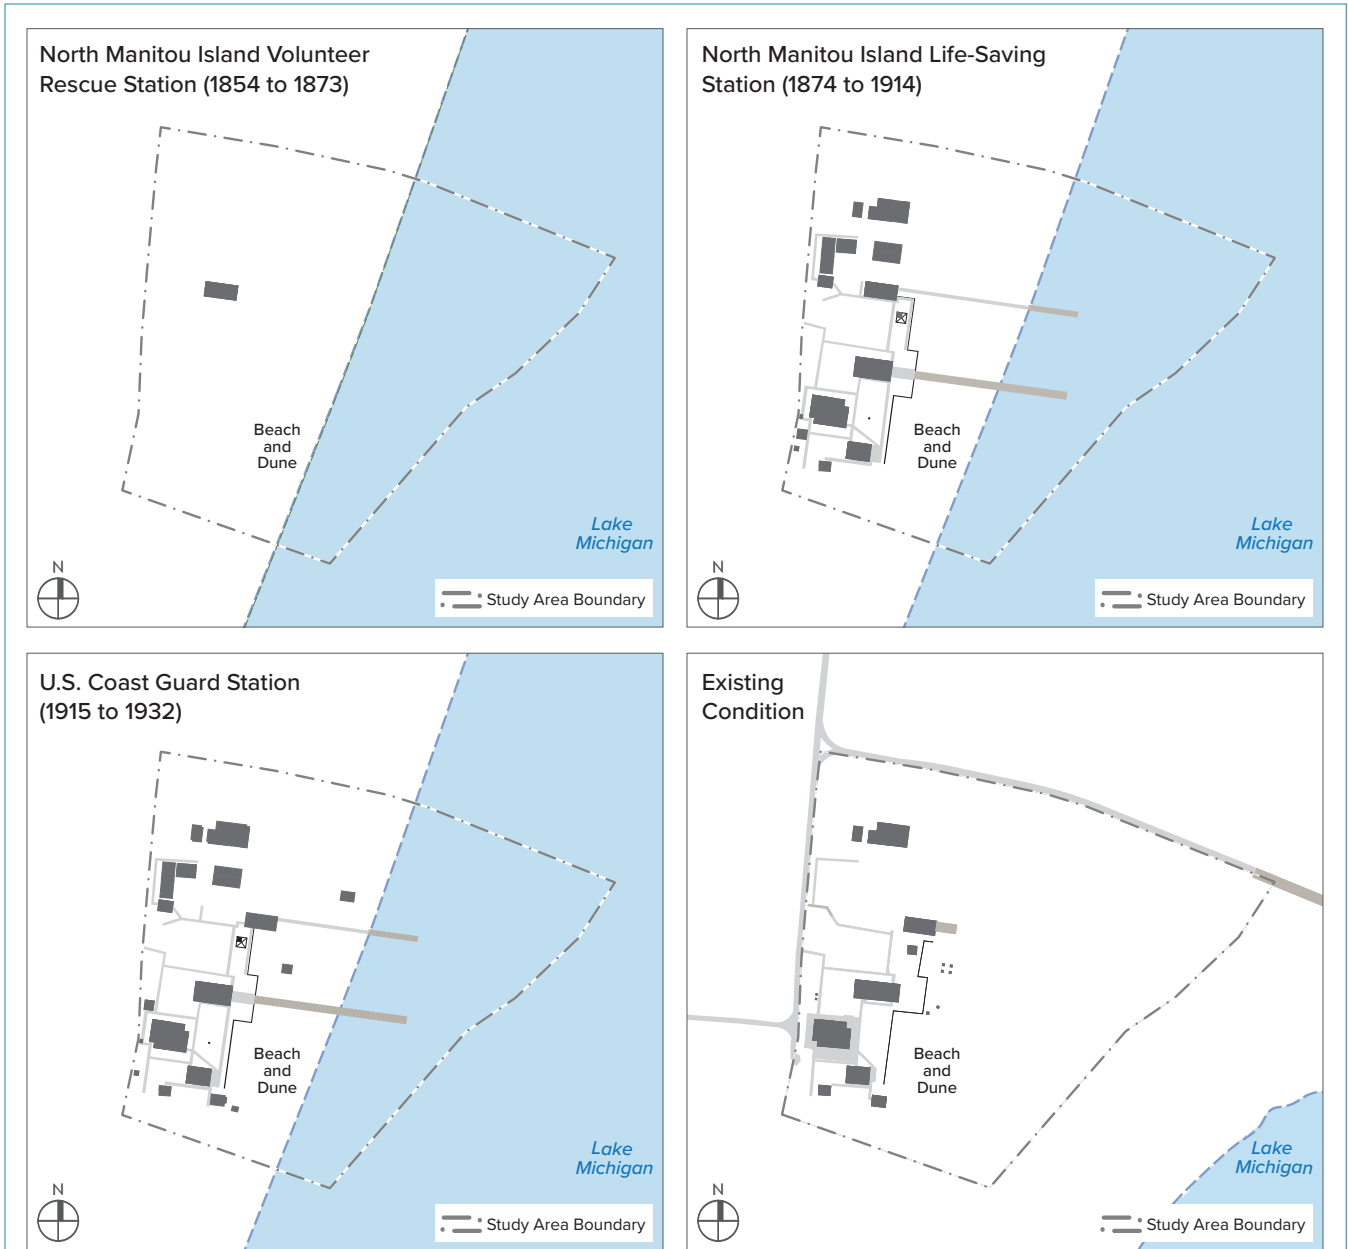
Figure 3-14. The number of buildings and site features evolved throughout the period of significance. The original grid arrangement and orientation to Lake Michigan established by the USLSS were maintained as the study area expanded. Volunteer Rescue Station was moved one full length toward Lake Michigan and placed the building on a concrete foundation shortly after the establishment of the USCG.

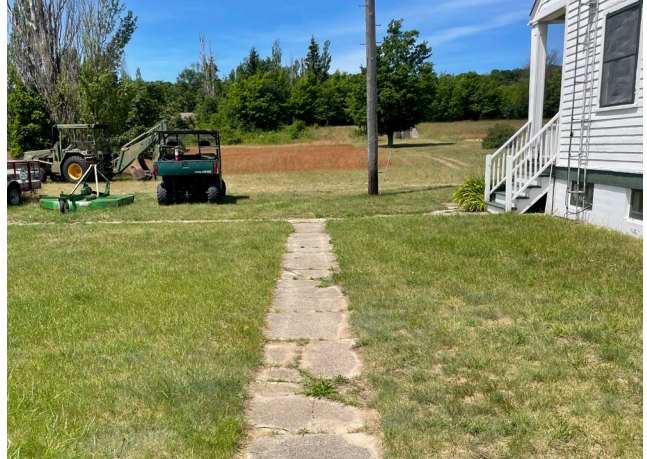
Figure 3-19. Orthogonal walks parallel building facades and are generally in fair to poor condition (source: Mundus Bishop, 2024).

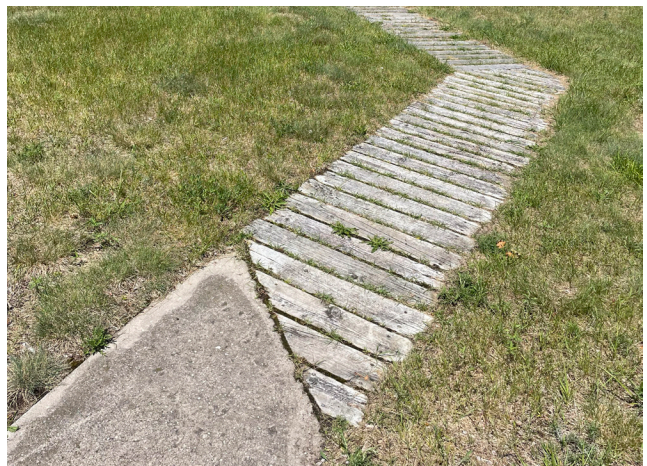
Figure 3-20. A wood boardwalk connects segments of concrete walk west of the Volunteer Rescue Station (source: Mundus Bishop, 2024).

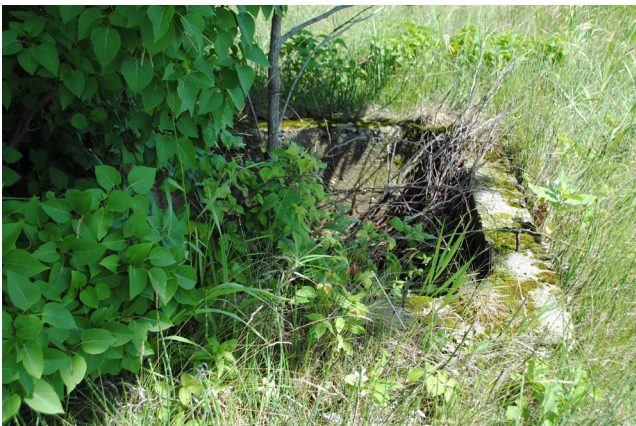
Figure 3-30. Fire Pump Well Foundation (source: Mundus Bishop, 2024).

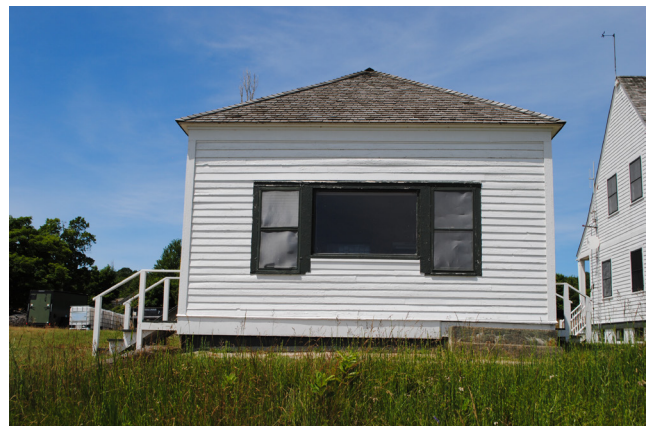
Figure 3-33. Crew Ready Room (source: Mundus Bishop, 2024).

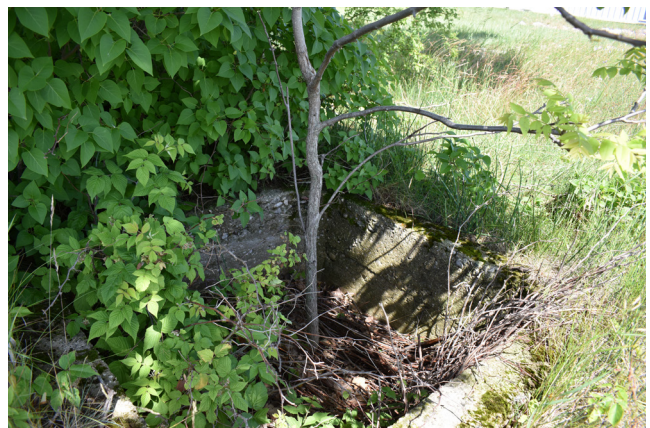
Figure 3-49. Establishment of vegetation within the Fire Pump Well Foundation (source: Mundus Bishop, 2024).
