Sleeping Bear Dunes National Lakeshore
Michigan

South Manitou Island Life-Saving Station and Village

Cultural Landscape Report

April 2026

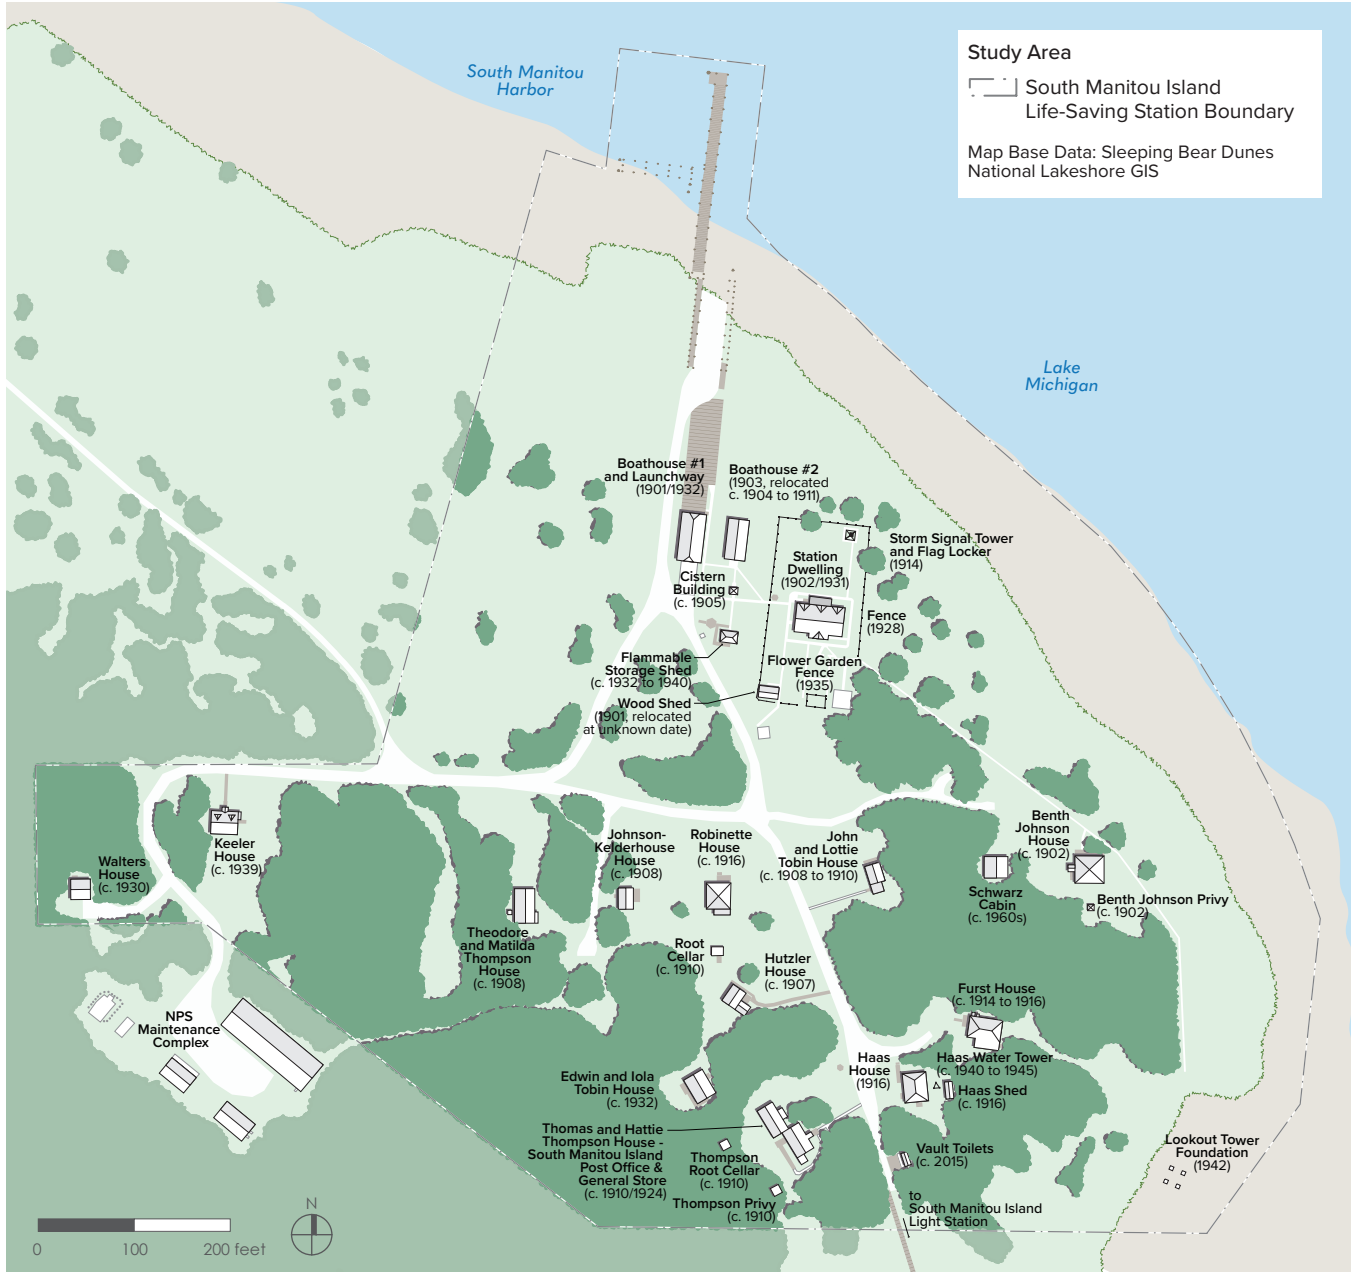
Figure 1-3. Existing condition of South Manitou Island Life-Saving Station and Village. The cultural landscape includes spatial patterns, buildings, structures, circulation, and small scale features established by the efforts of the U.S. Life-Saving Service and the U.S. Coast Guard (source: Mundus Bishop, 2025).

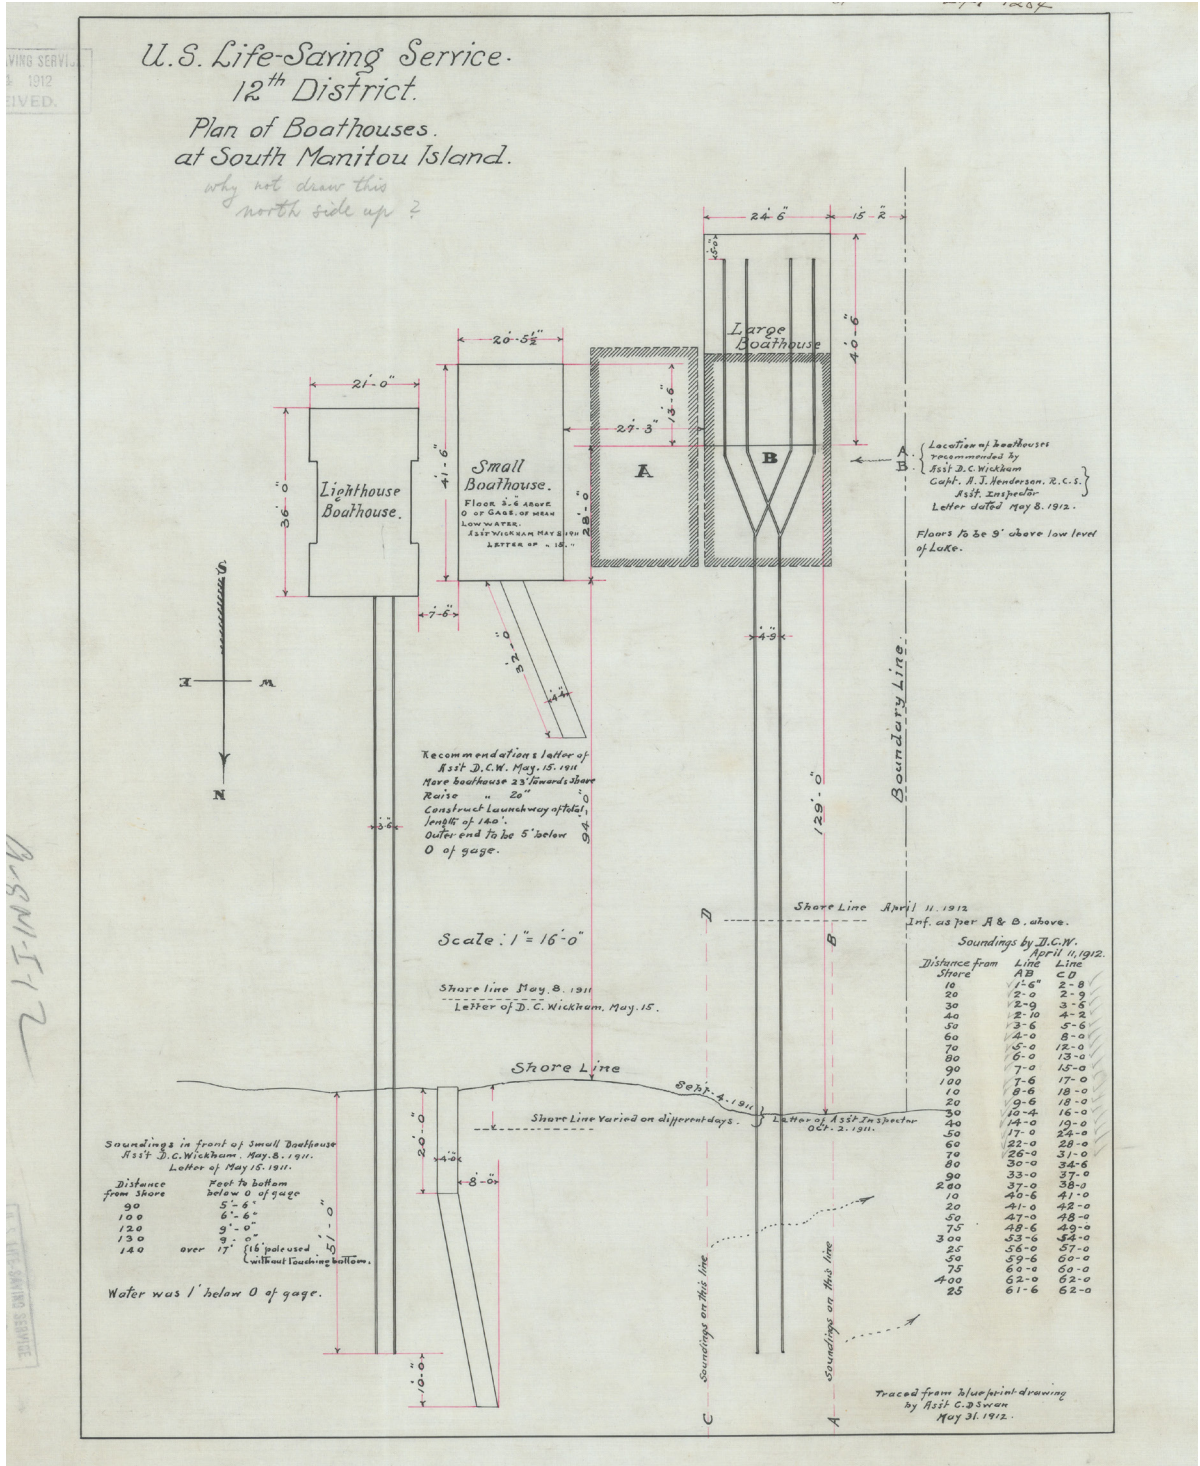
Figure 2-16. 1912 recommendations for locations of Boathouse #2 and Lighthouse Boathouse.

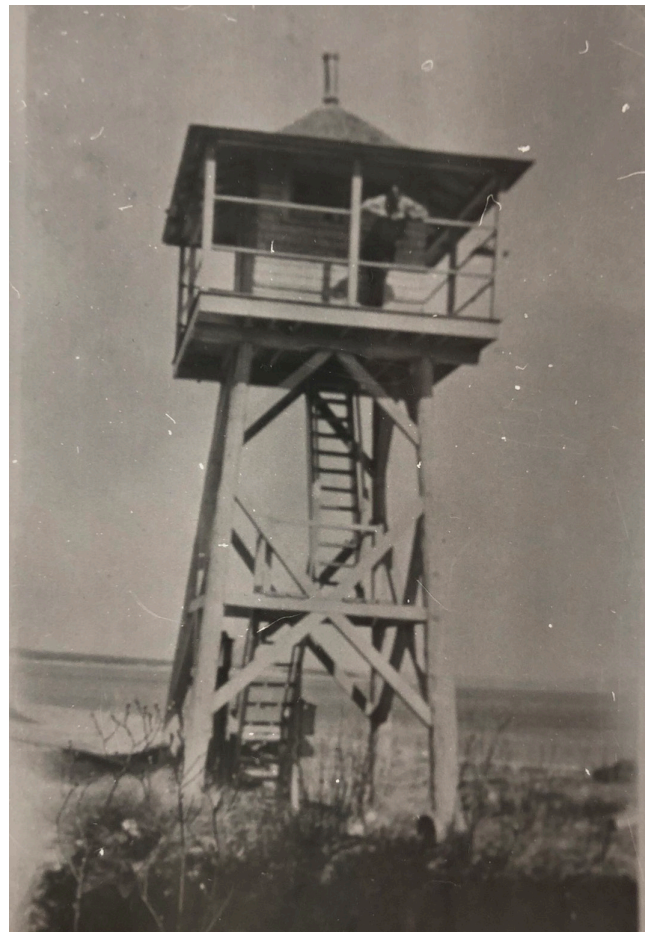
Figure 2-18. Coast Guard Lookout Tower after its relocation further inland, 1927 (source: National Visual Inventory Cards, Sleeping Bear Dunes National Lakeshore).

Water from Lake Michigan washed the beach at the Lookout Tower away. South Manitou Island Life-Saving Station's crew relocated the Lookout Tower further inland.^{2.70}

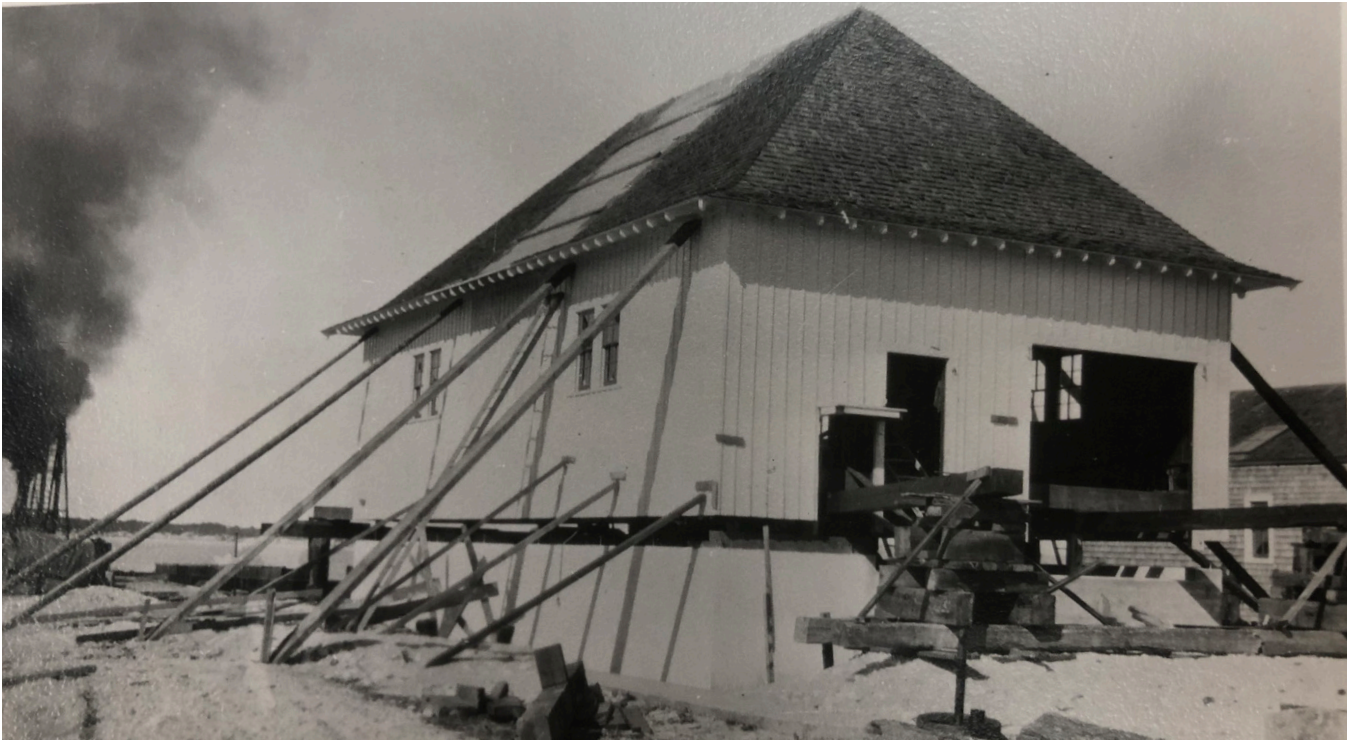
Figure 2-20. The raising of the Boathouse #2, 1916 (source: National Visual Inventory Cards, Sleeping Bear Dunes National Lakeshore).

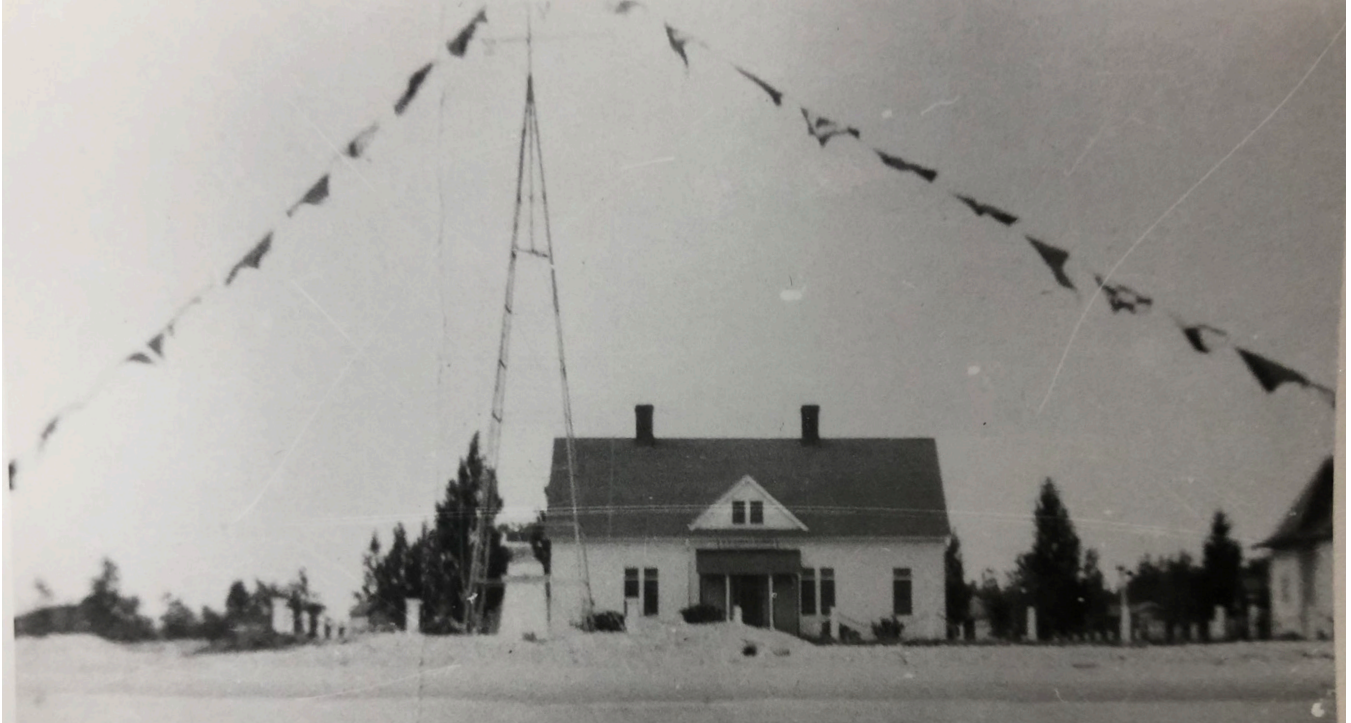
Figure 2-27. The Storm Signal Tower and Flag Locker at the Station Dwelling, 1928 (source: National Visual Inventory Cards, Sleeping Bear Dunes National Lakeshore).

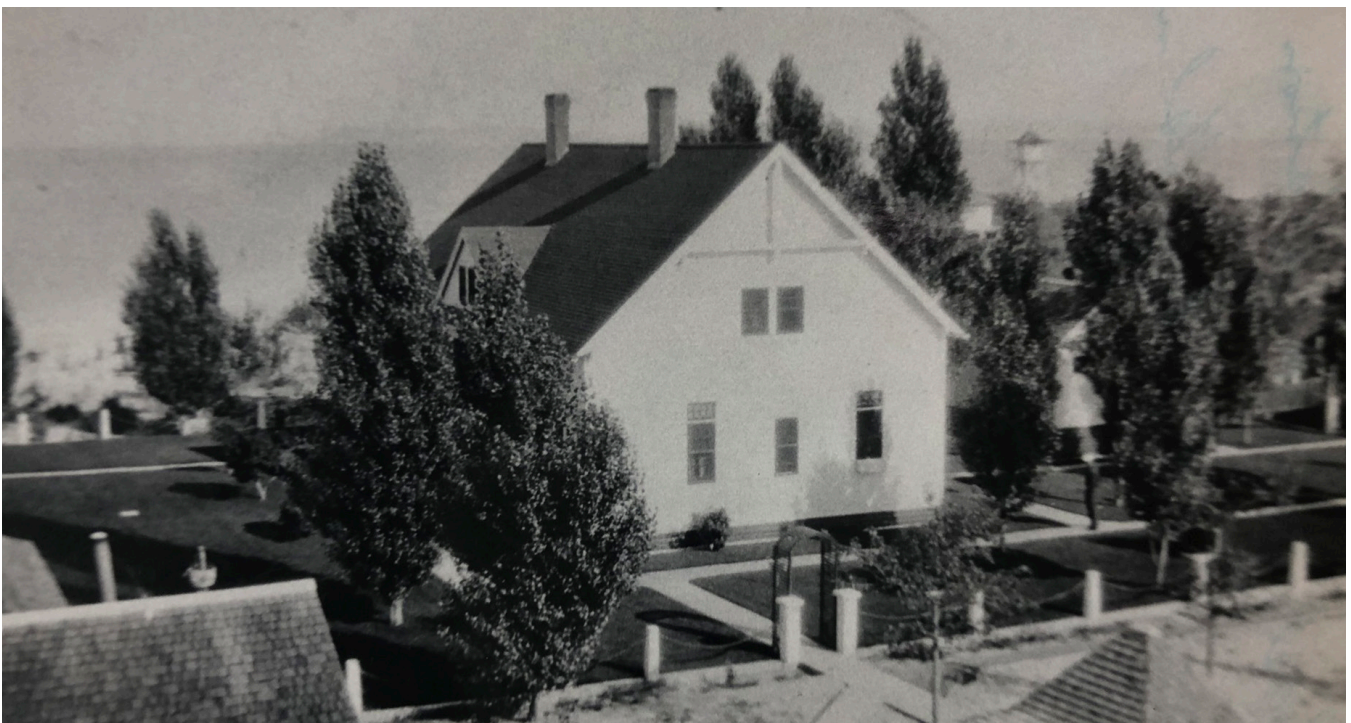
Figure 2-28. Concrete posts with a chain fence defining the perimeter of the lawn at the Station Dwelling, before 1932 (source: National Visual Inventory Cards, Sleeping Bear Dunes National Lakeshore).

South Manitou Island Life-Saving Station's crew built concrete posts for a chain fence around the lawn of Station Dwelling, a decorative archway over the path between the Station Dwelling and Boathouse #1, a chimney in the laundry building (likely Wood Shed), and the Pumphouse.^{2.77}

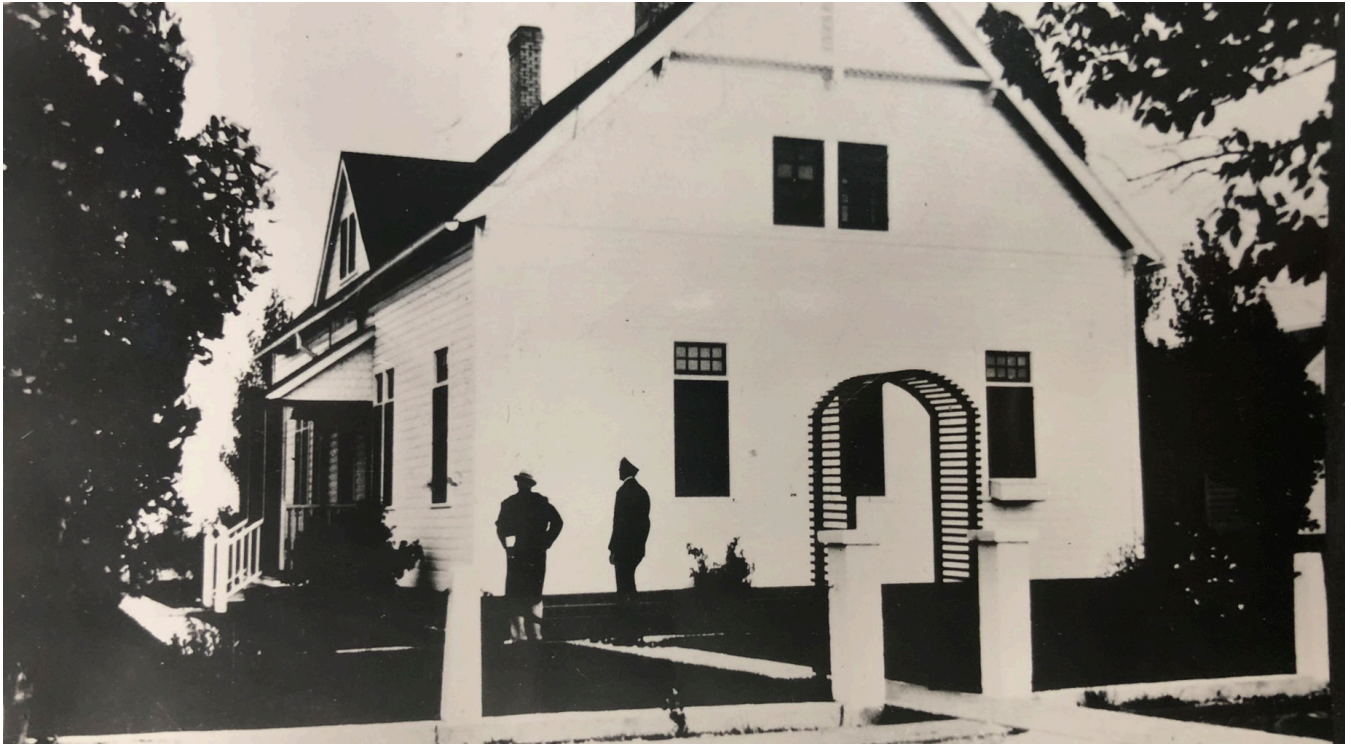
Figure 2-29. Decorative archway over the path at the Station Dwelling, 1930 (source: National Visual Inventory Cards, Sleeping Bear Dunes National Lakeshore).

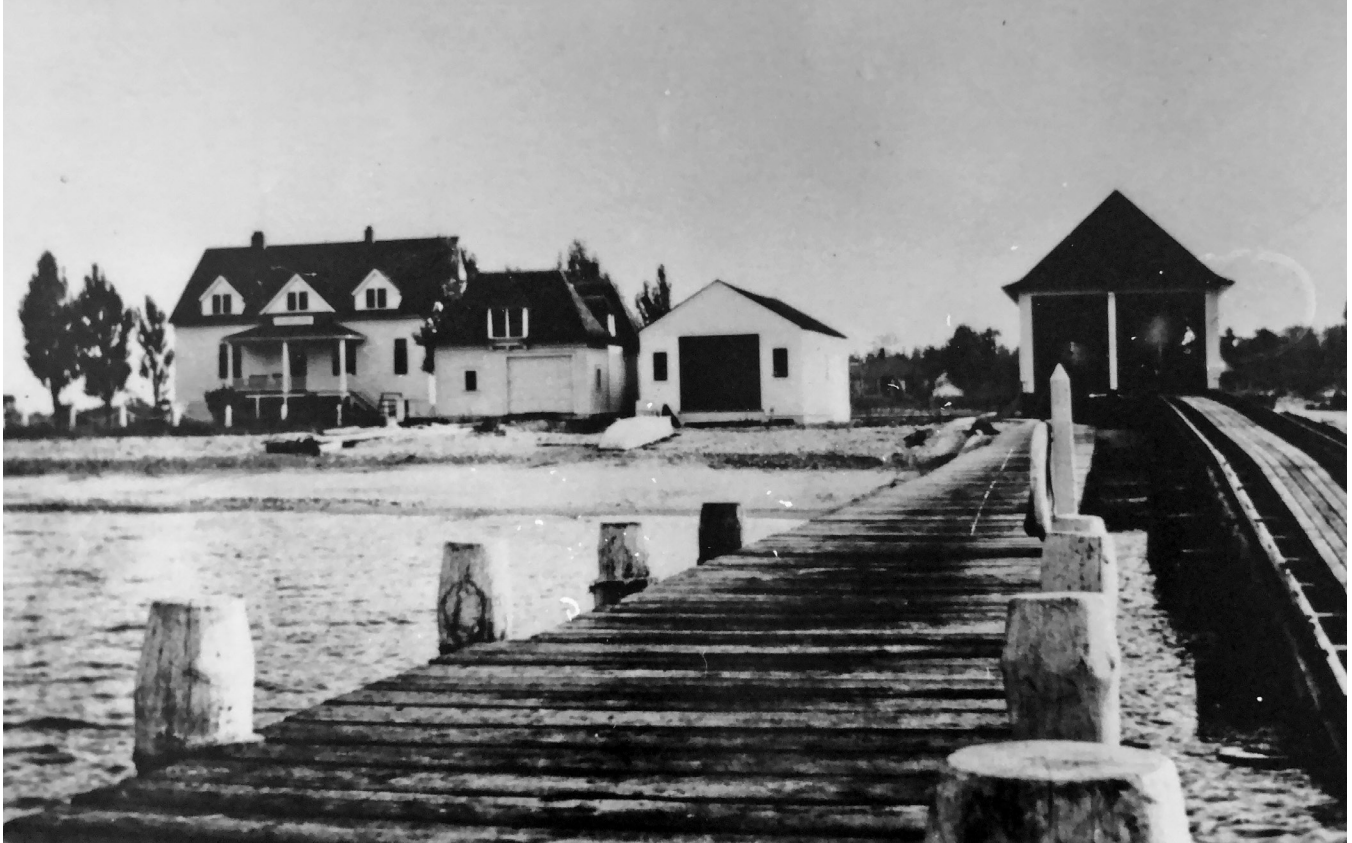
Figure 2-34. Launchway set on wooden piles with two tracks for lifeboats and pile bent dock built in 1932 (source: National Visual Inventory Cards, Sleeping Bear Dunes National Lakeshore).

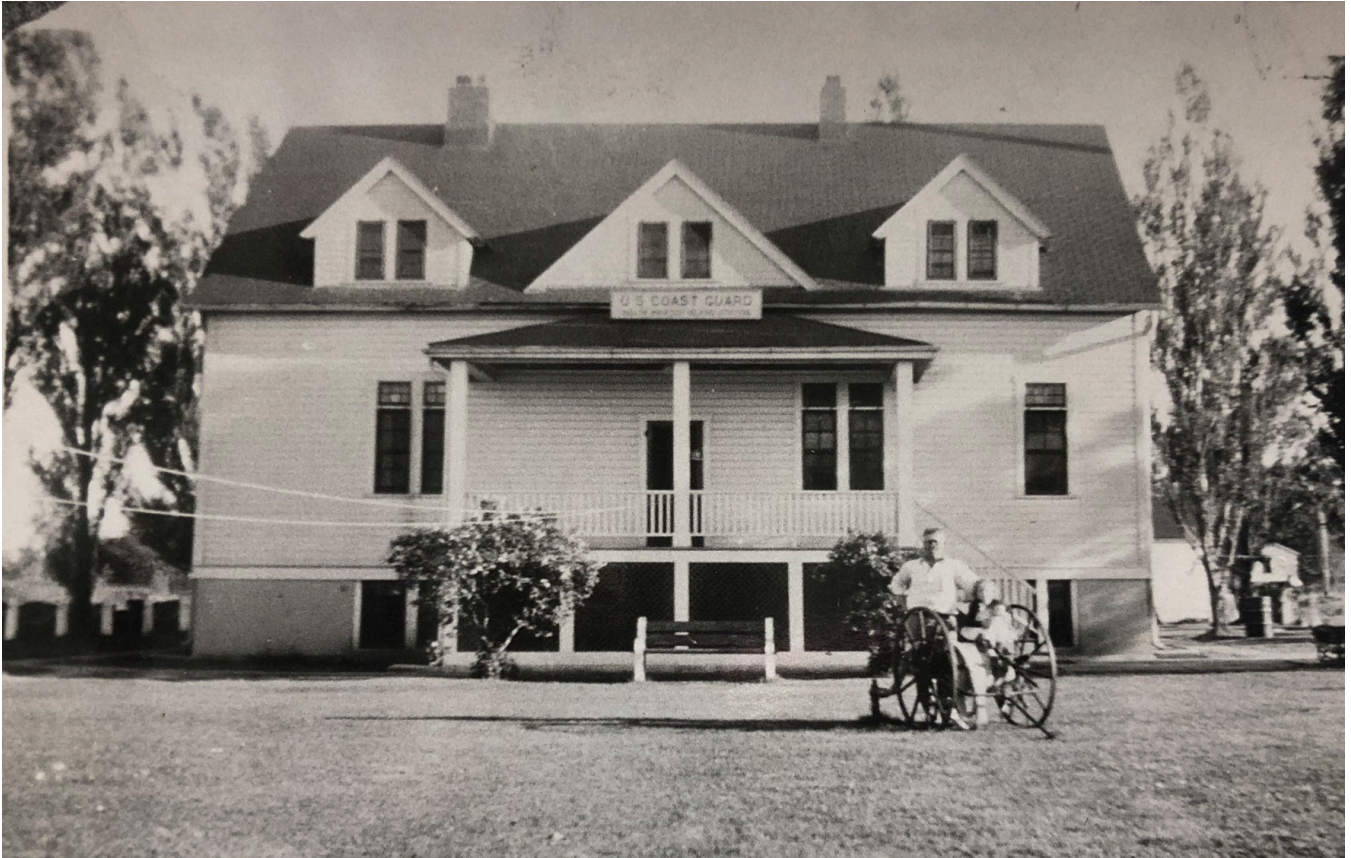
Figure 2-38. Raised Station Dwelling with front porch, c. 1946 (source: National Visual Inventory Cards, Sleeping Bear Dunes National Lakeshore).

The USCG developed plans to modernize the Station Dwelling, and John Senesi was awarded the construction contract in 1932. This included raising the building and underpinning it with a concrete basement. The basement included a boiler room, coal bin, laundry and storm clothes room, generator and pump room,

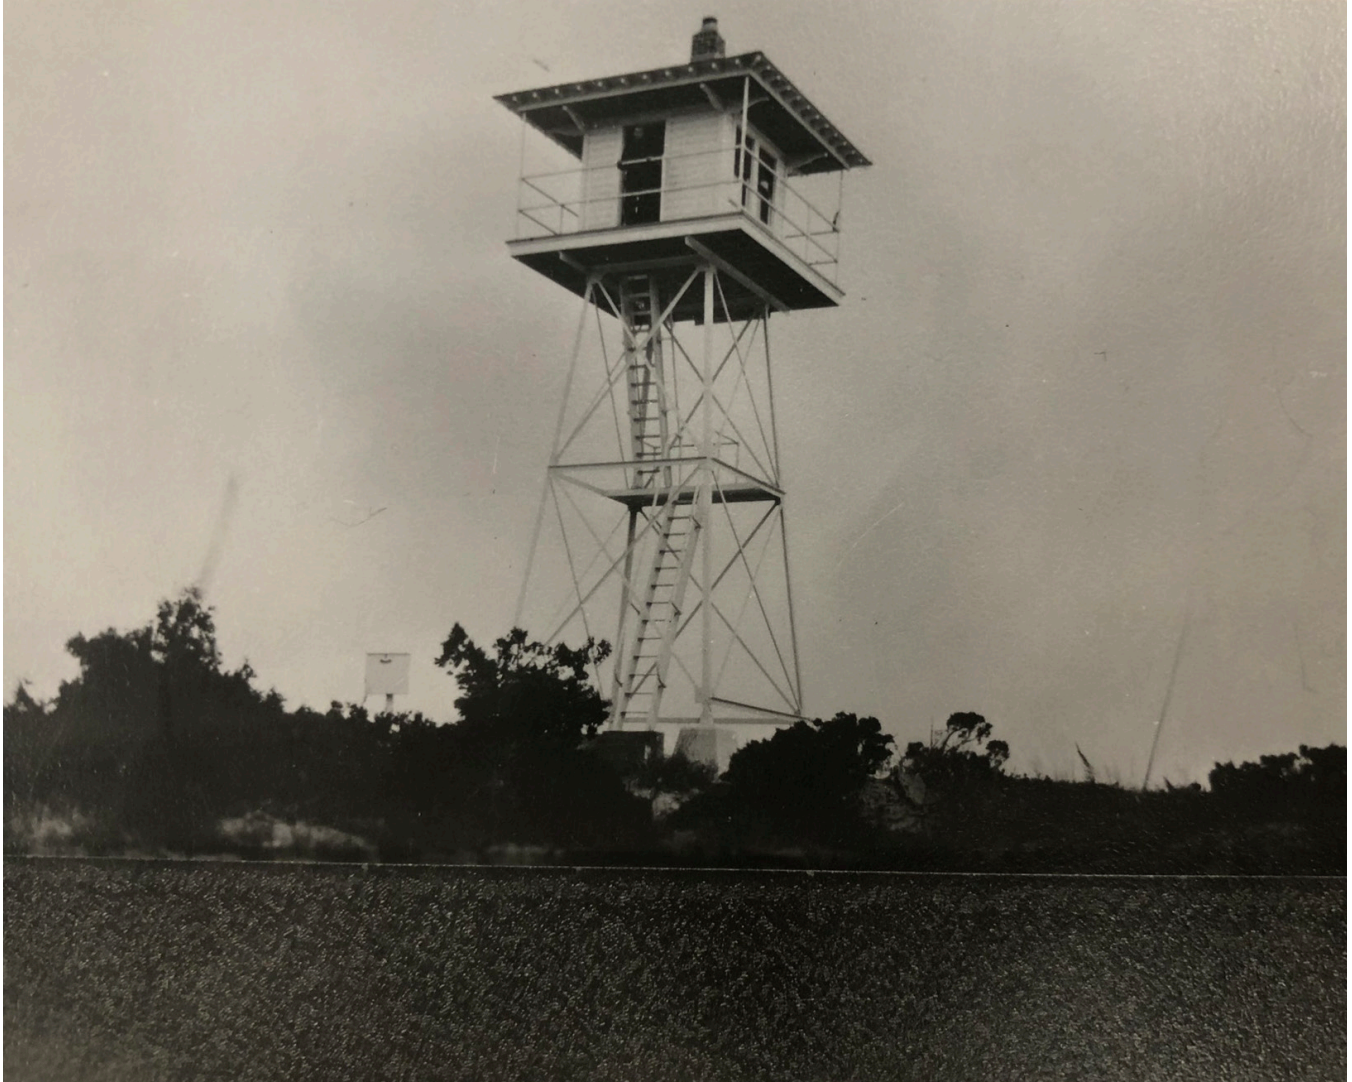
Figure 2-39. Steel Lookout Tower, after 1933 (source: National Visual Inventory Cards, Sleeping Bear Dunes National Lakeshore).

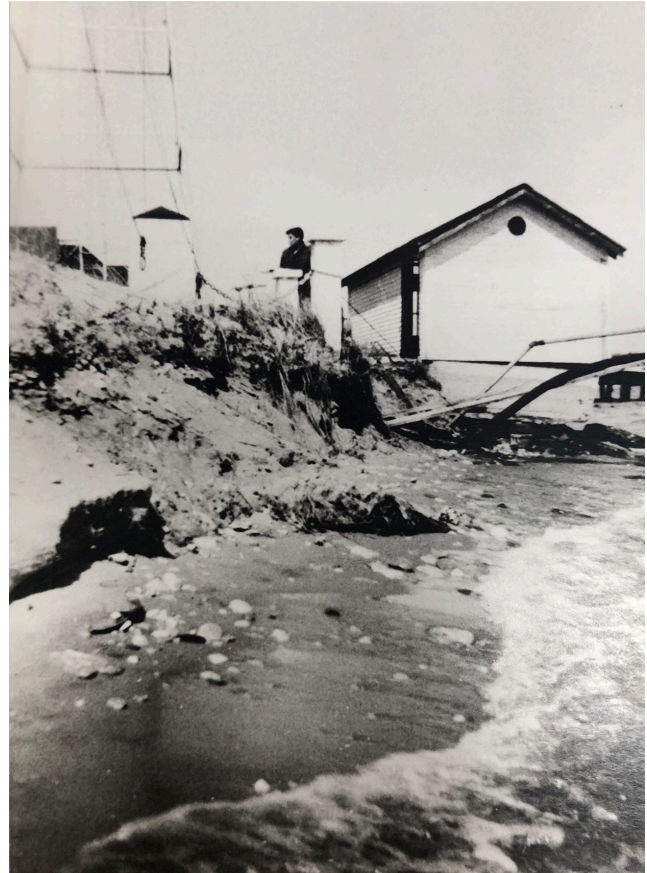
Figure 2-40. Erosion at shoreline, winter 1946. Pumphouse and Storm Signal Tower and Flag Locker are in the background (source: National Visual Inventory Cards, Sleeping Bear Dunes National Lakeshore).

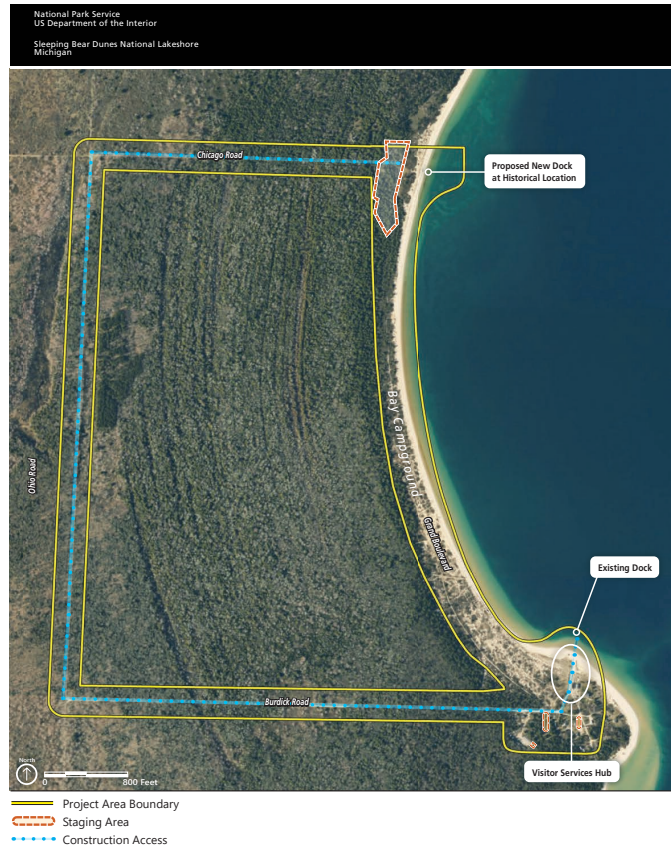
Figure 2-44. Proposed location of new dock (source: Sleeping Bear Dunes National Lakeshore).

The Great American Outdoors Act (GAOA) Legacy Restoration Fund allocated funding to address the impact of natural processes, such as littoral drift (shifting sands) and high water levels, on South Manitou Island’s existing dock. The NPS developed an Environmental Assessment (EA) to provide safe and reliable boat access to South Manitou Island. The following alternatives were developed.

- The no-action alternative would include maintenance and dredging at the existing dock on an as-needed basis, as funding allows. No new dock would be constructed.
- The action alternative (preferred) would improve boat access through the construction of a new pile-supported dock and demolition of the existing dock. The new dock would be built approximately 1 mile north of the existing dock at the site of a non-extant dock. The location would provide access to deep water and relatively protected conditions from wind and wave action.^{2.107}

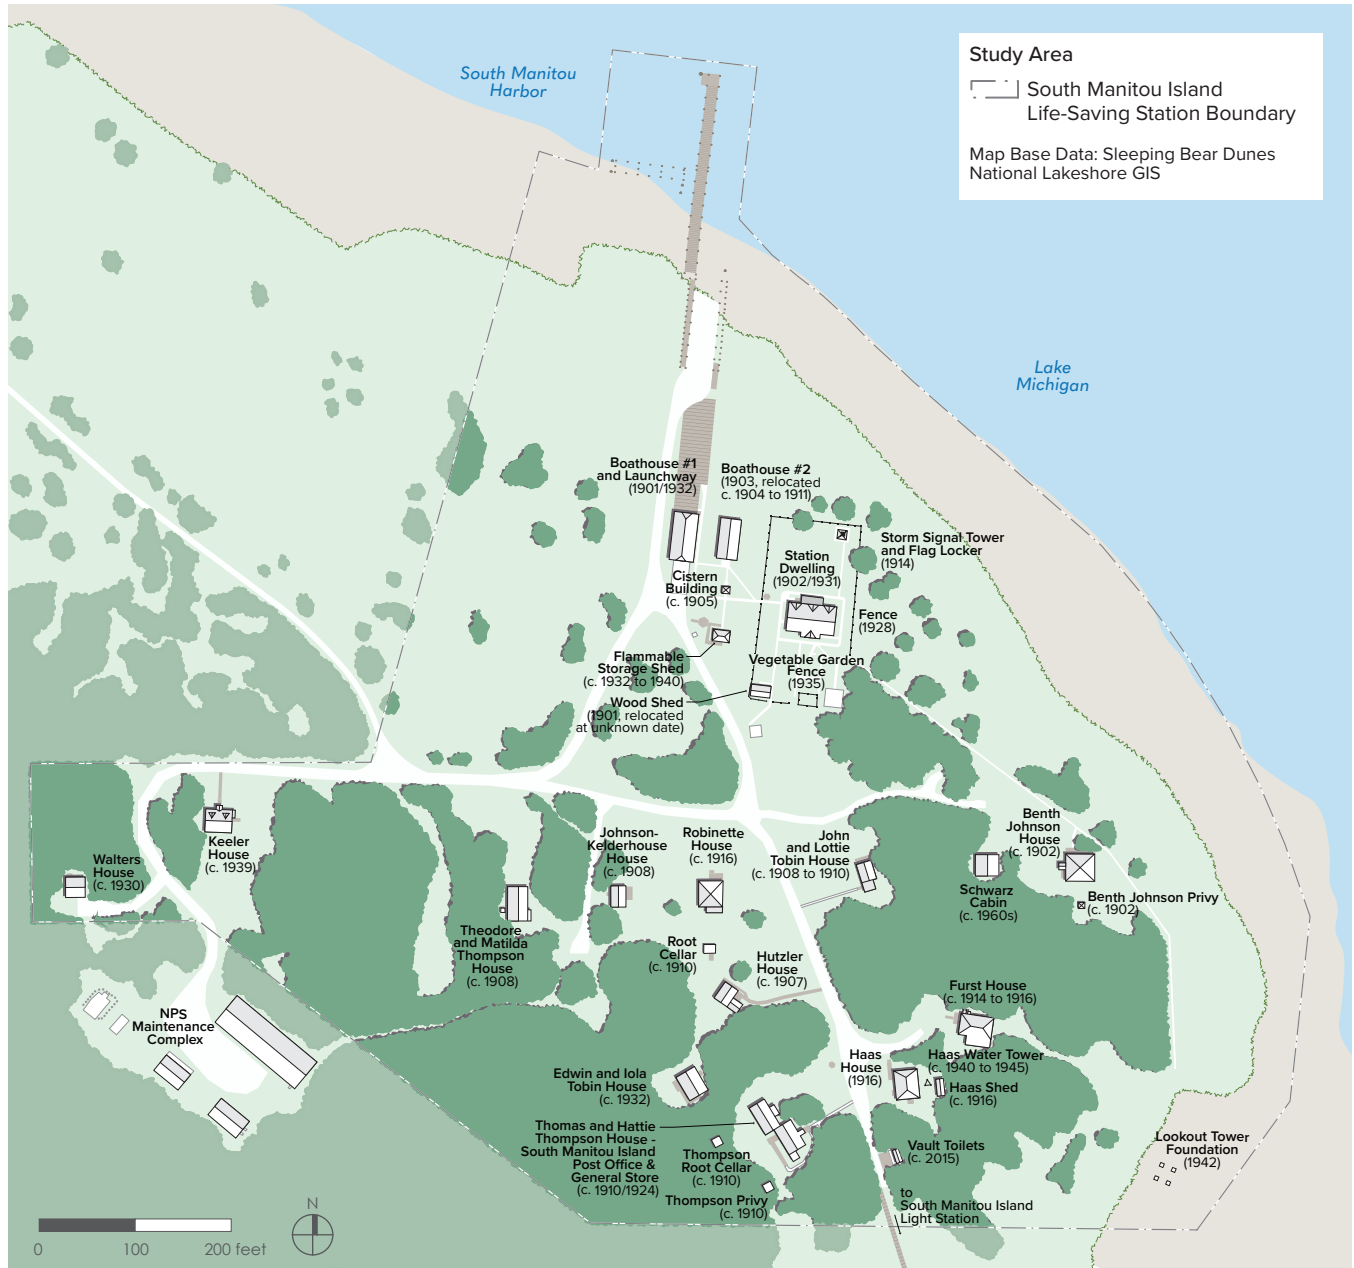
Figure 3-1. South Manitou Island Life-Saving Station and Village Existing Condition Plan (source: Mundus Bishop, 2025).

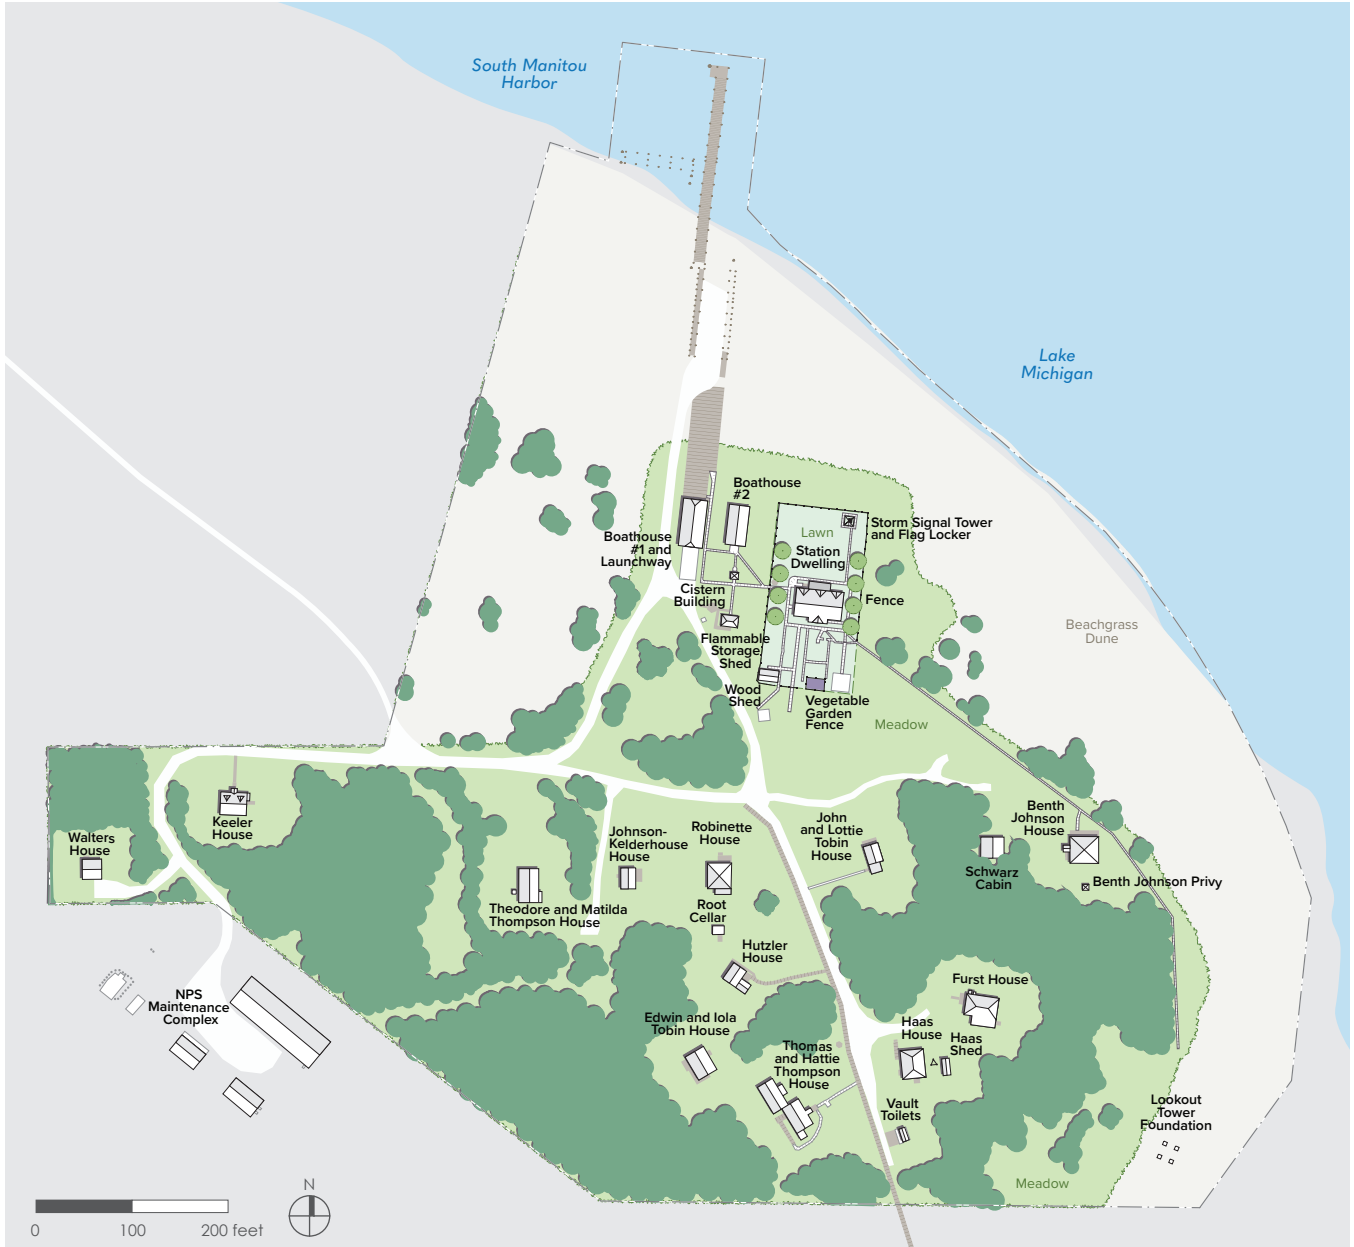
Figure 3-2. South Manitou Island Life-Saving Station and Village Treatment Plan (source: Mundus Bishop, 2025).

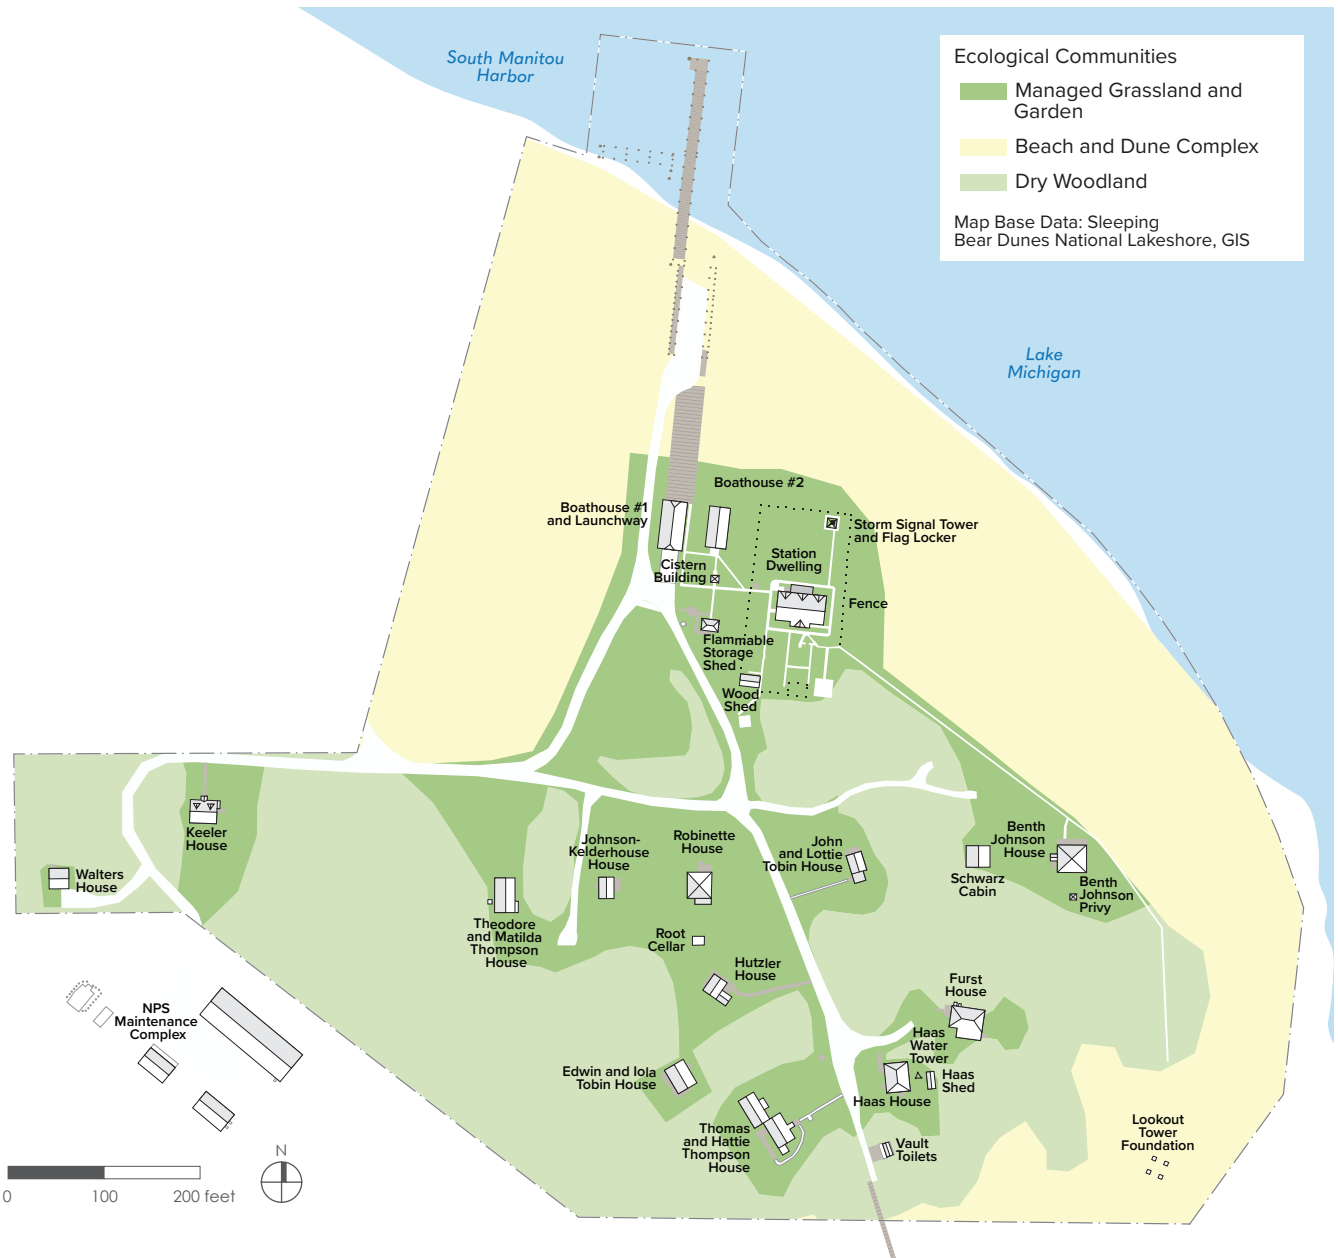
Figure 3-3. South Manitou Island Life-Saving Station and Village Natural Systems and Features Existing Condition (source: Mundus Bishop, 2025).

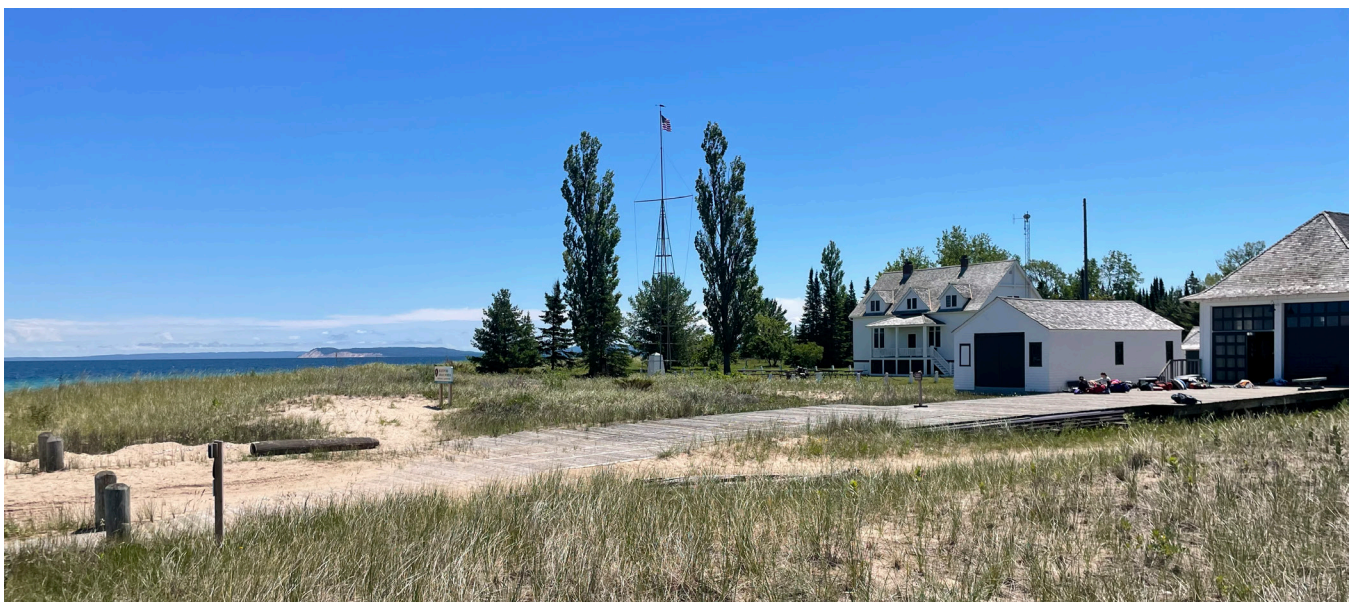
Figure 3-12. Building orientation to South Manitou Harbor and Lake Michigan (source: Mundus Bishop, 2024).

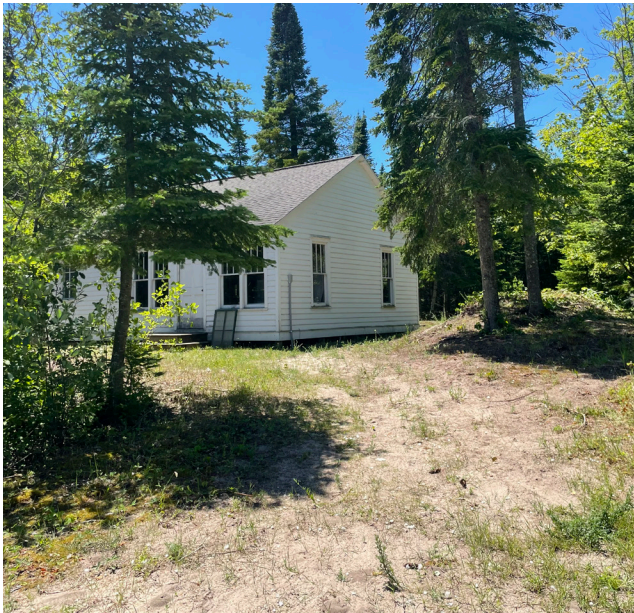
Figure 3-24. Berm north of the Edwin and lola Tobin House (source: Mundus Bishop, 2024).

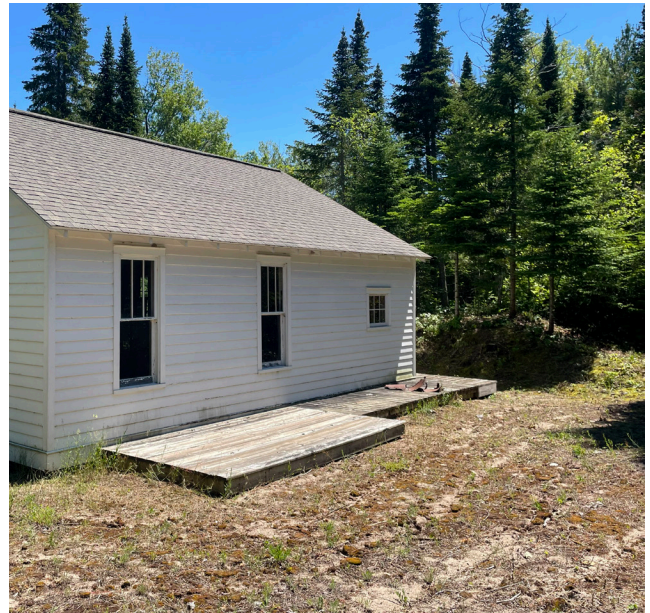
Figure 3-25. Berm south of the Edwin and lola Tobin House (source: Mundus Bishop, 2024).

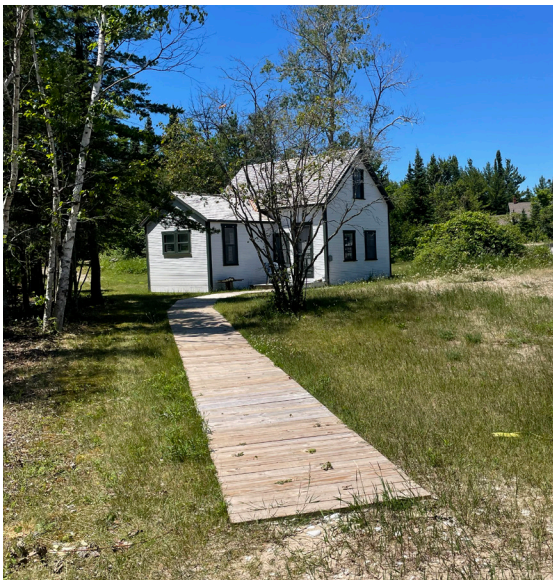
Figure 3-27. Boardwalk access to the Hutzler House (source: Mundus Bishop, 2024).

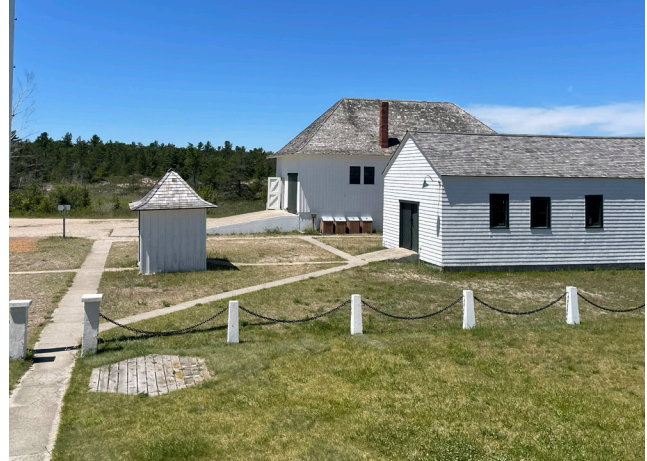
Figure 3-49. Utilitarian walks provide direction connections between buildings and features throughout the study area (source: Mundus Bishop, 2024).

South Manitou Island Life-Saving Station circulation includes utilitarian concrete walks providing access between buildings. Walks parallel building facades and provide direct connections between building entrances, reinforcing the formality of the cultural landscape. Walks are 2'-0" to 4'-0" wide and are stamped "USLSS." Walks are largely in fair to poor condition with areas of cracking, spalling, and missing material.

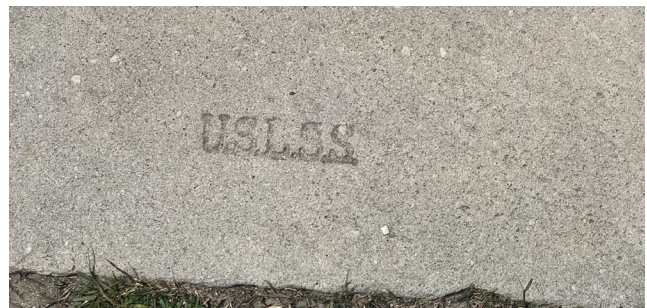
Figure 3-50. USLSS stamped on concrete walk (source: Mundus Bishop, 2024).

USLSS logs indicate walks were built as new buildings were added or existing buildings were moved. A wood boardwalk was typically built first and replaced later with a concrete walk. Gravel borders were placed along walk edges to aid in grass trimming and protect concrete work.

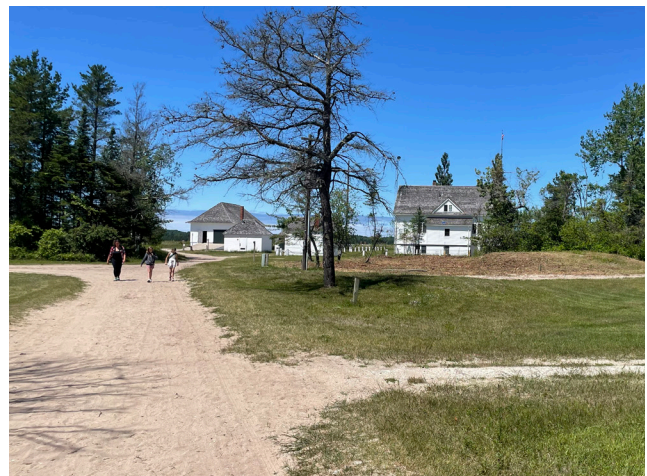
Figure 3-51. Sand and gravel routes provide pedestrian and NPS vehicle access (source: Mundus Bishop, 2024).

Hardpacked surface routes provide access for pedestrians and NPS administrative vehicles. These include routes from Boathouse #1 south through South Manitou Island Village to the Thomas and Hattie Thompson House and a route from the Benth Johnson House to the NPS Maintenance Complex. Hardpack surface routes are generally in good condition.

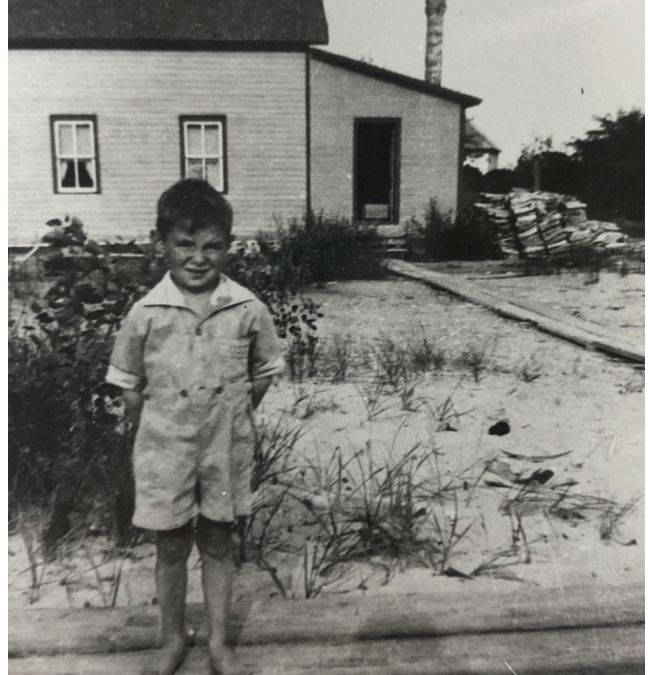
Figure 3-52. Narrow wood boardwalks historically provided access to the John and Lottie Tobin House, 1955 (source: Sleeping Bear Archives).
