Sleeping Bear Dunes National Lakeshore
Michigan

South Manitou Island Life-Saving Station and Village

Cultural Landscape Report

April 2026

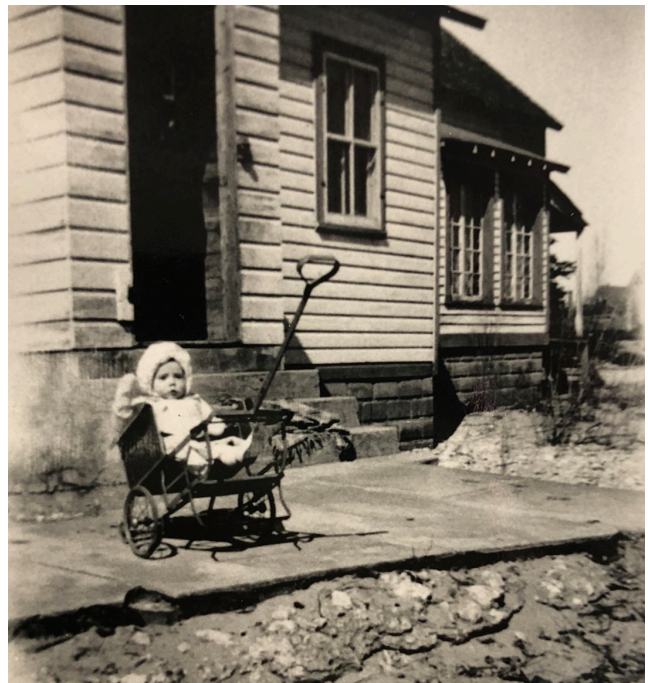
Figure 3-53. Concrete walks historically provided access to the Thomas and Hattie Thompson House and Post Office, after 1925 (source: Sleeping Bear Archives).

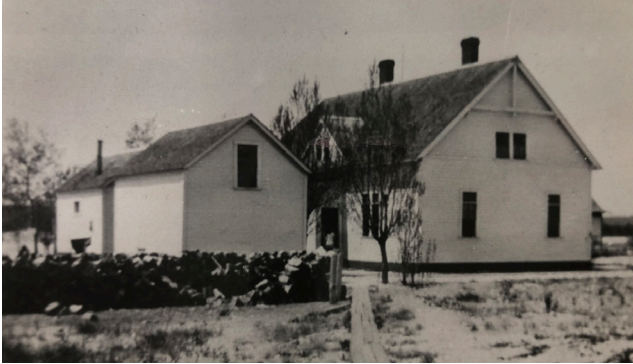
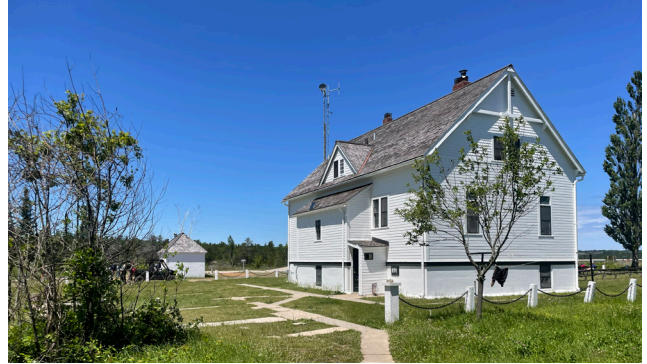
Figure 3-54. Boardwalks south-southeast of the Station Dwelling, 1927 and present-day walks (right) (source: National Visual Inventory Cards, Sleeping Bear Dunes National Lakeshore and Mundus Bishop, 2024).

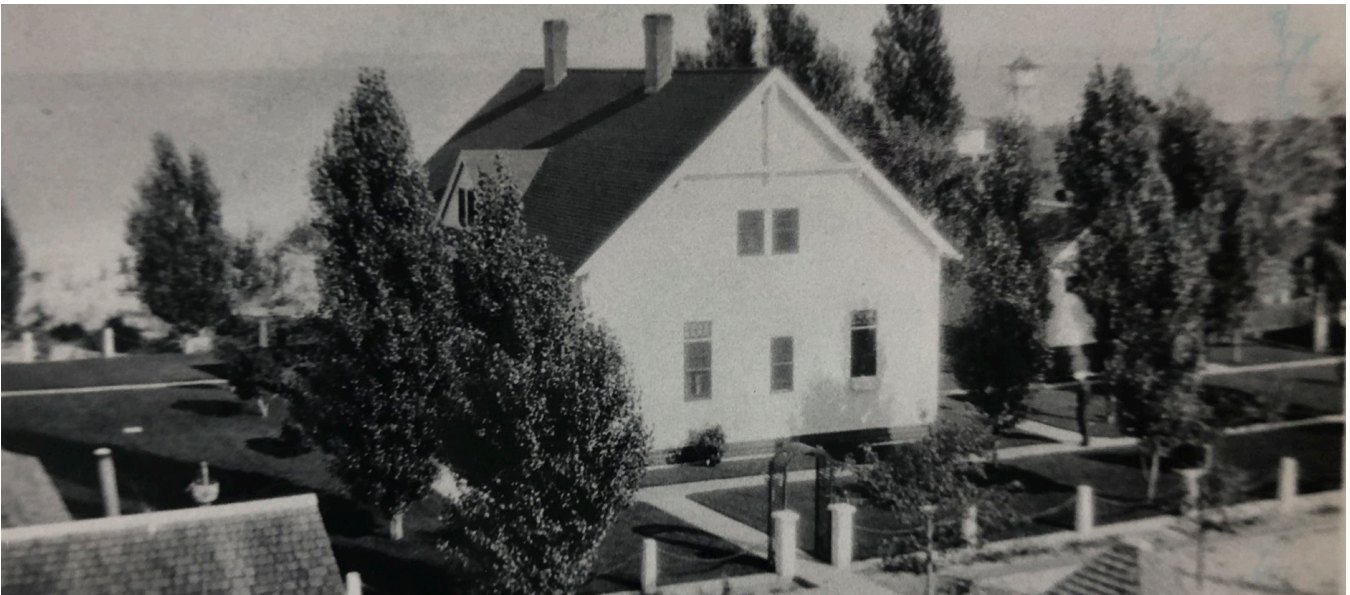
Figure 3-55. Orthogonal walks at the Station Dwelling, before 1932 (source: National Visual Inventory Cards, Sleeping Bear Dunes National Lakeshore).

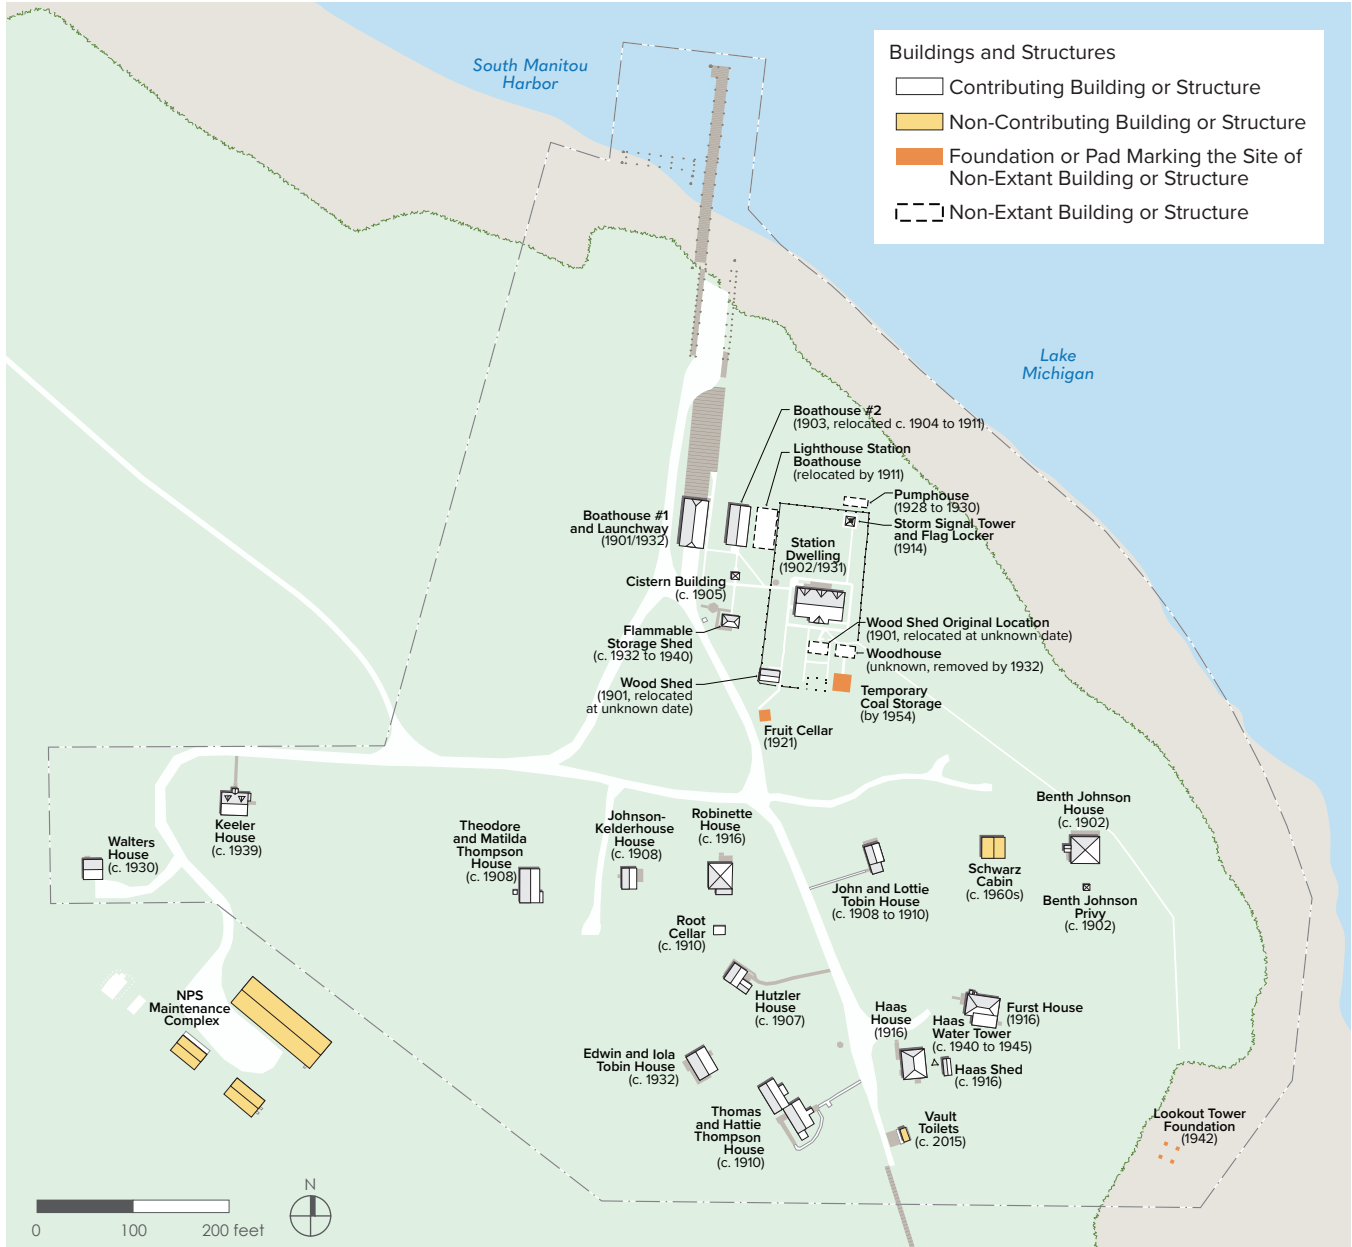
Figure 3-59. South Manitou Island Life-Saving Station and Village Contributing and Non-Contributing Buildings and Structures (source: Mundus Bishop, 2025).

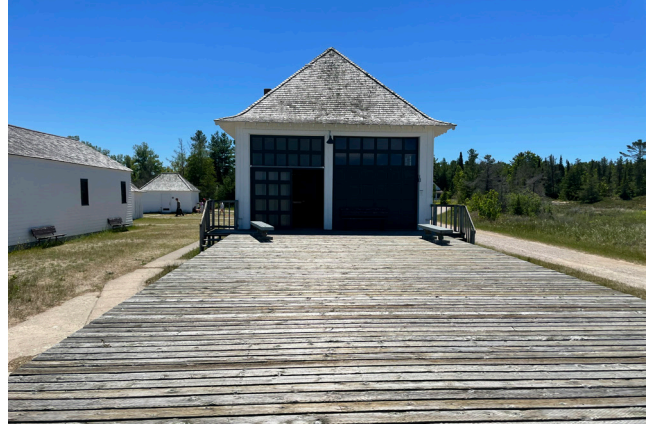
Figure 3-60. Boathouse #1 and Launchway (source: Mundus Bishop, 2024).

Feature	Description	CRIS-CL Resource ID	CRIS-HS Resource ID	FMSS Record Type	FMSS Record Number	Condition	Contributing/ Non-Contributing
Boathouse #1 and Launchway	24'-0" by 50'-0" wood-frame building with a wood shingled hip roof and interior brick chimney and two bays, one with a marine rail for launching surfboats.	—	006007	Location	1868		Contributing
Boathouse #2	42'-0" by 21'-0" wood-frame building with a gable roof and one bay.	—	006009	Location	1869		Contributing
Cistern Building (Small Shed)	7'-4" by 8'-5" one-story wood frame building on a concrete foundation with a wood shingled hip roof with flared eaves and exposed round rafter tails. Building is sheathed with vertical board and batten with double board and batten doors at north and south facade.	—	006008	Location	1870		Contributing
Flammable Storage Shed	10'-0" by 10'-0" one-story concrete building with wood shingled hip roof and modern metal entry doors at north and south facade. Building has been rehabilitated for comfort station use.	—	015245	Location	2173		Contributing

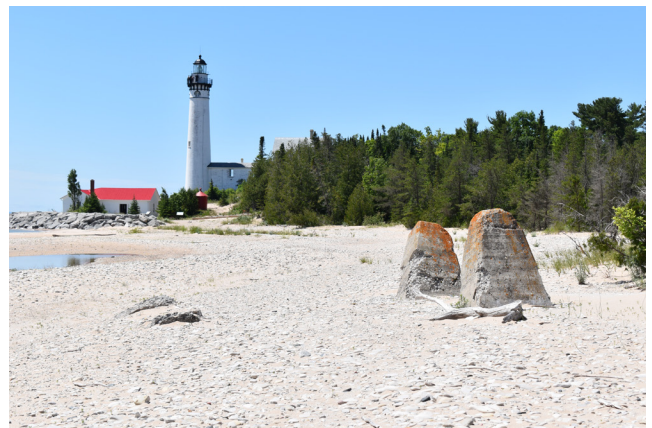
Figure 3-67. Lookout Tower Foundation (source: Mundus Bishop, 2024).

Lookout Tower Foundation	Four concrete piers. Two east piers are ruins. West piers are 6'-0" tall and 4' square at base and are pyramidal in form. Condition is impacted by deterioration of concrete and lichen growth.	—	543975	Asset	015061		Contributing
Storm Signal Tower and Flag Locker	8'-0" by 10'-0" by 70'-0" metal tower. 4'-0" by 4'-0" by 8'-0" metal flag locker.	—	015062	Asset	543275		Contributing
Station Dwelling	30'-0" by 50'-0" two-story wood frame building with a concrete foundation, full basement, one gable dormer on the south and three gable dormers on the north.	—	006005	Location	1819		Contributing
Wood Shed	12'-0" by 18'-0" one-story wood-frame building with a side gable wood shingle roof, lap siding exterior walls with cornerboards and wood shingles in gable ends.	—	006010	Location	1871		Contributing

Preserve the Lookout Tower Foundation.

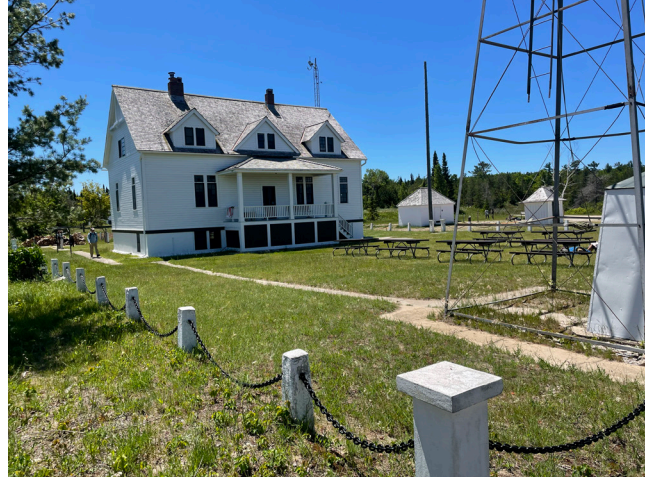
Figure 3-85. Fence, picnic tables, telephone pole, and radio tower at the Station Dwelling (source: Mundus Bishop, 2024).

Contributing features include fences surrounding the grounds and garden at the Station Dwelling, telephone poles, and a well. The stone planter at the Benth Johnson House likely dates to the period of significance. The concrete bench, steam powered fog whistle, and farm machinery at the Thomas & Hattie Thompson House—South Manitou Island Post Office and General Store date to the period of significance.

Preserve and repair small scale features that contribute to the historic character of the cultural landscape, including the fence surrounding South Manitou Island Life-Saving Station grounds and its historic garden, a well, telephone poles, stone planter at the Benth Johnson House, and bench, steam powered fog whistle, and farm machinery at the Thomas & Hattie Thompson House—South Manitou Island Post Office and General Store.

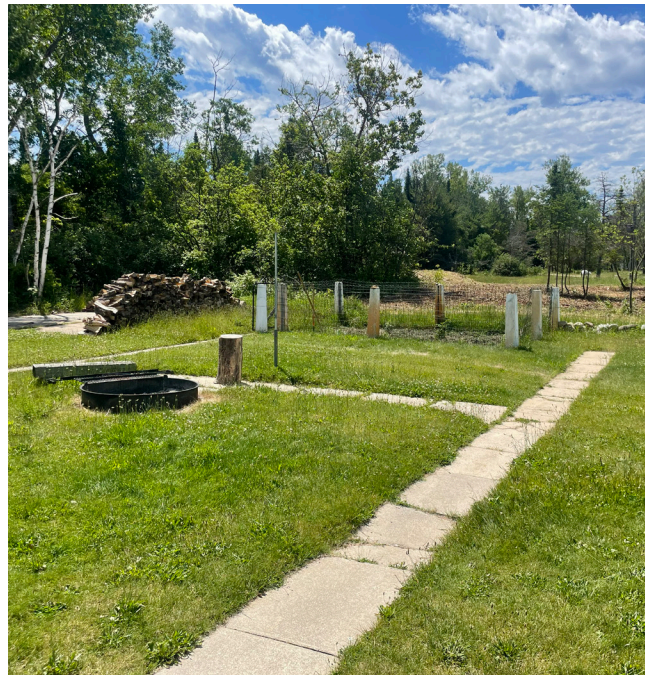
Figure 3-86. Wire fence defining the vegetable garden at the Station Dwelling. Non-contributing grill/fire ring has been removed (source: Mundus Bishop, 2024).

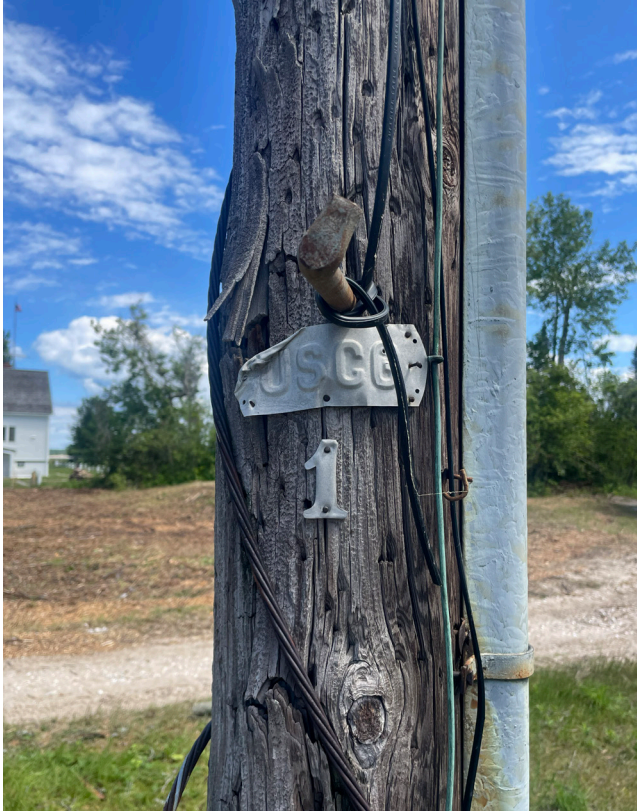
Figure 3-87. Telephone pole with USCG plate (source: Mundus Bishop, 2024).

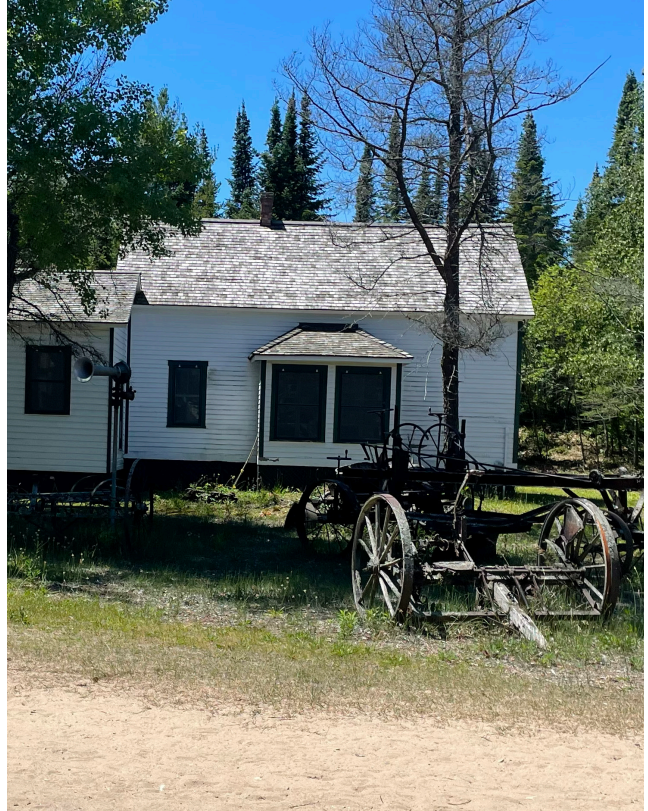
Figure 3-88. Fog whistle and farm machinery at the Thomas & Hattie Thompson House—South Manitou Island Post Office and General Store (source: Mundus Bishop, 2024).

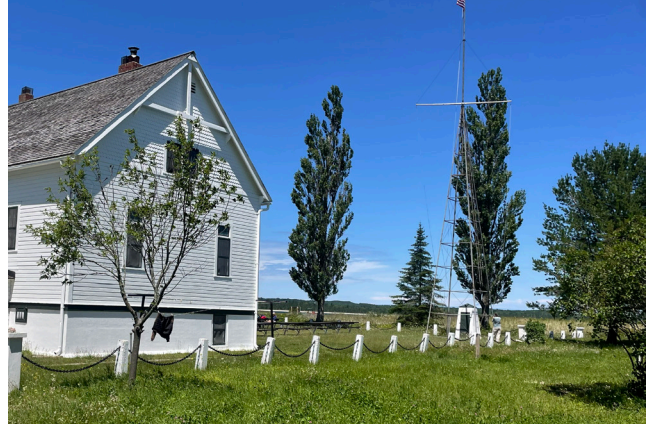
Figure 3-94. Mown lawn and Lombardy poplar trees at the Station Dwelling (source: Mundus Bishop, 2024).

Additional plantings at the Station Dwelling included apple trees, shrubs along its foundation, trees planted in a uniform grid pattern west of the building, and a vegetable garden to the south of the building. Two Lombardy poplar trees remain north of the Station Dwelling and the vegetable garden remains and

Preserve Lombardy poplar trees north of the Station Dwelling, continuing to perform routine pruning to maintain tree form and health. Do not replace in current locations north of the Station Dwelling when they become hazards or die to maintain clear sight lines to South Manitou Harbor, Manitou Passage, and Lake Michigan from Station Dwelling.

- Repair the lawn to have a smooth, even grade with an even grass cover. Maintain the lawn with a low (3-inch) cut. Trim lawn away from edges of concrete walks and concrete curb to maintain a neat appearance.
- Monitor for weeds and bare patches. Repair damaged areas and maintain the lawn with an even cover of grass. Remove invasive and volunteer plants from the lawn.
- Maintain the area outside the fence with native low-growing grasses.

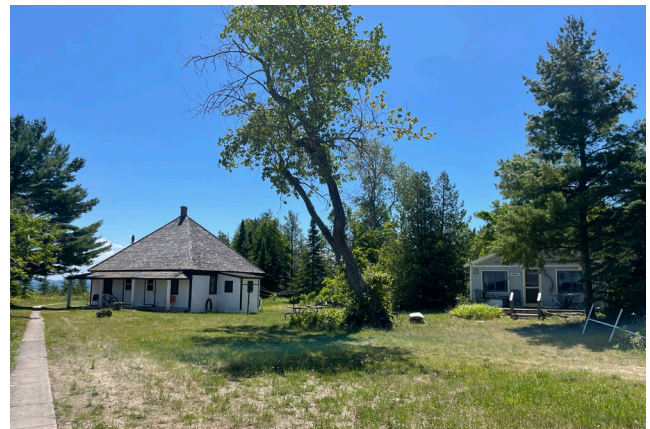
Figure 3-95. Lawn and low grasses at house sites (source: Mundus Bishop, 2024).

Repair historic patterns of open landscape surrounding South Manitou Island Village house sites. Manage vegetation to repair views to adjacent homes, South Manitou Island Life-Saving Station, and South Manitou Harbor and Lake Michigan.

- Provide a park-approved seed mixture of native and hardy sod-forming grasses and forbs with a maintained lawn appearance. Allow grasses to seed periodically. Monitor for weeds and bare patches. Repair damaged areas and maintain the lawn with an even cover of grass. Remove invasive and volunteer plants from the lawn.

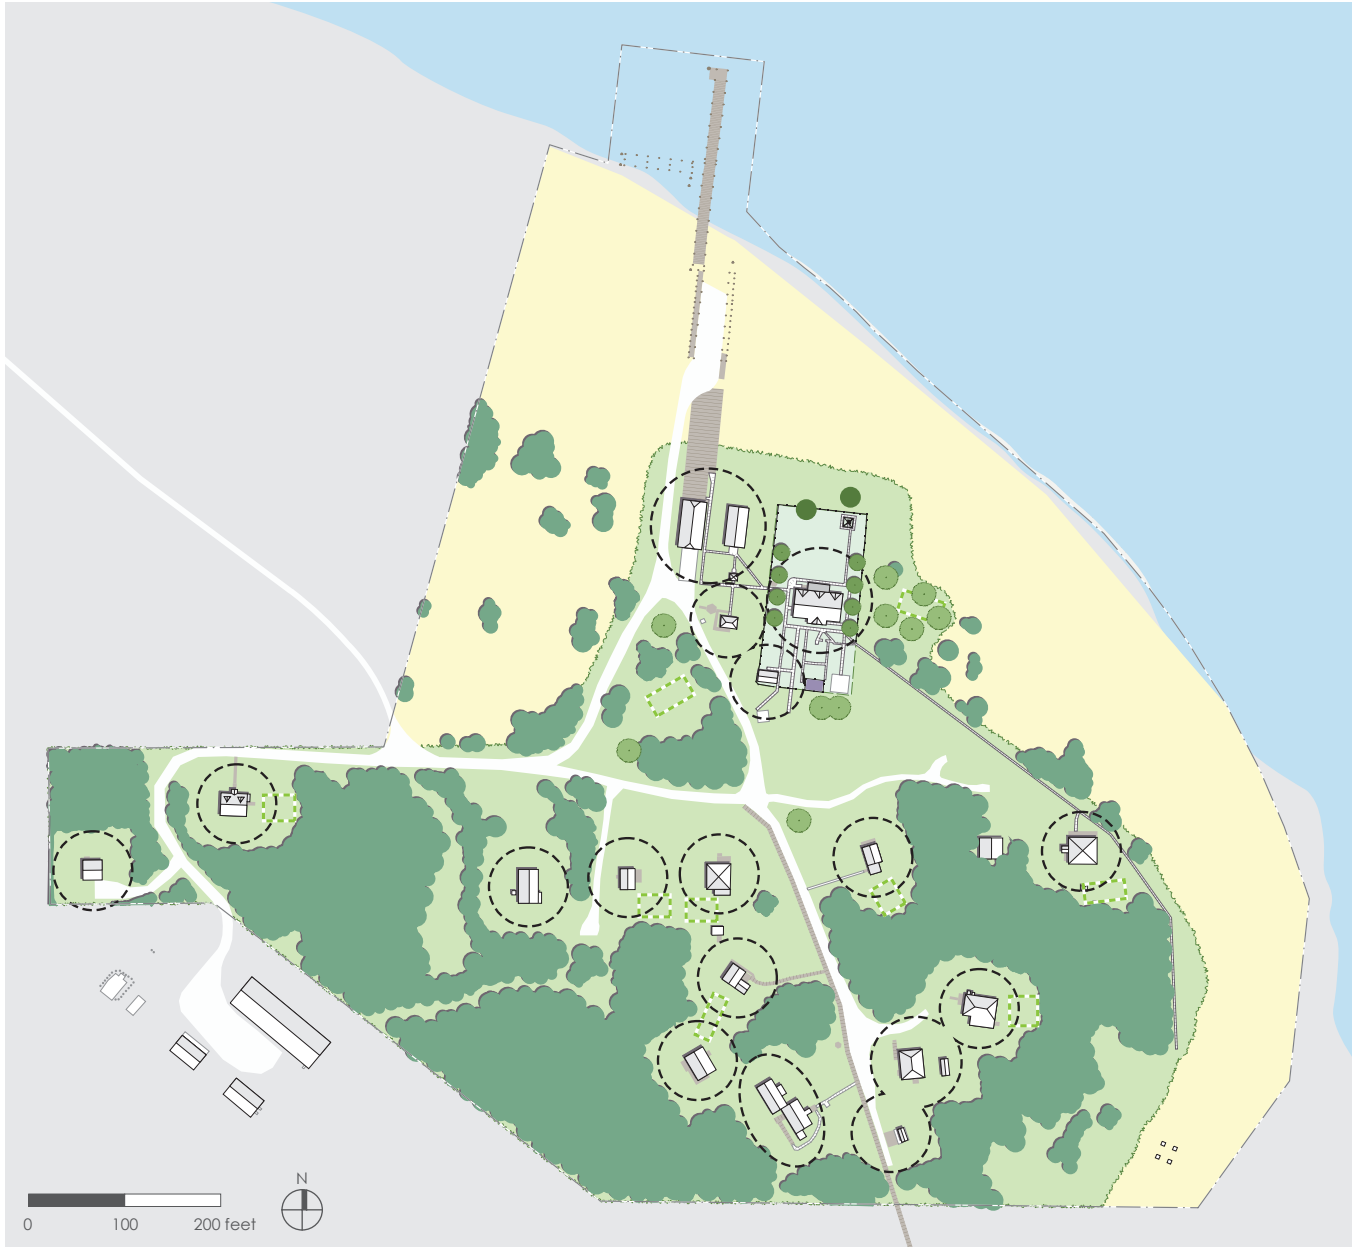
Figure 3-97. South Manitou Island Life-Saving Station and Village Vegetation Treatment (source: Mundus Bishop, 2025).

- Repair the historic tree allee at Staton Dwelling
 - Preserve existing Lombardy poplar trees and do not replace in current locations
 - Preserve extant apple trees
 - Maintain the lawn surrounding Station Dwelling
- Maintain grass free of shrubs and trees at leech field sites
 - Preserve managed grassland and garden vegetation
 - Preserve native beachgrass dune vegetation
 - Maintain fire buffers at buildings and structures

Repair historic patterns of non-extant allees at the Station Dwelling. Select trees of a similar columnar form to historic allees that are tolerant of high wind and sandy conditions with a tap root and slower growth rate. Consider species such as *Quercus 'Crimschmidt'*, *Populus x canescens 'Tower'* and *Populus tremula 'Erecta'* as alternatives to Lombardy poplar trees.
